Mapping Floodplain Fish Habitat in the Heart of the Fraser River and Restoration Options for Impacted Attributes on Selected Large Mid-Channel Islands

Thesis Submitted in Partial Fulfillment of the
Requirements for the Degree of
Master of Science in Ecological Restoration

© Lori Susan Bartsch 2019
SIMON FRASER UNIVERSITY
Spring 2019

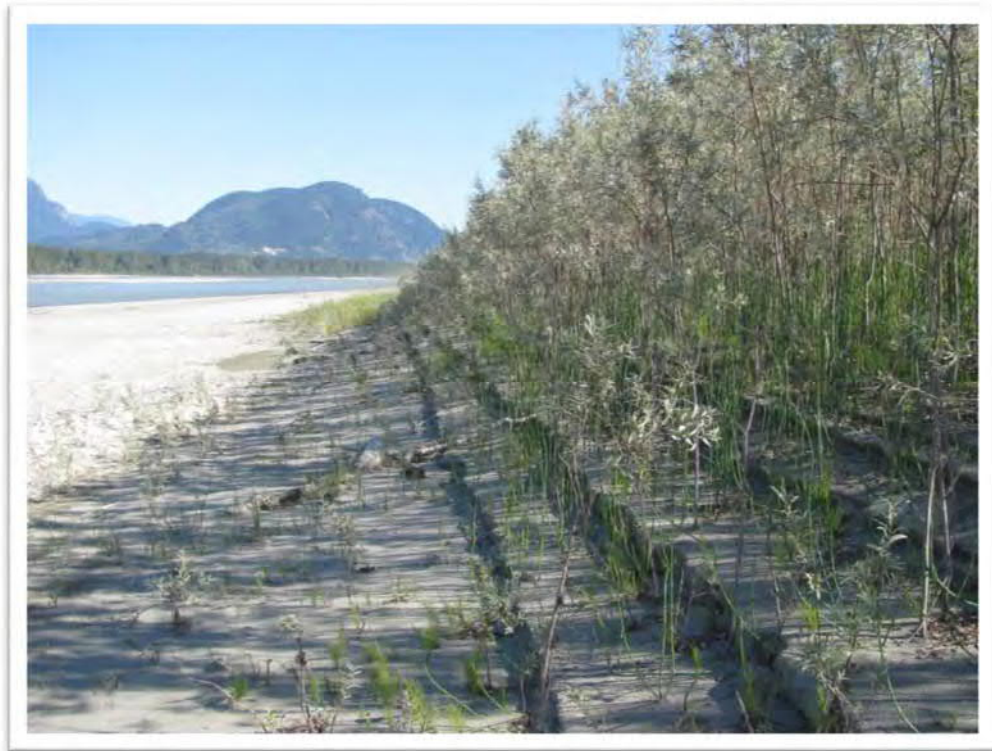
Figure 3. Deposited fine sediments and terraces created by erosive forces of receding water levels at Fraser River Ecological Reserve. Photo: Bill and Bev Ramey, 2008.

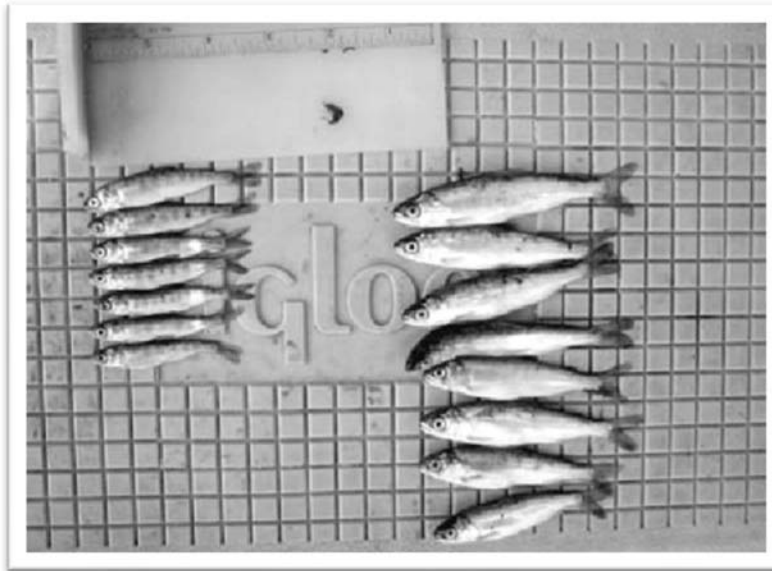
Figure 4. Comparison of Cosumnes River, California, juvenile Chinook Salmon reared in intertidal river habitat (left) vs those reared in floodplain vegetation (right), after 54 days (Jeffres et al., 2008).

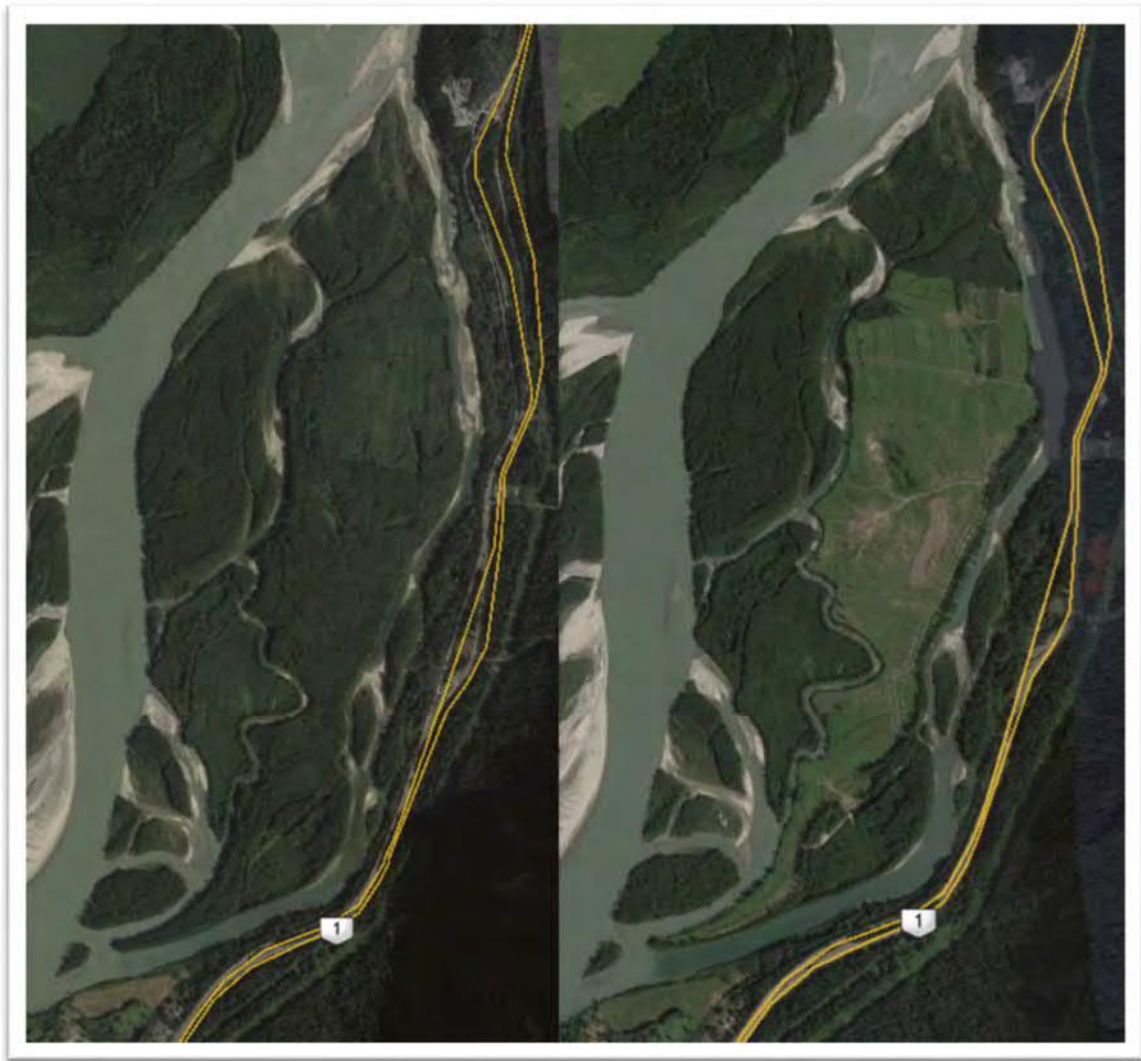
Figure 10. Google Satellite Imagery (accessed February 12, 2019) of Herrling Island from August 2016, on the left, and one year later in August 2017, on the right. Using Quantum GIS (QGIS), the cleared portion was digitized to produce a polygon for which the surface area (in acres) was calculated. Approximately 192 ha of cottonwood plantations were harvested.

There are several cross-island channels (Figure 10, 11) at Herrling island that constitute off-channel habitat (including flooded island surfaces) during freshet and high-water flows in this reach. The use of off-channel habitats by White Sturgeon, Chinook and other salmon in the lower Fraser River as described in Chapter 1 tells us that these off-channel habitats at Herrling are highly likely to be used as well.

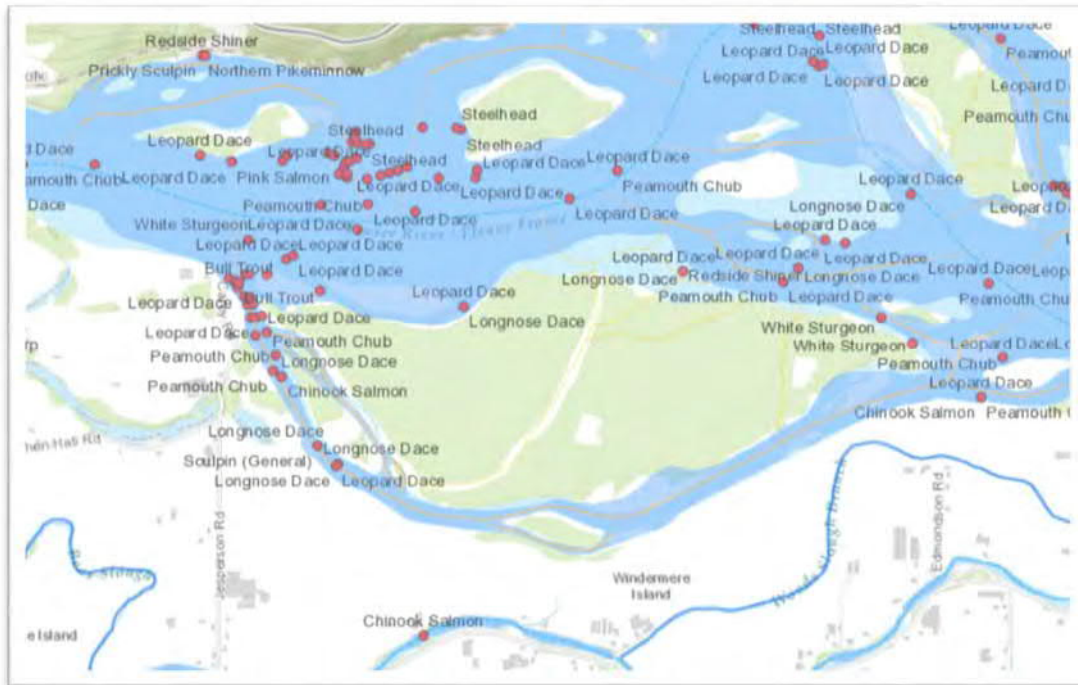
Figure 15. Habitat Wizard map of all fish occurrences in the vicinity of Carey Island, including both species-at-risk and those not warranted listing (Government of BC Habitat Wizard, 2019).

Like Herrling Island, the waters around Carey Island are defined as White Sturgeon habitat and the main secondary channel has been shown to be a location of White Sturgeon spawning (Perrin et al. 2003). Mapping using Habitat Wizard (BC Government, 2019) shows reported and mapped occurrences of various fish species in the vicinity of the island (Figure 15). It is important to note that this figure shows only those fish sightings reported and mapped by the agencies and others; the potential list of species that occur within this area is likely much more exhaustive than those shown on this image (Rosenau and Angelo, 2007).

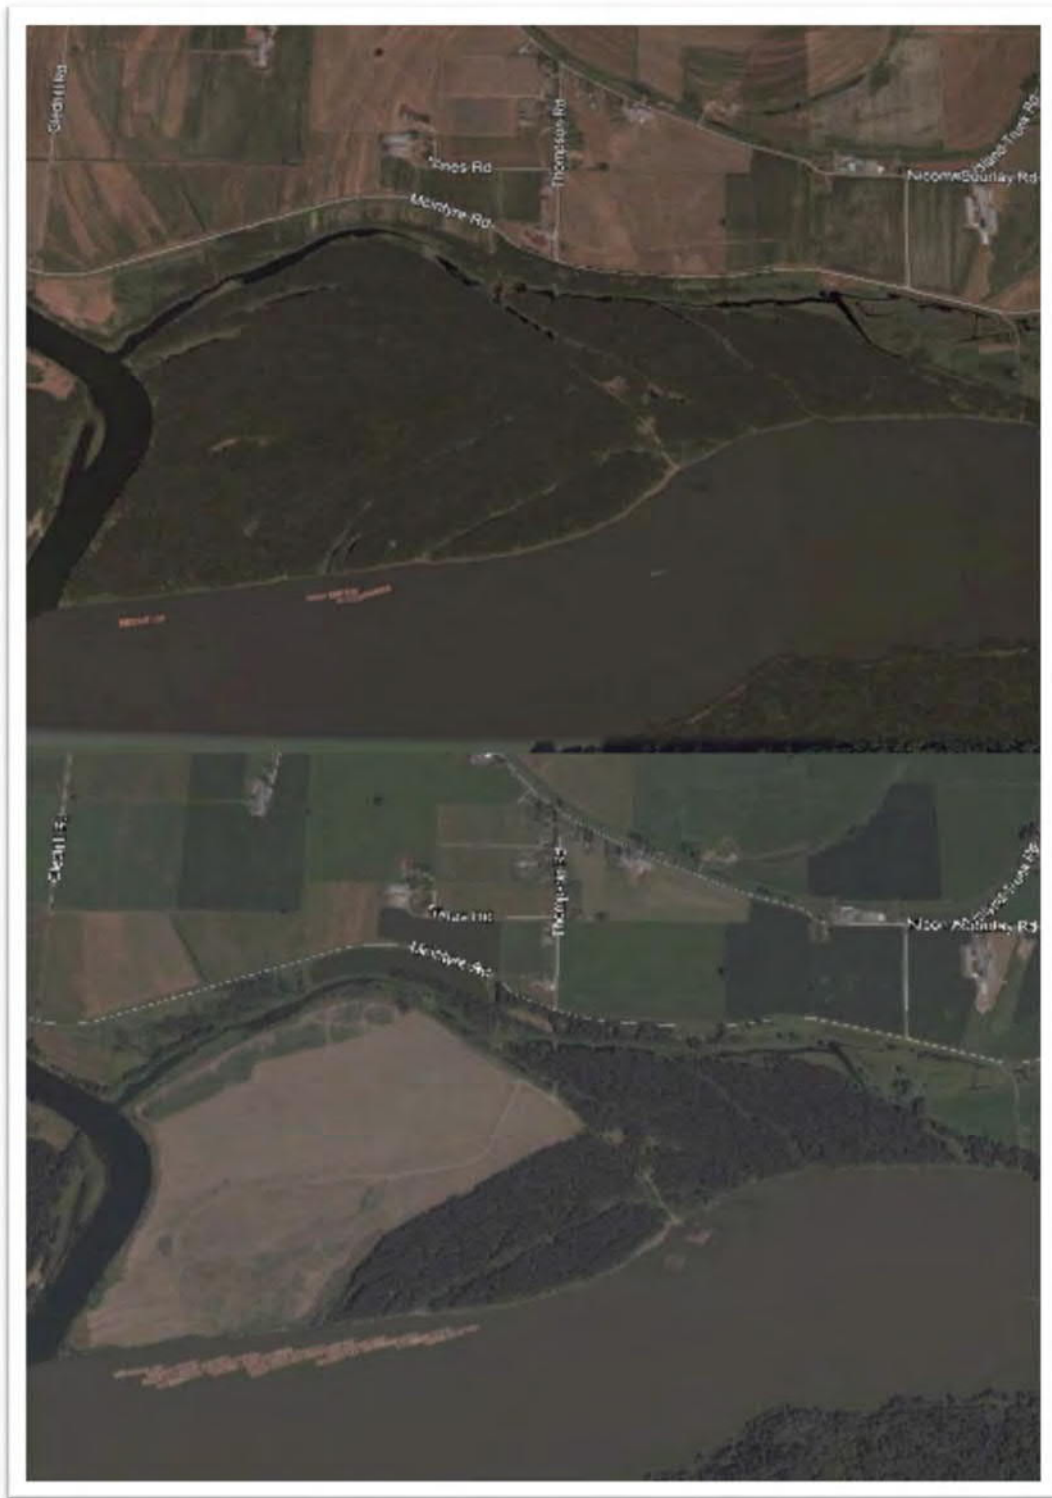
Figure 17. Google Satellite Imagery (accessed February 15, 2019) from September 2015 (top) and July 2016 (bottom) showing the harvest of cottonwood forest at Strawberry Island. Using Quantum GIS (QGIS), the cleared portion was digitized to produce a polygon for which the surface area (in acres) was calculated. Approximately 95 ha of cottonwood plantations were harvested.

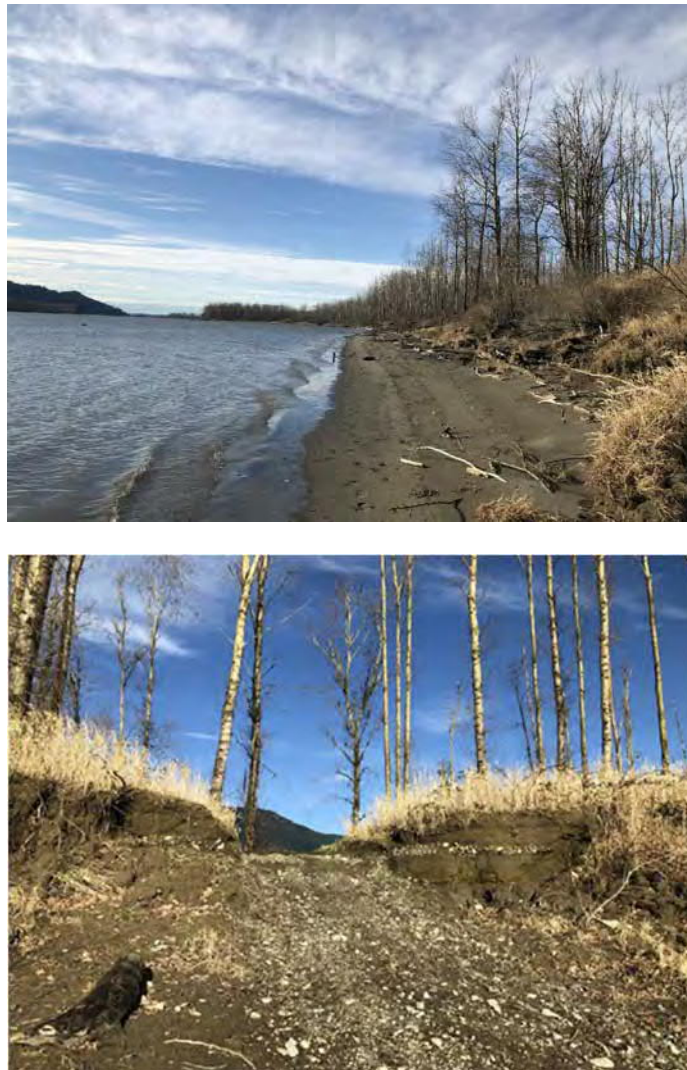
Figure 20. Images from Viewpoint #1 located at the eastern limit of Bert Brink WHA at Strawberry Island along the shore of the Fraser River (Figure 21), picture on the left is facing west showing mature cottonwood forest along the whole shoreline of Strawberry Island within Bert Brink WMA. Picture on the right facing north from Viewpoint #1 shows mature cottonwood surrounding a man-made clearing and bank erosion
Photos: L. Bartsch, 2019.

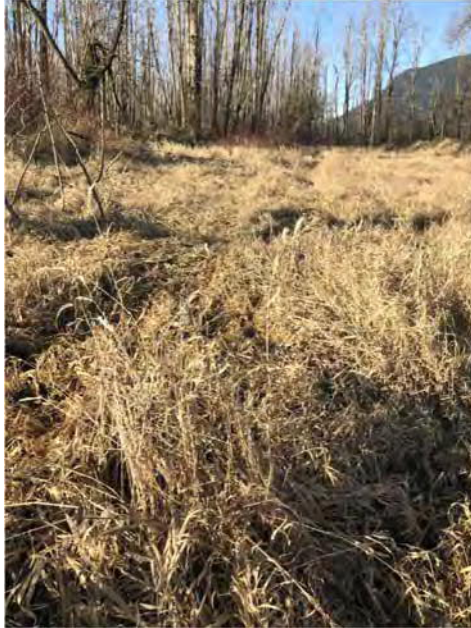
Reference Site #1 - Plot A: Edge of reed canary grass dominated wetland. Cottonwood only grow on adjacent low bench site. This can be viewed as a lower than low bench site.

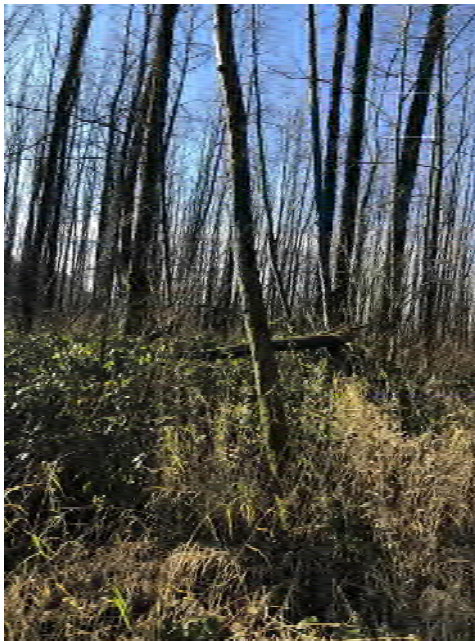
Reference Site #1 - Plot B: Vegetation Resources Inventory (VRI) Age Class 3 – high bench open cottonwood stands (approx. 50 years old) with some alder – understory dominated by Himalayan Blackberry, Willow spp., and Salmonberry.

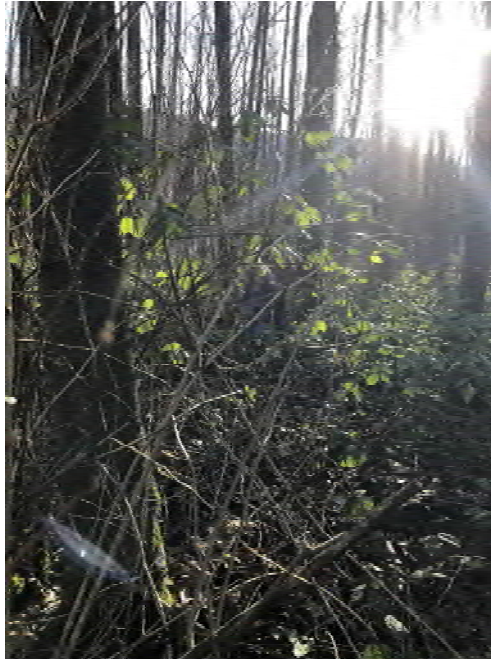
Reference Site #1 - Plot C: Vegetation Resources Inventory (VRI) Age class 5 high bench cottonwood stand (oldest trees approx. 80 years old) – understory dominated by Willow spp., Salmonberry, and Red-osier Dogwood (tall shrub understory).

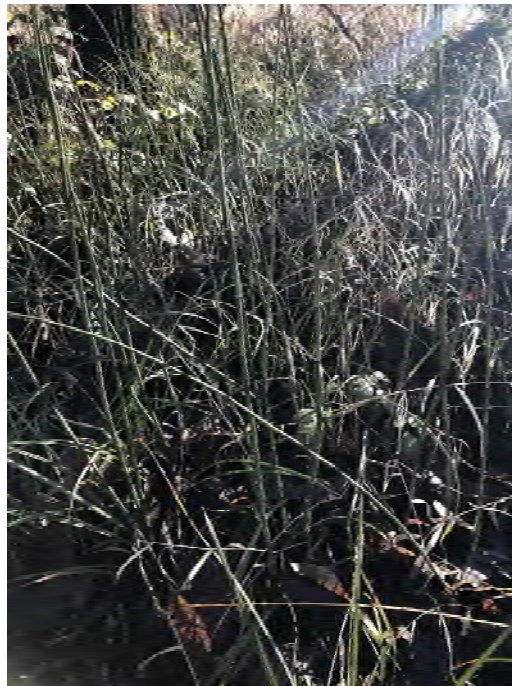
Reference Site #1 - Plot D: Horsetail and grasses in sparse patchy cottonwood forest on middle bench site.

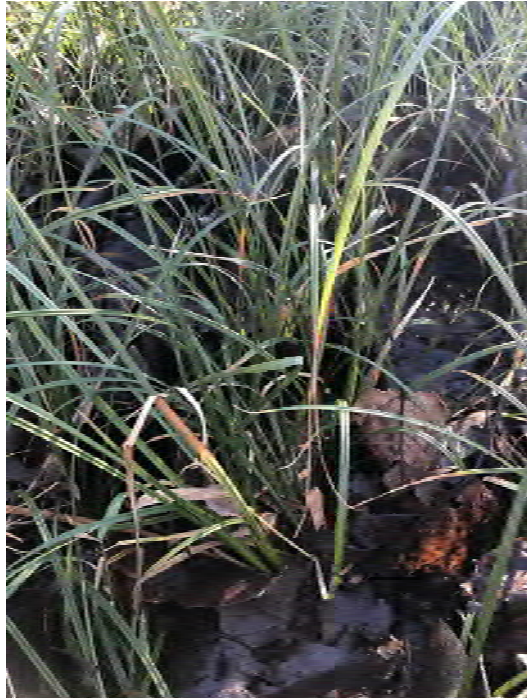
Reference Site #1 - Plot D: Native grasses in Plot D. Lower lying area between two stands of Cottonwood trees.

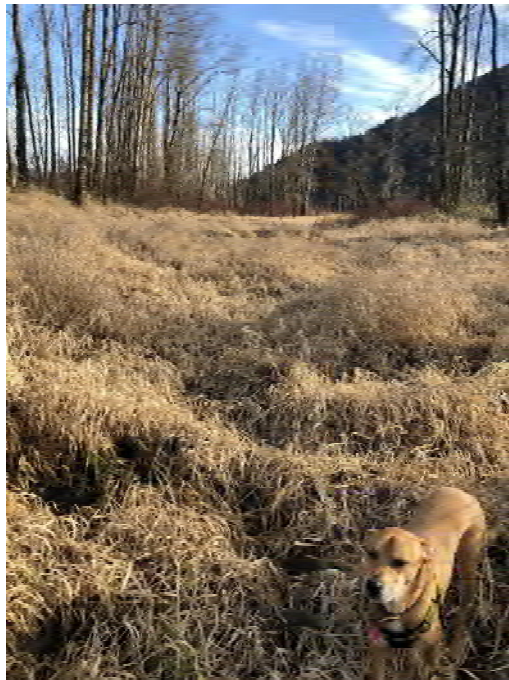
Reference Site #1 - Viewpoint 2: Large wetland dominated by Reed Canary grass. Located on lower than low bench site.

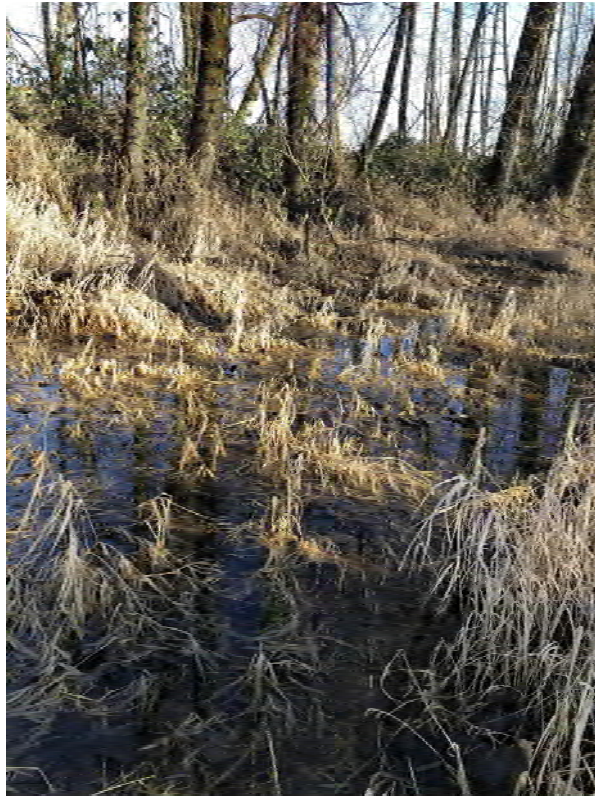
Reference Site #1 – Viewpoint 3 – Edge of unnamed slough #1 at high bench cottonwood forest.

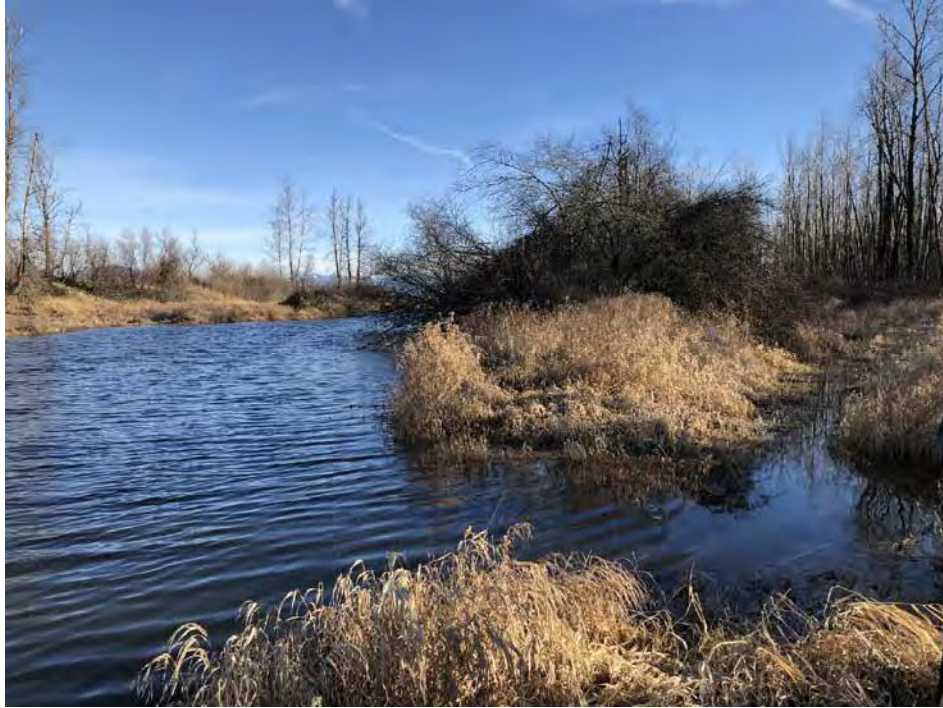
Reference Site #1 - Viewpoint 5 – Confluence of unnamed sloughs #1 and #2 facing east. Fully connected to the Fraser River via Strawberry Slough to the west and Nicomen Slough

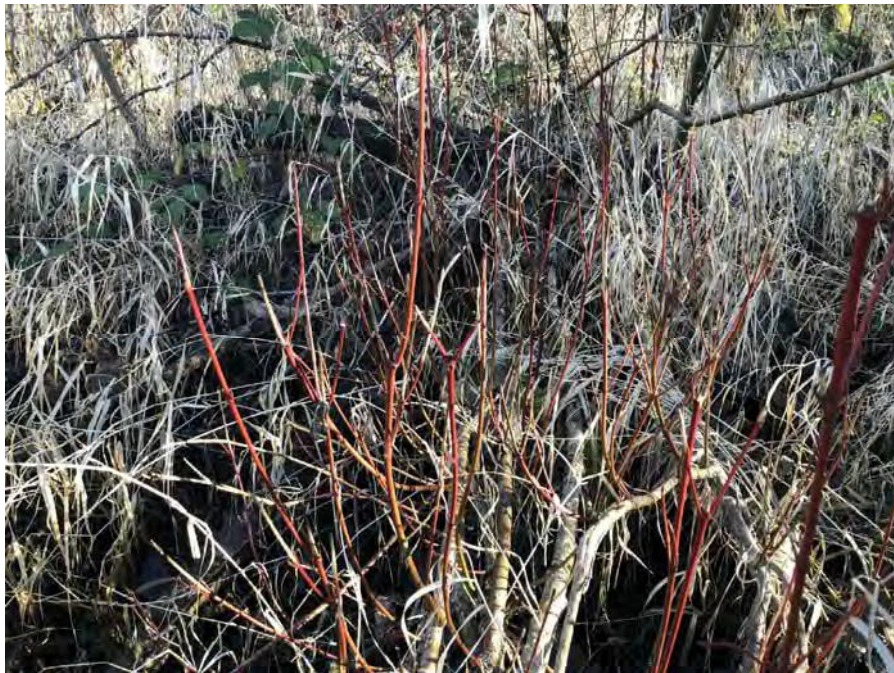
Reference Site #1 – Viewpoint 6 – Representative example of deer browse. Browse on Willow spp. and Red-Osier Dogwood throughout site.

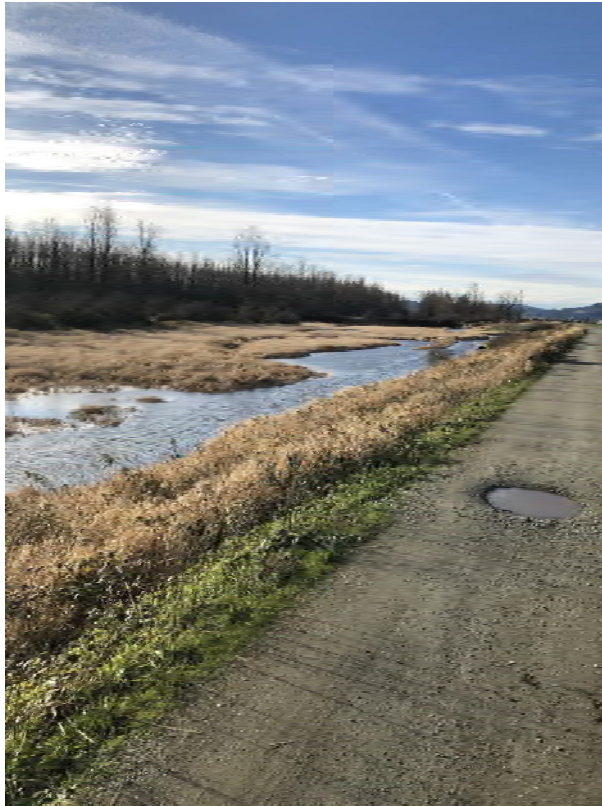
Reference Site #1 – Viewpoint #7 – Unnamed slough #3 looking southwest. Fully connected to the Fraser River via Strawberry Slough and Nicomen Slough to the west.

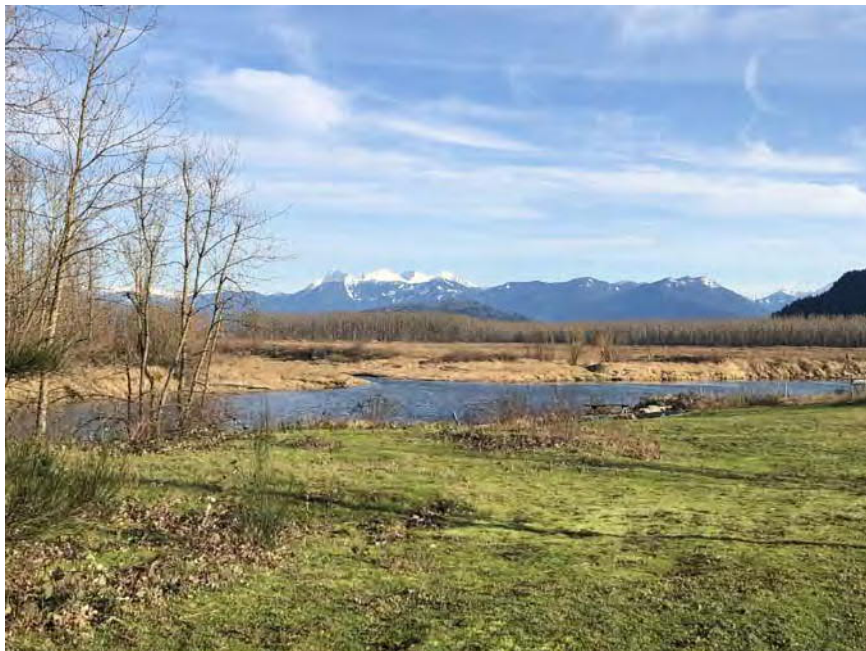
Reference Site #1 – Viewpoint #8 – Looking east from west side of Nicomen Slough towards Strawberry Island and Slough. Fully connected to the Fraser River.

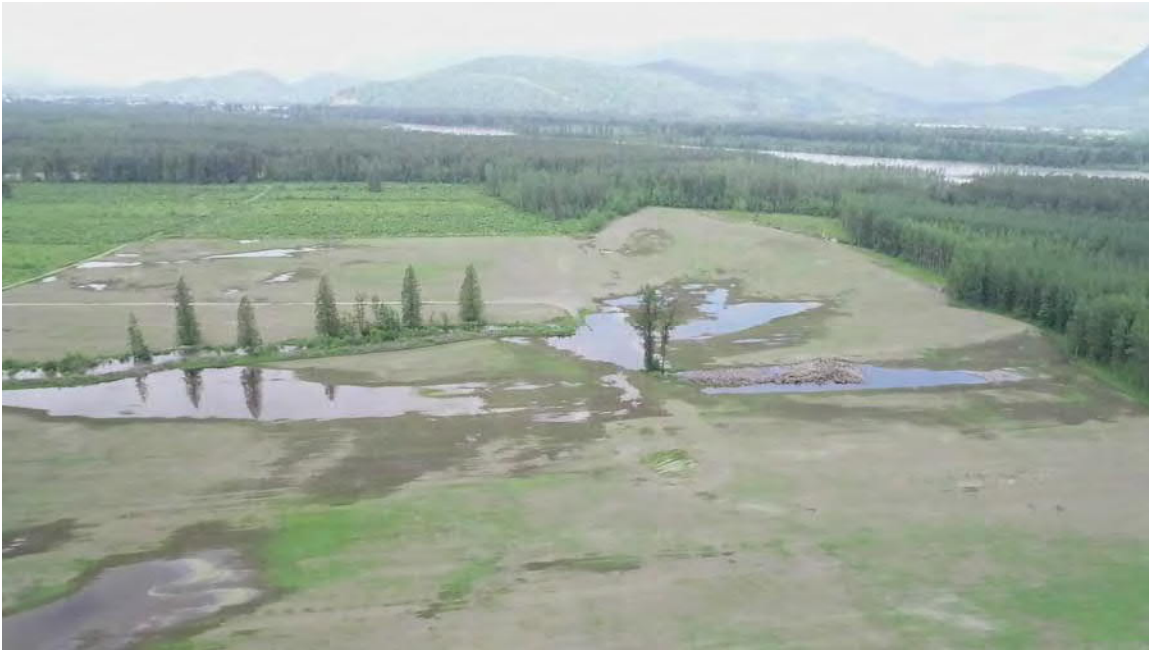
Picture captured by drone from side channel between Herrling Island and Highway 1 facing northwest showing inundated areas within the harvest area.

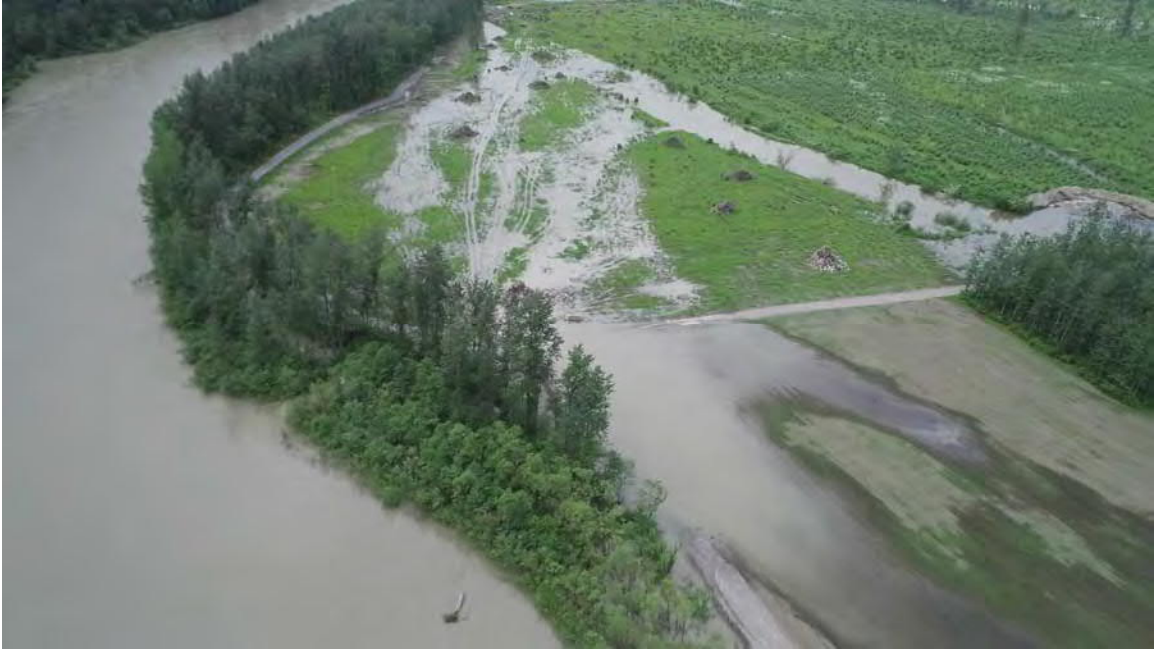
Picture captured by drone from side channel between Herrling Island and Highway 1 facing west showing inundated areas within the harvest area.

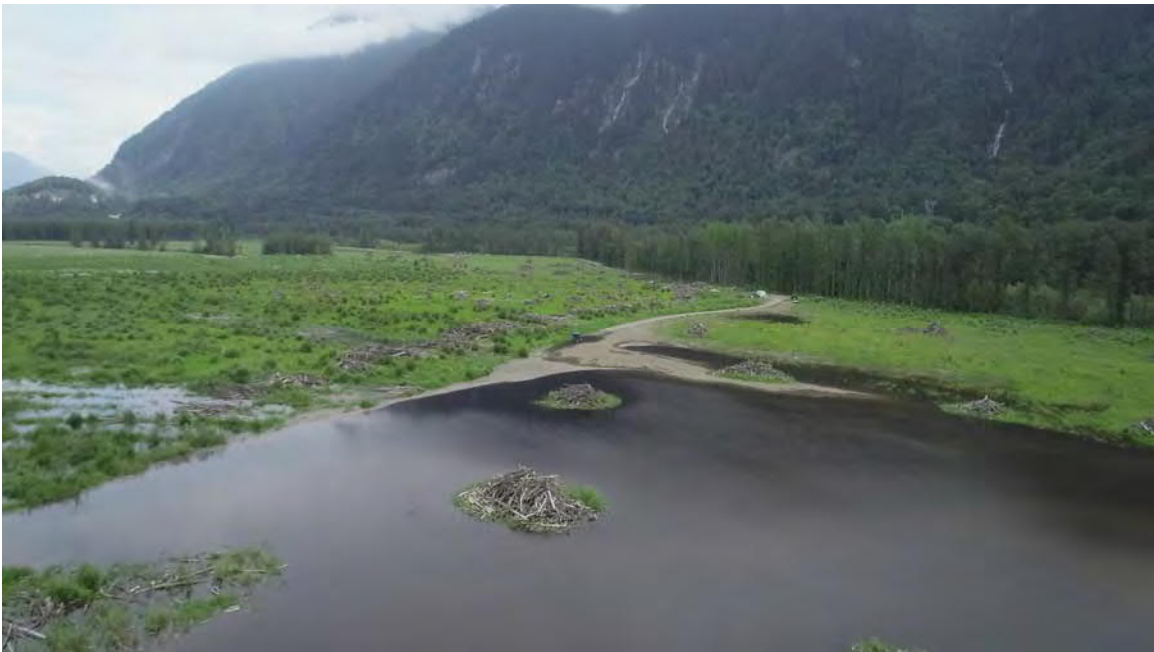
Picture captured from near centre of harvested area facing southeast showing large inundated area connected to tertiary channel that bisects greater Herrling Island.

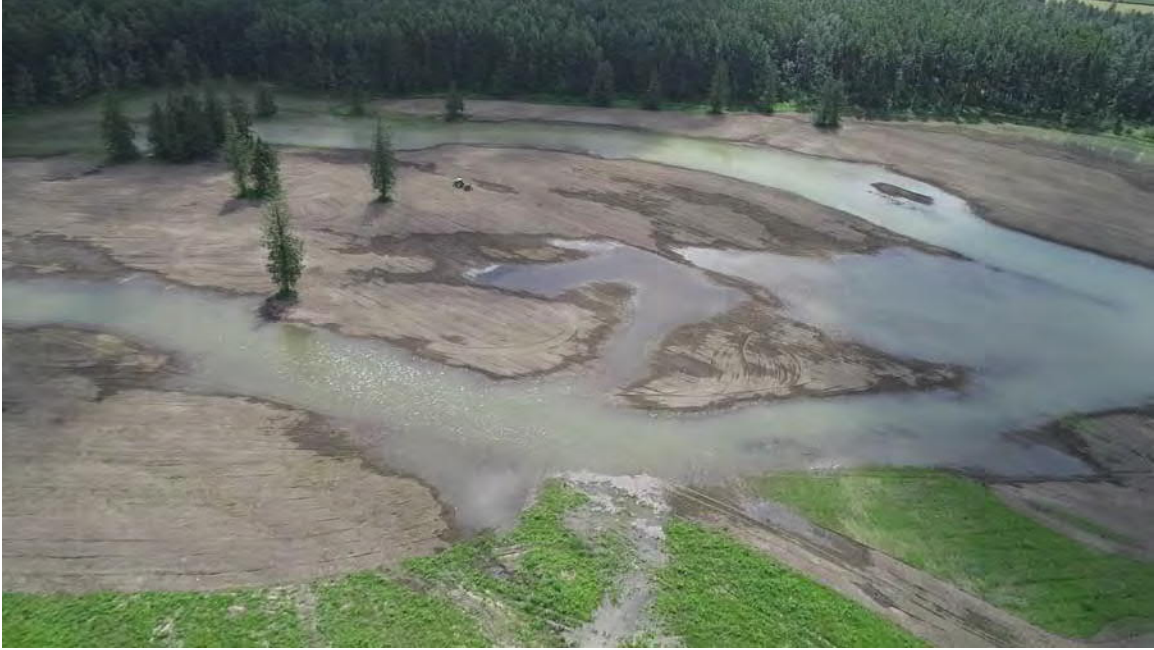
Picture captured from northern edge of westernmost clearing on Carey Island facing southwest showing floodplain fish habitat at flood pulse (freshet).

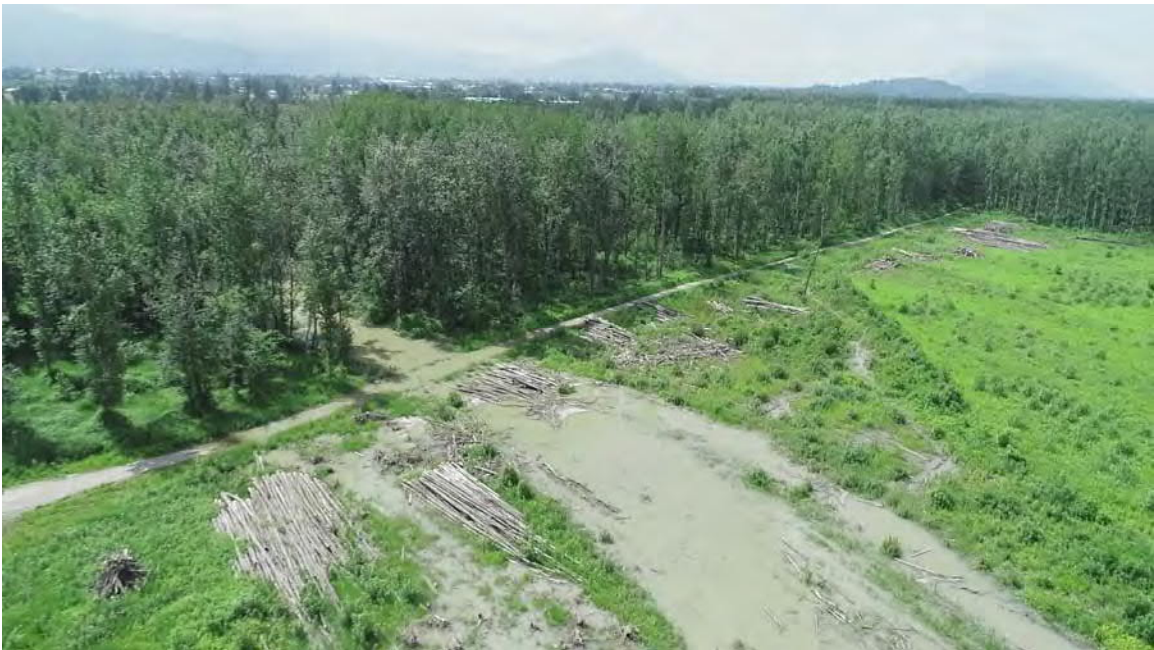
Picture captured from northern edge of easternmost clearing on Carey Island facing southwest showing floodplain fish habitat at flood pulse (freshet).

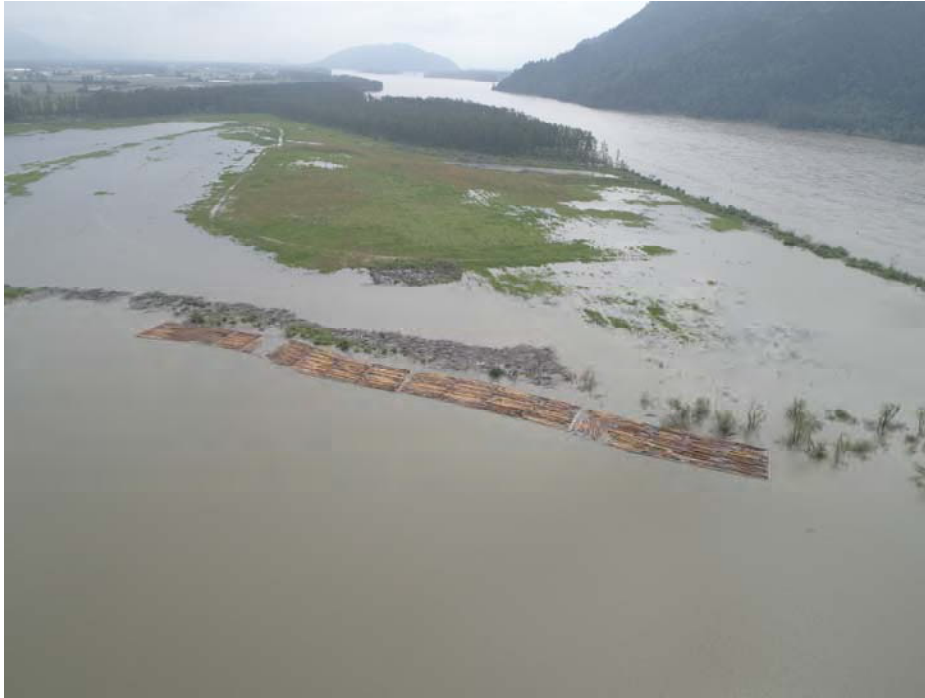
Picture captured from western boundary of Strawberry Island along Nicomen Slough. Facing east with Fraser river along top right corner.

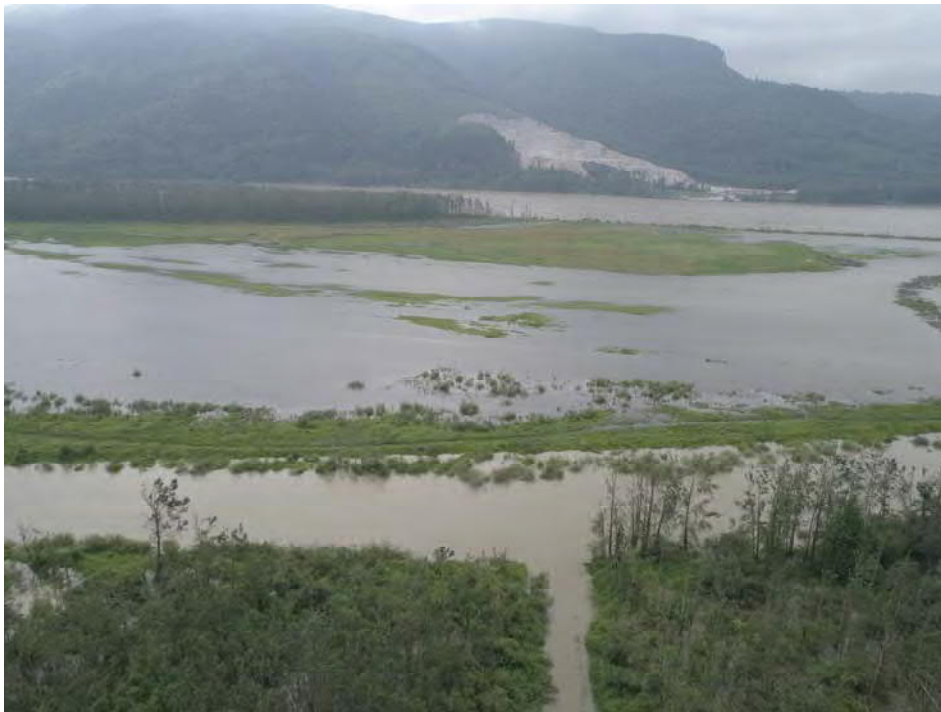
Picture captured from north of Strawberry Island with Strawberry Slough below. Facing south-southeast to the Fraser River in the background below large gravel pit on Sumas Mountain.

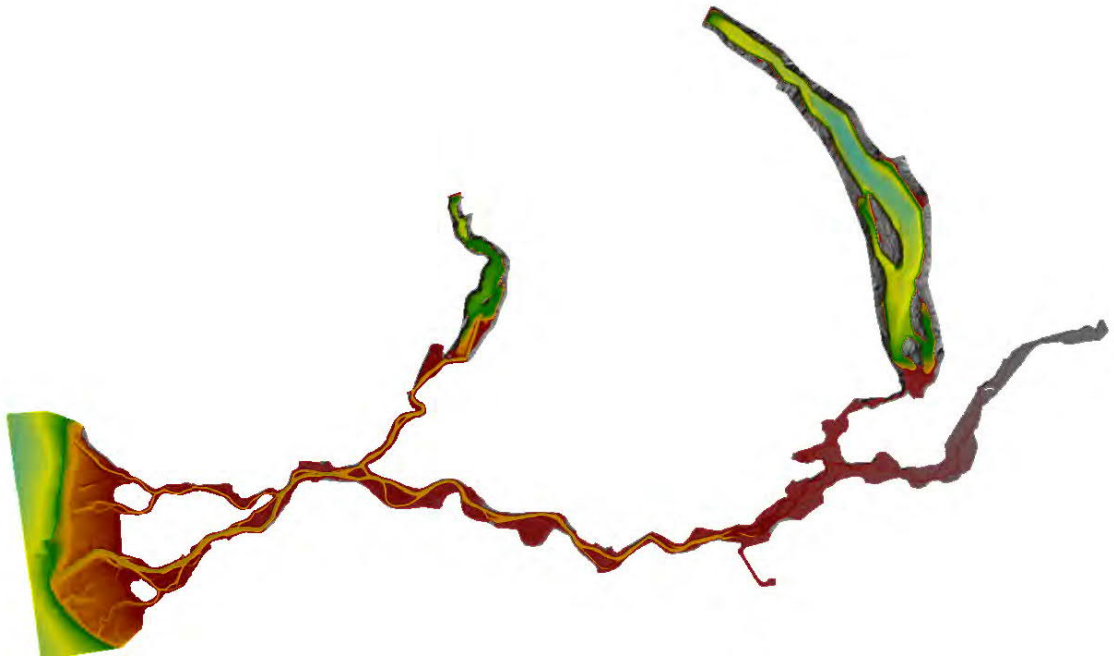
Hydraulic Model

Image above shows conversion of data by processing 13 grids into one Terrain Model exported as a GeoTiff in image below.
