Field Trials on a Living Dike in British Columbia: Wave Attenuation of Edge Treatment Features

by
Braydon Foster

Project Submitted in Partial Fulfillment of the
Requirements for the Degree of
Master of Science

© Braydon Foster 2024
SIMON FRASER UNIVERSITY
BRITISH COLUMBIA INSTITUTE OF TECHNOLOGY
Winter 2024

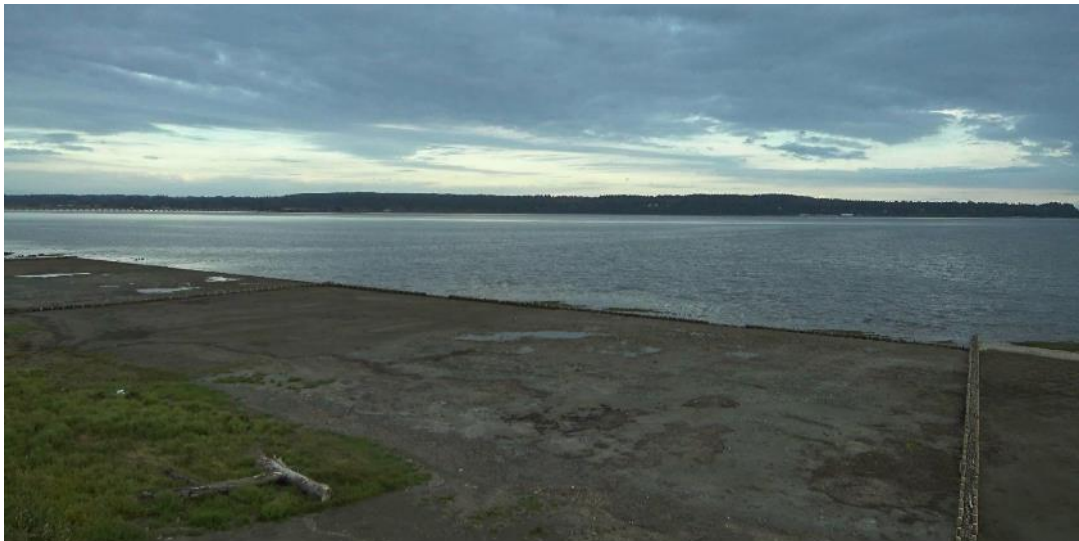
Figure 2: Picture overview of the Living Dike pilot project S1 site in Boundary Bay, British Columbia. View south overlooking the test plots. Image courtesy of City of Surrey.

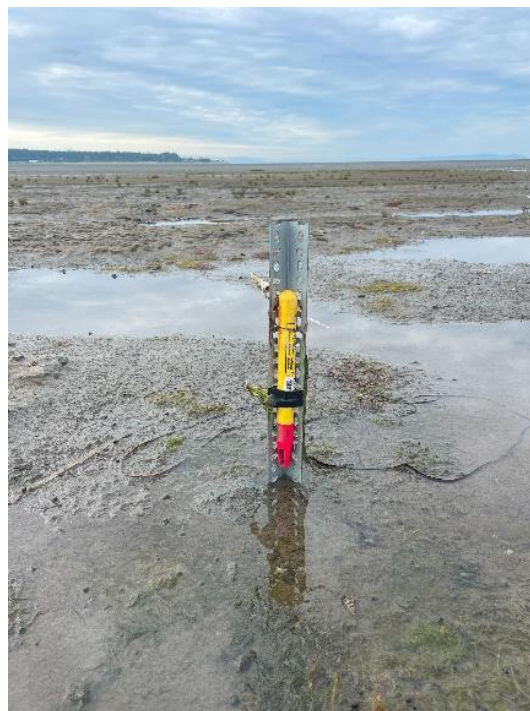
Figure 5: Image showing an RBRsolo instrument attached to a perforated L-shaped angle bar at the S1 LDPP study site in Boundary Bay, British Columbia, used to obtain wave data from October 2023 to January 2024.

The RBRsolo pressure sensors operated in wave mode, sampling 4096 points per sample at 16 Hz with a 20-minute sampling interval. Positioned 0.05 m above the substrate, the RBRsolo sensors were affixed to perforated L-shaped angle bars driven into the substrate (Figure 5).

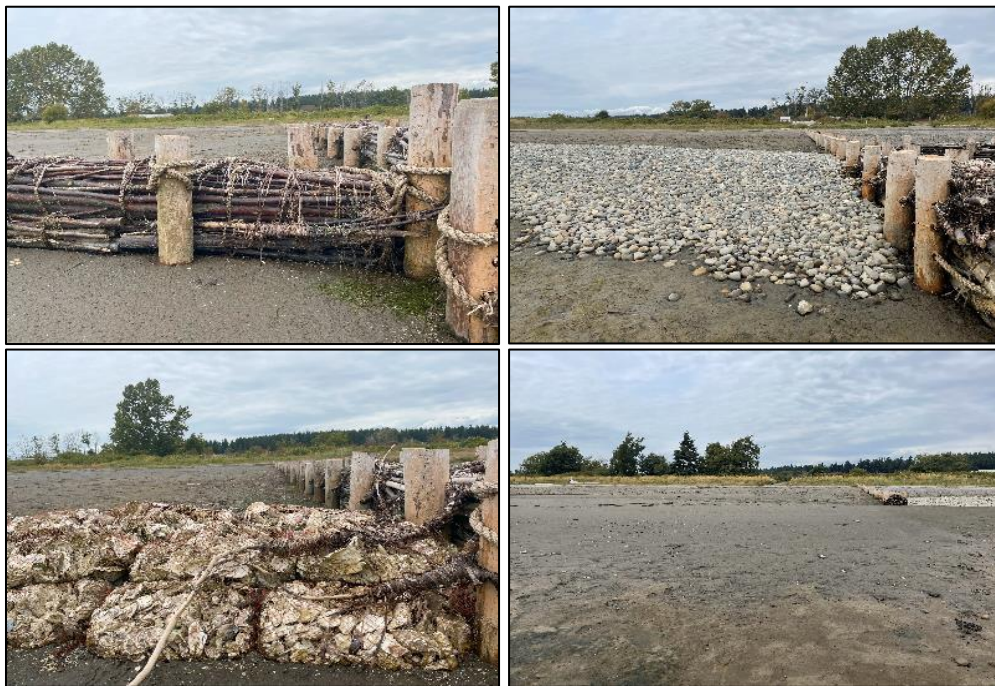
Figure 6: Image showing the four edge treatments at the S1 LDPP study site in Boundary Bay, British Columbia. Clockwise from the top left: brushwood dam, gravel berm, sand berm, oyster bag berm.

The brushwood dam stands 0.40 m tall and consists of untreated wooden posts, each with a diameter of 0.15 m, serving as anchor points (Figure 6, 7). Bundles of brushwood, measuring 0.30 m wide, and 2.0 m in length, are held together by 6 mm biodegradable twine and are securely fastened to the posts using 16 mm biodegradable rope. The gravel berm has a width of 2.0 m at its peak and has a seaward slope of 1(V):8(H) towards the mudflat (Figure 6, 8). Approximately 0.35 m in height, the berm uses $D_{50} \approx 70$ mm gravel, with an additional granular filter gravel positioned along the landward side of the plot. The sand berm spans 15.0 m in width, stands at approximately 0.40 m in height, features a frontal slope of 1(V):4(H), and is composed of imported sand material ($D_{50} = 0.30$ mm; Figure 6, 9). The oyster berm is approximately 0.40 m tall, 1.0 m wide, and consists of oyster shells enclosed in biodegradable plastic meshing with a mesh size of 1.0 cm (Figure 6, 10). The berm is stacked with three bags on the bottom layer and two on the top, with a granular filter gravel placed on the landward side of the plot. The elevations (in meters above geodetic datum, CGVD28GVRD2018) of the top of each structure are as follows: the brushwood dam ranges from 1.3 m to 1.4 m, the gravel berm stands at 1.1 m, the sand berm at 1.0 m, and the oyster bag berm varies between 1.1 m and 1.2 m. For context, Higher High Water Mean Tide is 1.1 m elevation (CGVD28GVRD2018) and 4.0 m elevation (Chart Datum).

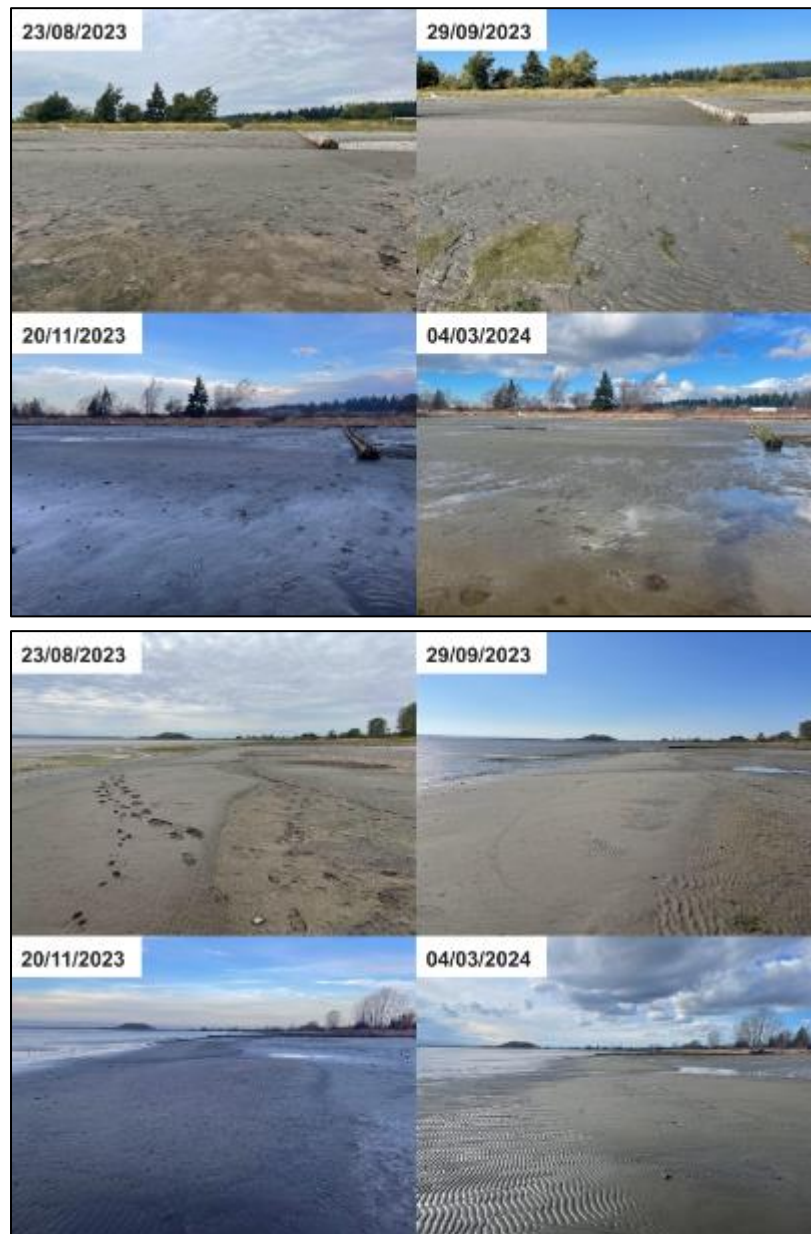
Figure 15: Photo monitoring of the sand berm treatment between August 23rd, 2023 and March 4th, 2024 at the S1 LDPP site in Boundary Bay, British Columbia.

The sand berm began to deform three weeks after construction was completed, and movement was noted during small summer storm events ($H_s < 0.15$ m). Large storm events in November 2023 and January 2024 further flattened the berm slope and moved sand onto the mudflat and fill sections of the plot. It was observed that most of the sediment movement occurred during storm events ($H_s > 0.15$ m). At the conclusion of this study, the sand berm had decreased in height by approximately 0.10 m and expanded seaward and landward by approximately 3.0 m in both directions. The marsh fill behind the sand berm experienced the most reshaping out of the four treatments and

exhibited a 0.14 m decrease in elevation. The initial frontal slope of 1(V):4(H) for the sand berm reshaped to a final slope of approximately 1(V):30(H).

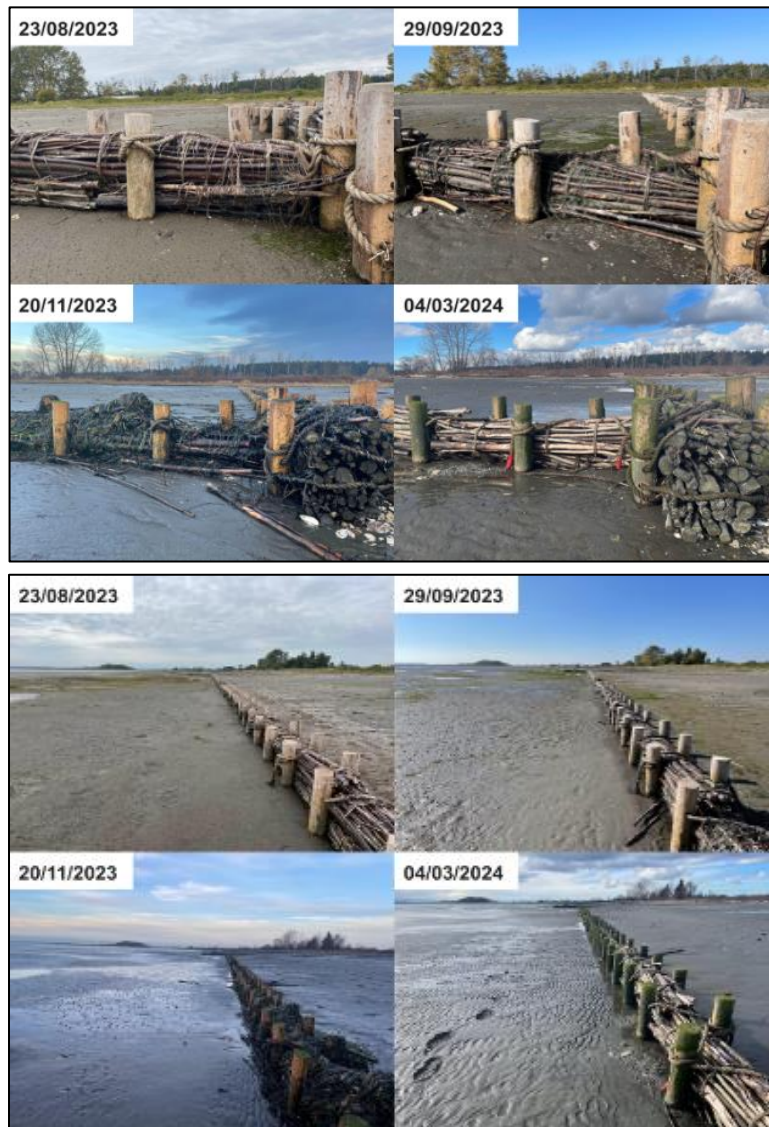
Figure 17: Photo monitoring of the brushwood dam treatment between August 23rd, 2023 and March 4th, 2024 at the S1 LDPP site in Boundary Bay, British Columbia. The March 4th, 2024 image shows a repaired brushwood bundle.

The brushwood dam began to exhibit fraying on the 6 mm biodegradable twine, used to secure the bundled brushwood, in November 2023, three months after installation. The thicker 16 mm biodegradable rope used to secure the bundles to the

posts did not show signs of fraying. After the November 2023 storm event ($H_s = 0.30$ m), one bundle of brushwood had split open, and that portion of the dam likely became ineffective. Further signs of fraying on the rest of the bundle twine was noted in December and two more sections of the dam came apart after a storm event in January 2024 ($H_s = 0.46$ m). The placed marsh fill elevation, at the interface with the brushwood dam, decreased by approximately 0.10 m and the slope landward of the structure steepened from the constructed 1(V):100(H) fill slope to a slope of 1(V):25(H). The new slope extended approximately 8.0 m landward of the dam before returning to the original fill elevation.

The brushwood dam was shown to hold up well to wave conditions, which was expected given their use on similar projects in Europe and Asia [25,11]. However, the study observed recurrent failures in the twine binding the brushwood bundles, a phenomenon not reported in prior research. It is hypothesized that the abrasion of the

bundle twine by driftwood during high tides might be a contributing factor. This hypothesis is supported by the lack of fraying on the perpendicular brushwood dividers (used to separate plots) that were not exposed to driftwood impacts and associated damage. Boundary Bay's abundance of driftwood may explain why such weathering/damage mechanisms were not previously documented in European or Asian studies. Increasing the thickness of the bundle twine could mitigate the risk of failure, irrespective of the underlying cause, thereby prolonging the longevity of the brushwood dams. Failure of the brushwood dam was not reported in Provan et al.'s [9] laboratory study which highlights the importance of conducting field trials. Studies such as Schmitt et al.'s [31] investigation into bamboo and rope brushwood dams indicated that minor adjustments in design could potentially extend their lifespan to five-to-seven years [11].

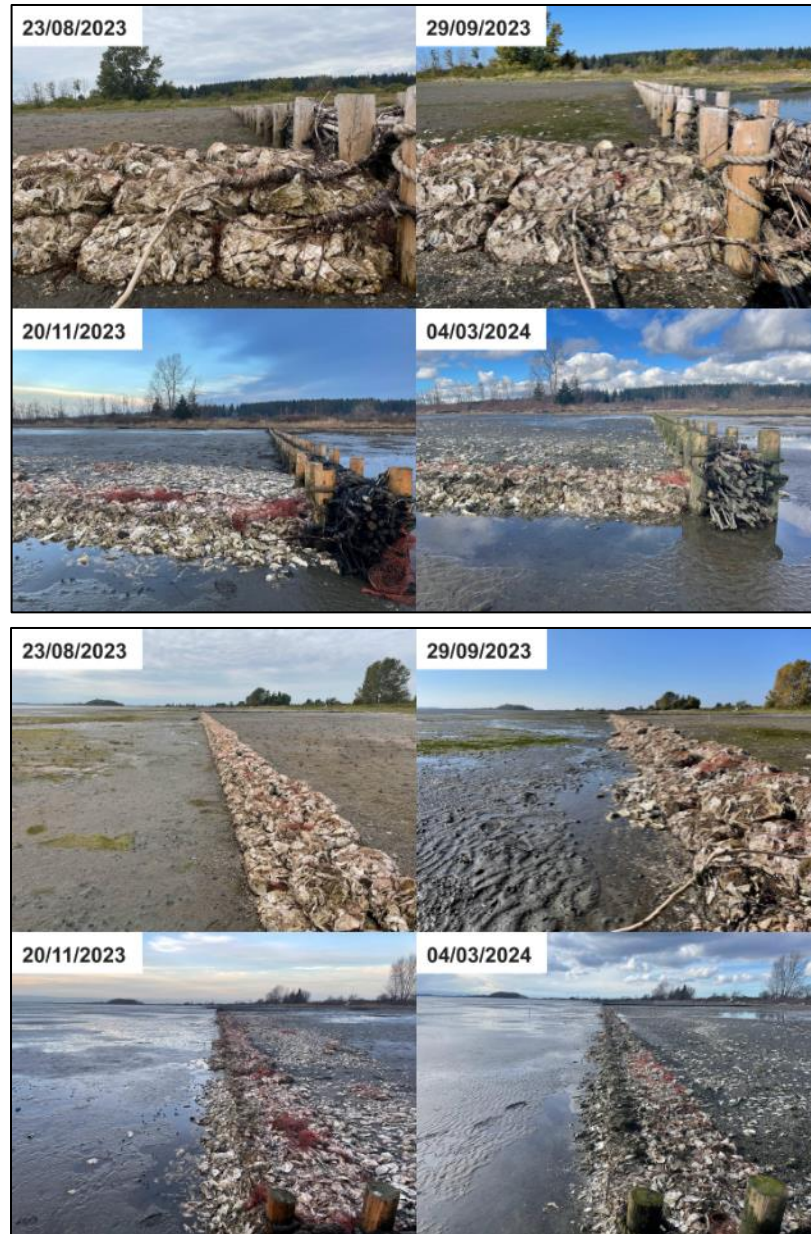
Figure 18: Photo monitoring of the oyster-shell bag berm treatment between August 23rd, 2023 and March 4th, 2024 at the S1 LDPP site in Boundary Bay, British Columbia.

The oyster bag berm showed signs of weathering one month after construction was completed. Tears in the biodegradable bags used to hold the shells in place were evident after the first summer storms. During the November storm event ($H_s = 0.30$ m) 60% of the bags were torn open, most of the shells in the first layer of the berm were spread across the site, and the biodegradable mesh bags were observed strewn around the site. The damage from the storm resulted in the lowering of the oyster bag berm below its constructed height and rendered it less effective as subsequent wave data showed higher wave transmission coefficients. A subsequent storm event in January 2024 damaged the rest of the bags and at the end of the monitoring study approximately 80% of the oyster bag berm had been destroyed. During the period before the November 2023 storm, little marsh fill movement took place, and no scour was noted behind the oyster bag berm.

The oyster bag berm effectively attenuated waves but experienced the most significant weathering among all structures due to the weakness of the biodegradable bags. To address this issue, adopting steel gabion cages, designed to rust out within a few years, could offer a viable solution. This approach was proven effective in the Eastern Scheldt Oyster Reef pilot project [40], but additional testing would be required in Boundary Bay.
