Sound Transmission of Wood Frame Split Insulated Rainscreen Cavity Wall Assemblies:  
an Experimental Approach

A Thesis  
in the  
Building Science Graduate Program

November 2017

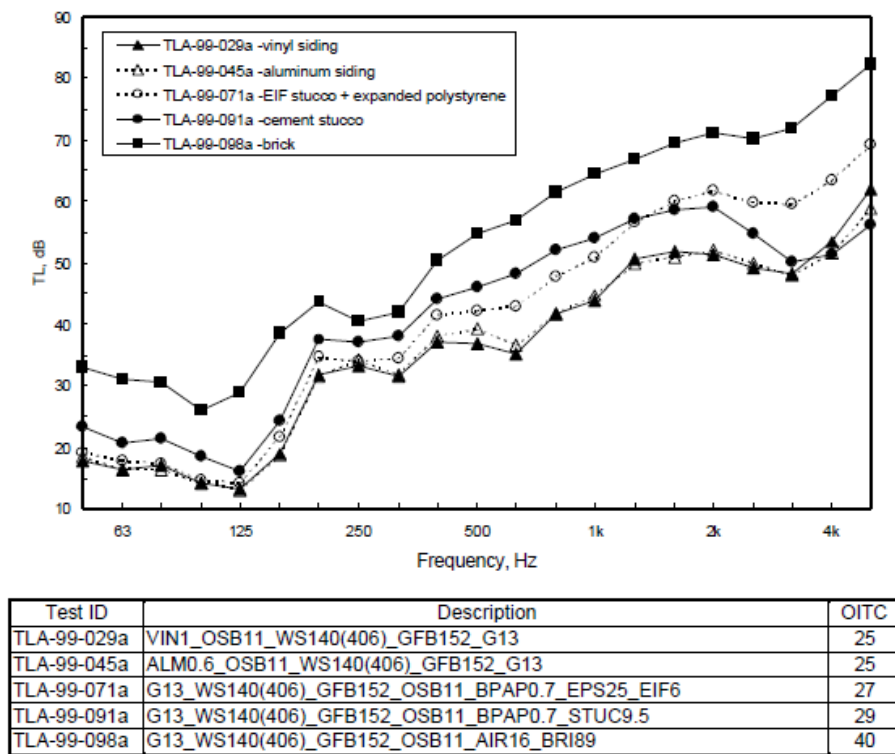
Figure 2.12. Sound transmission loss versus 1/3 octave frequency for varied exterior cladding.  
(Source: Bradley & Birta, 2000)

was selected as the cladding type because it had the lowest transmission loss values for all types of cladding. They found out that for all tests comparing attachments, the transmission loss for vinyl fixed directly on the sheathing without attachment was the lowest result (Figure 2.13) at mid and high frequencies. This result suggests that cladding separated from the sheathing, having an air cavity in between them, tends to improve the transmission loss of a wall assembly. The results also showed that the attachment material has a significant impact on the mid and high frequencies on transmission loss.

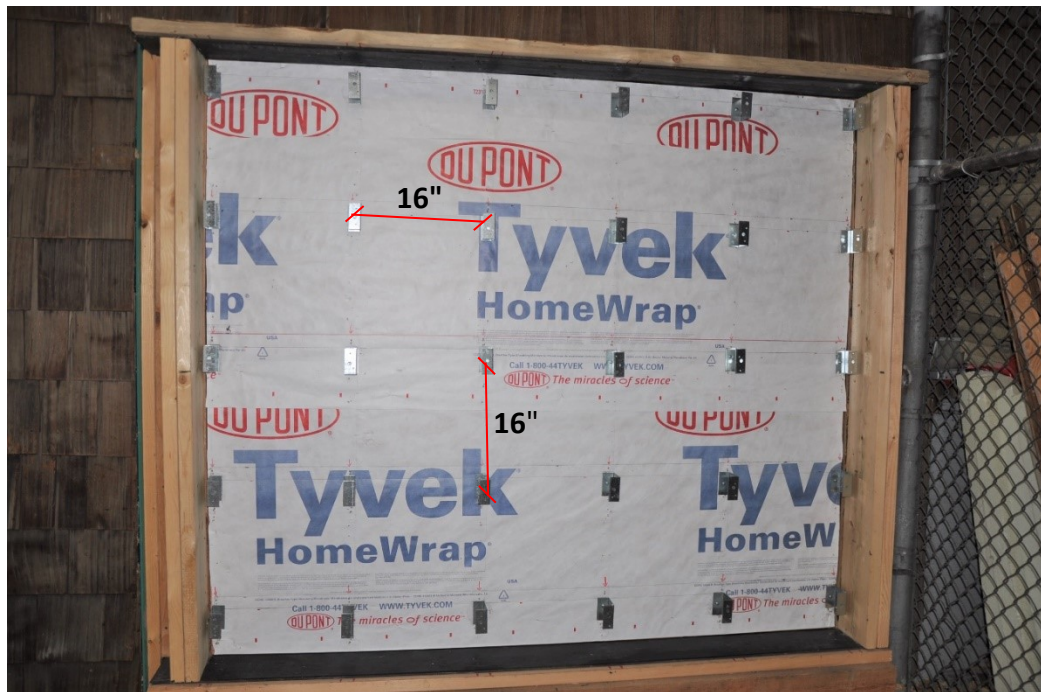
*Figure D.1. Metal clips attached to the base wall without exterior insulation.*

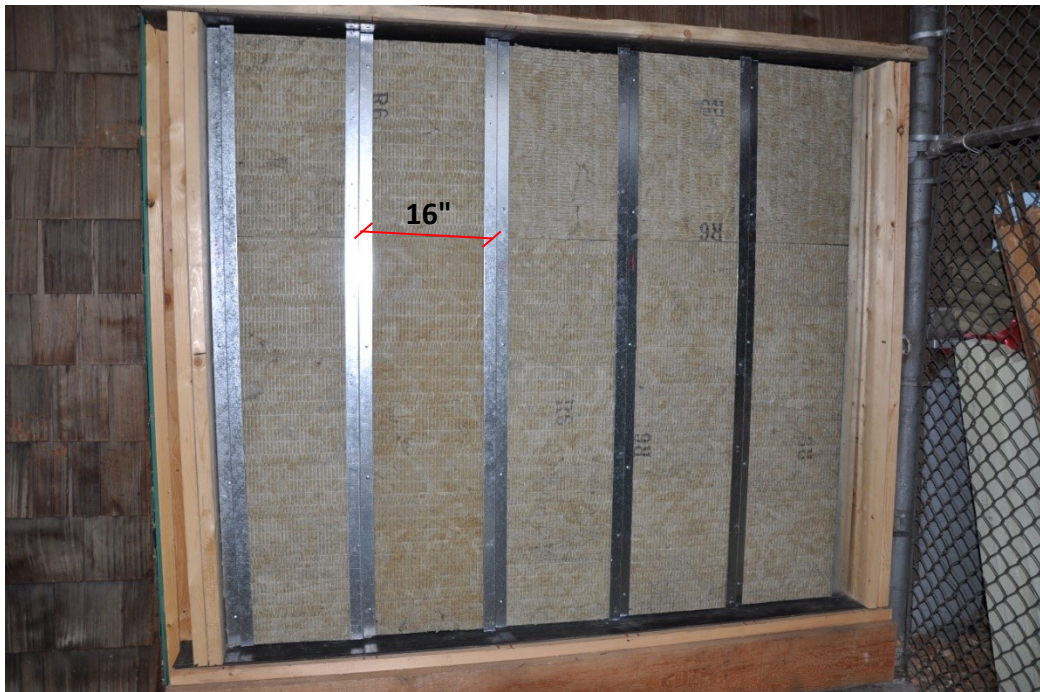
*Figure D.3. Metal clips, mineral wool, and S-track steel furring.*

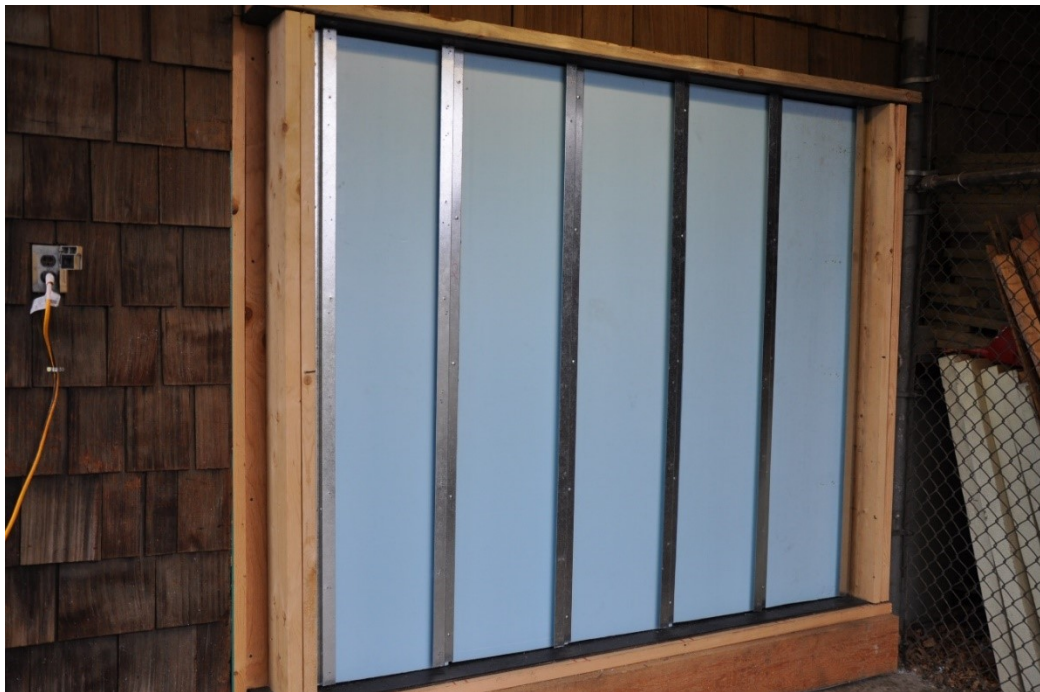
*Figure D.5. Metal clips, XPS, and S-track steel furring.*

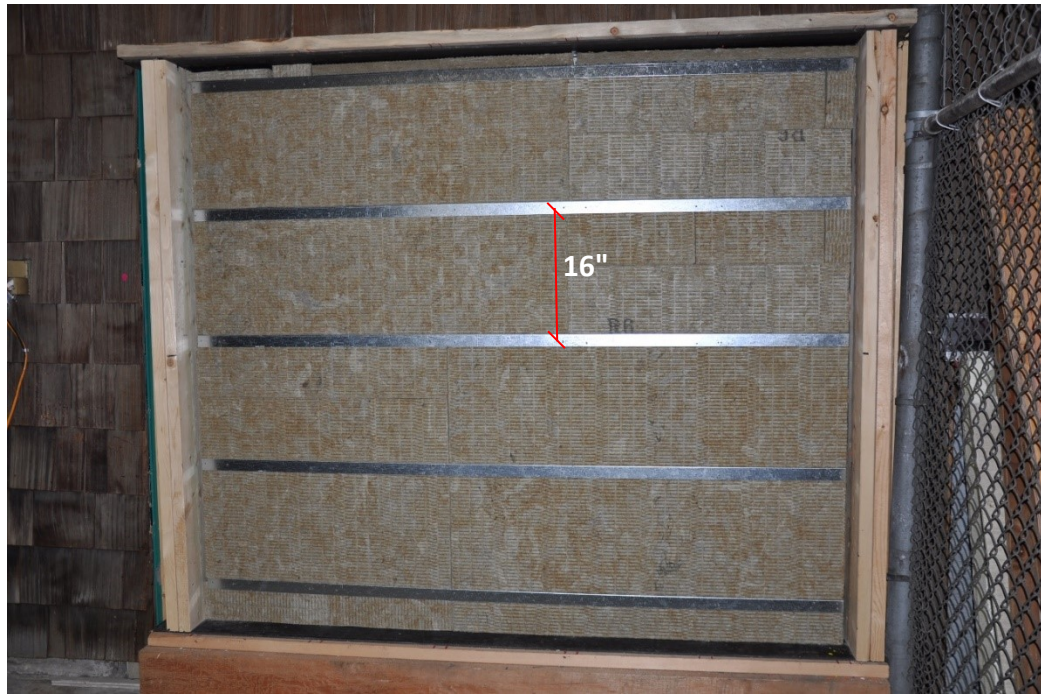
*Figure D.6. Horizontal Z-girt and mineral wool exterior insulation.*

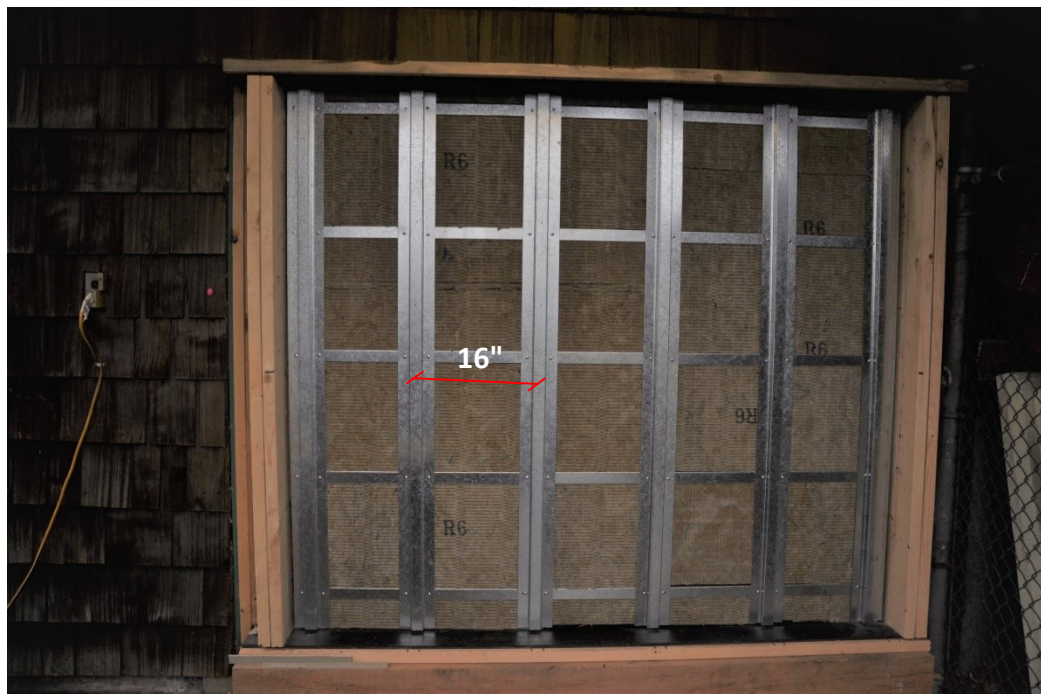
*Figure D.7. Horizontal Z-girt, mineral wool, and vertical Hat-track furring.*

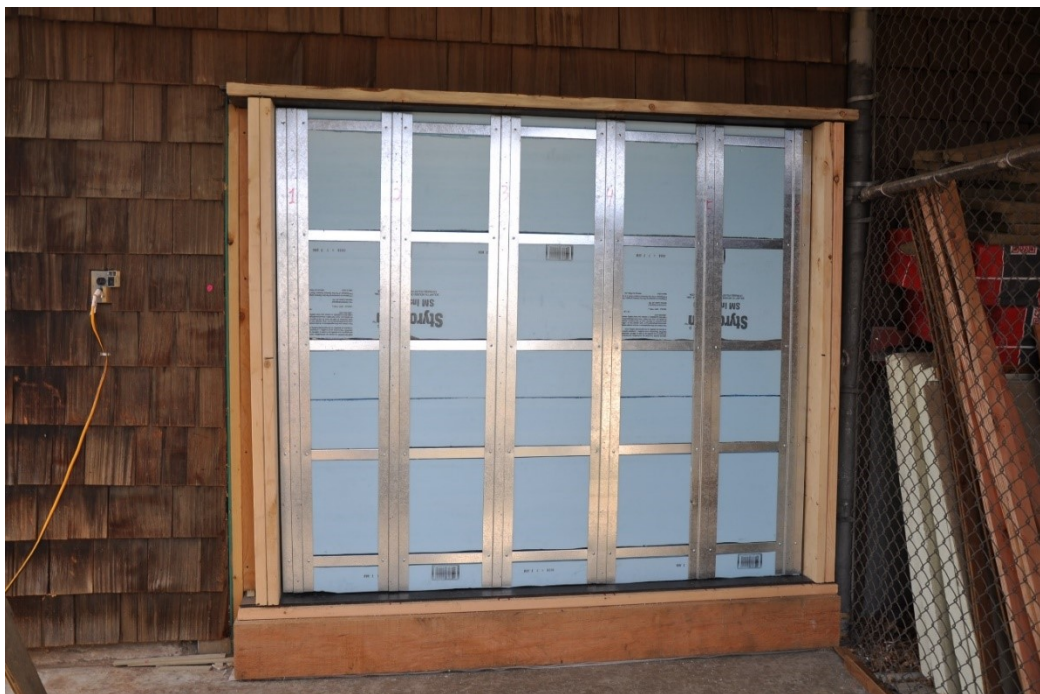
*Figure D.9. Horizontal Z-girt, XPS, and vertical Hat-track furring.*

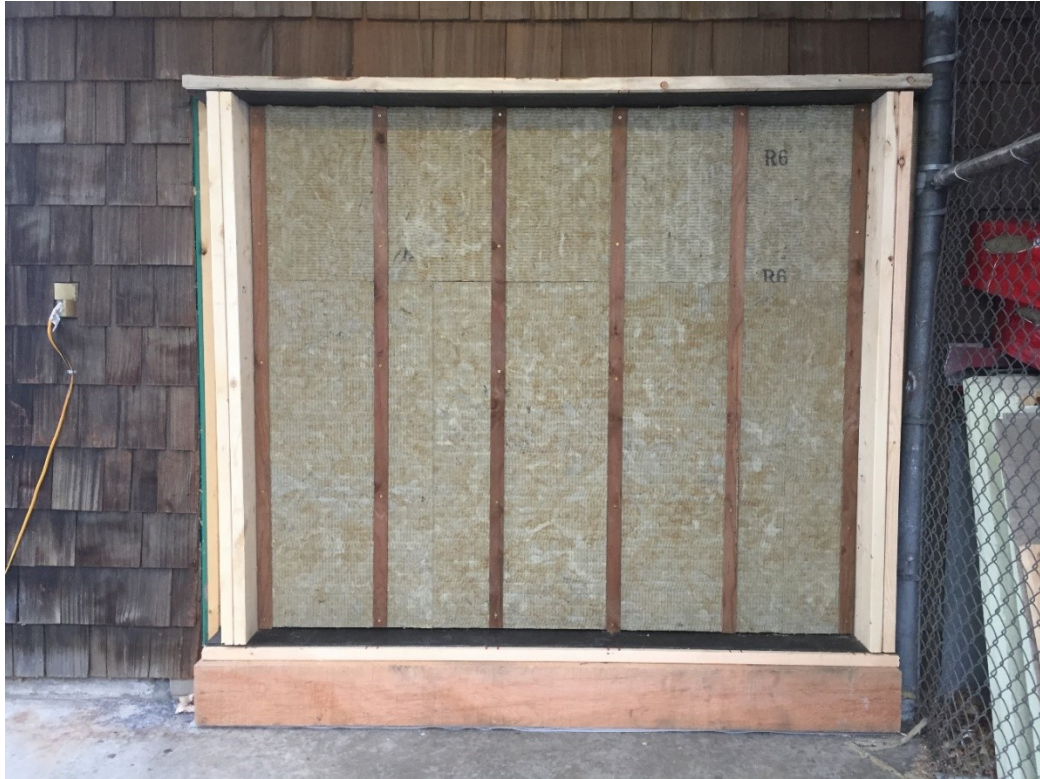
*Figure D.10. Wood strapping and mineral wool exterior insulation.*

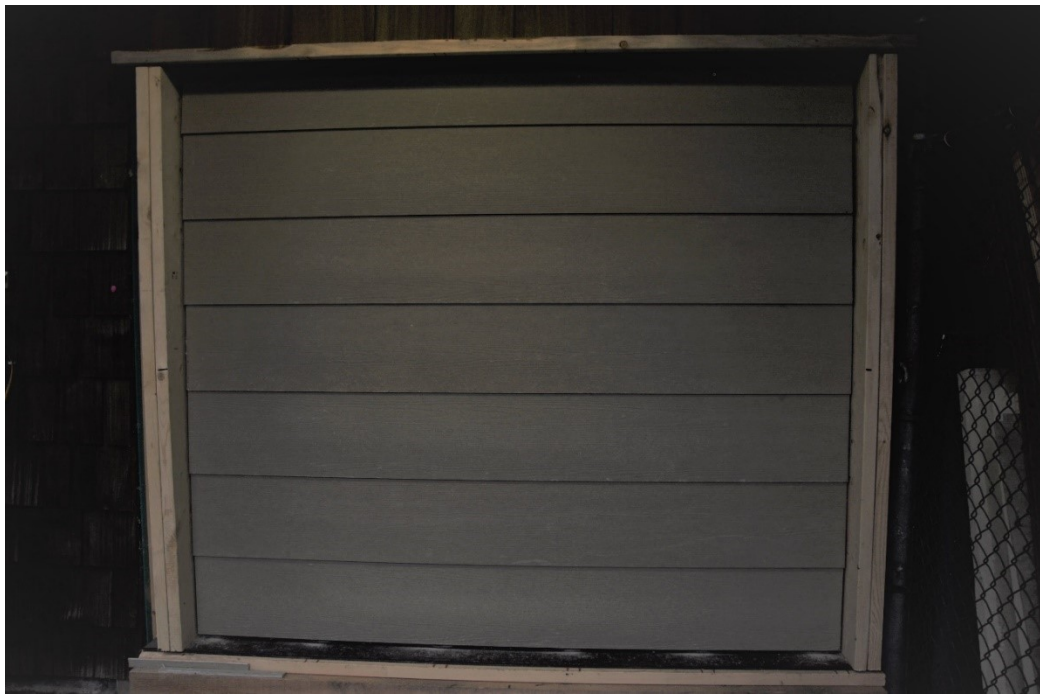
*Figure D.11. Fiber cement board siding (cladding).*

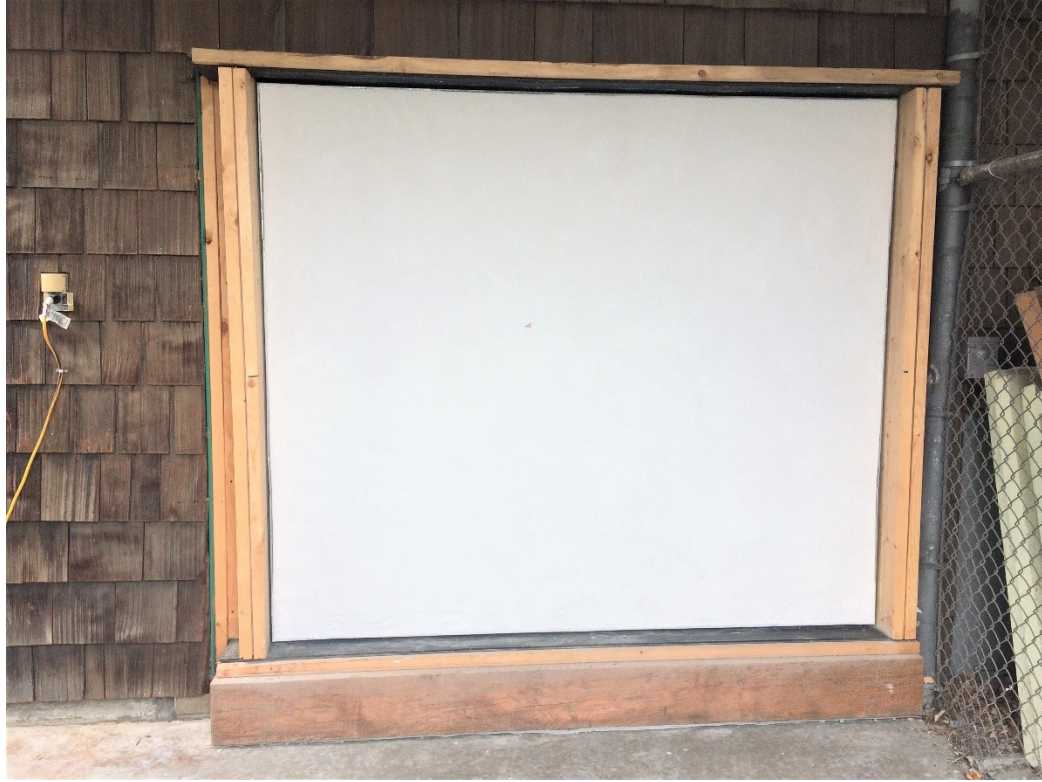
*Figure D.12. Stucco wall.*

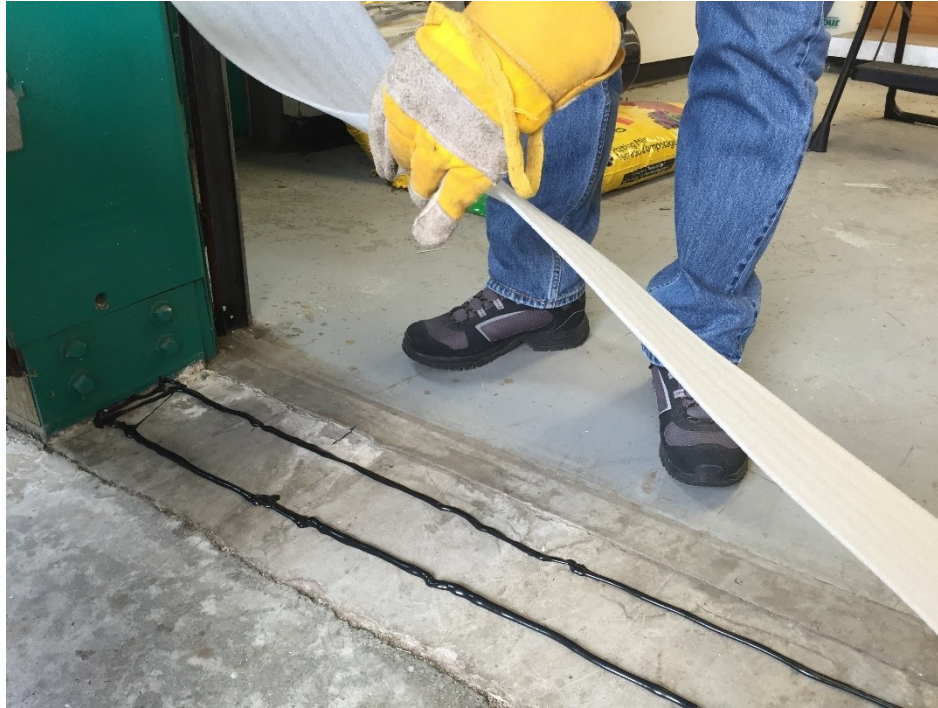
*Figure E.14. Acoustic sealant and gasket application.*

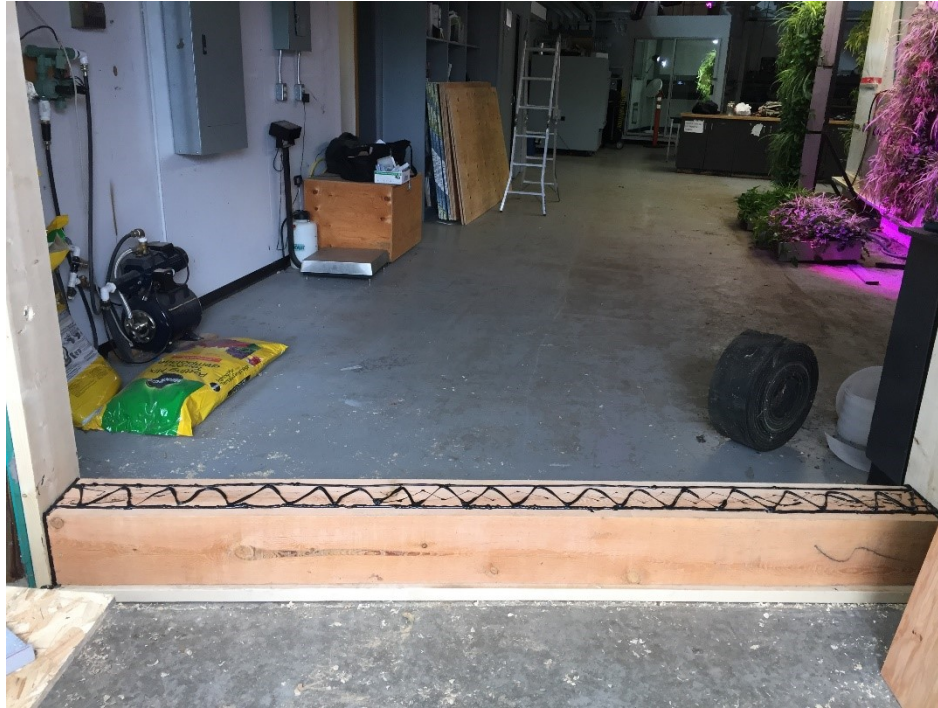
*Figure E.17. Acoustic sealant applied over the 8" x 8" wood.*

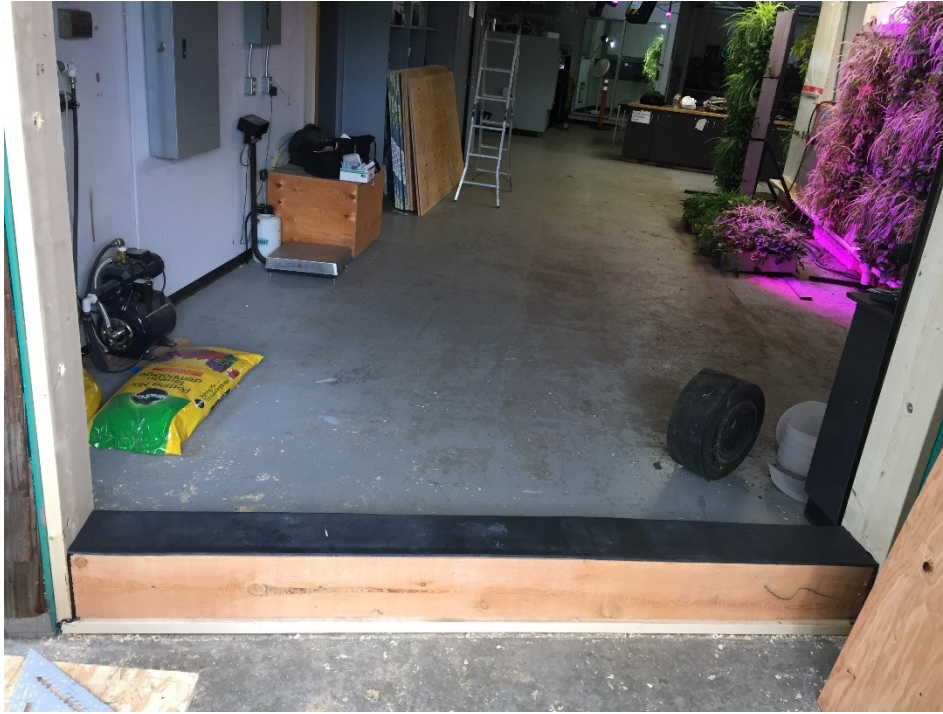
*Figure E.18. Inferior components of the sub-frame wall.*

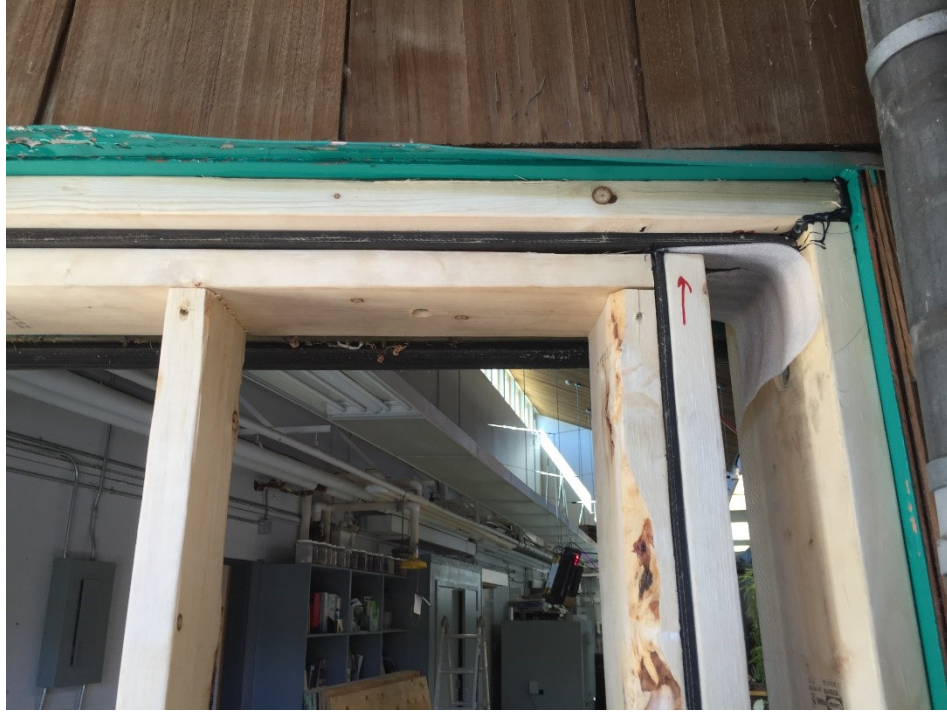
*Figure E.21. Rubber layer between frame and sub-frame for lateral and superior components.*

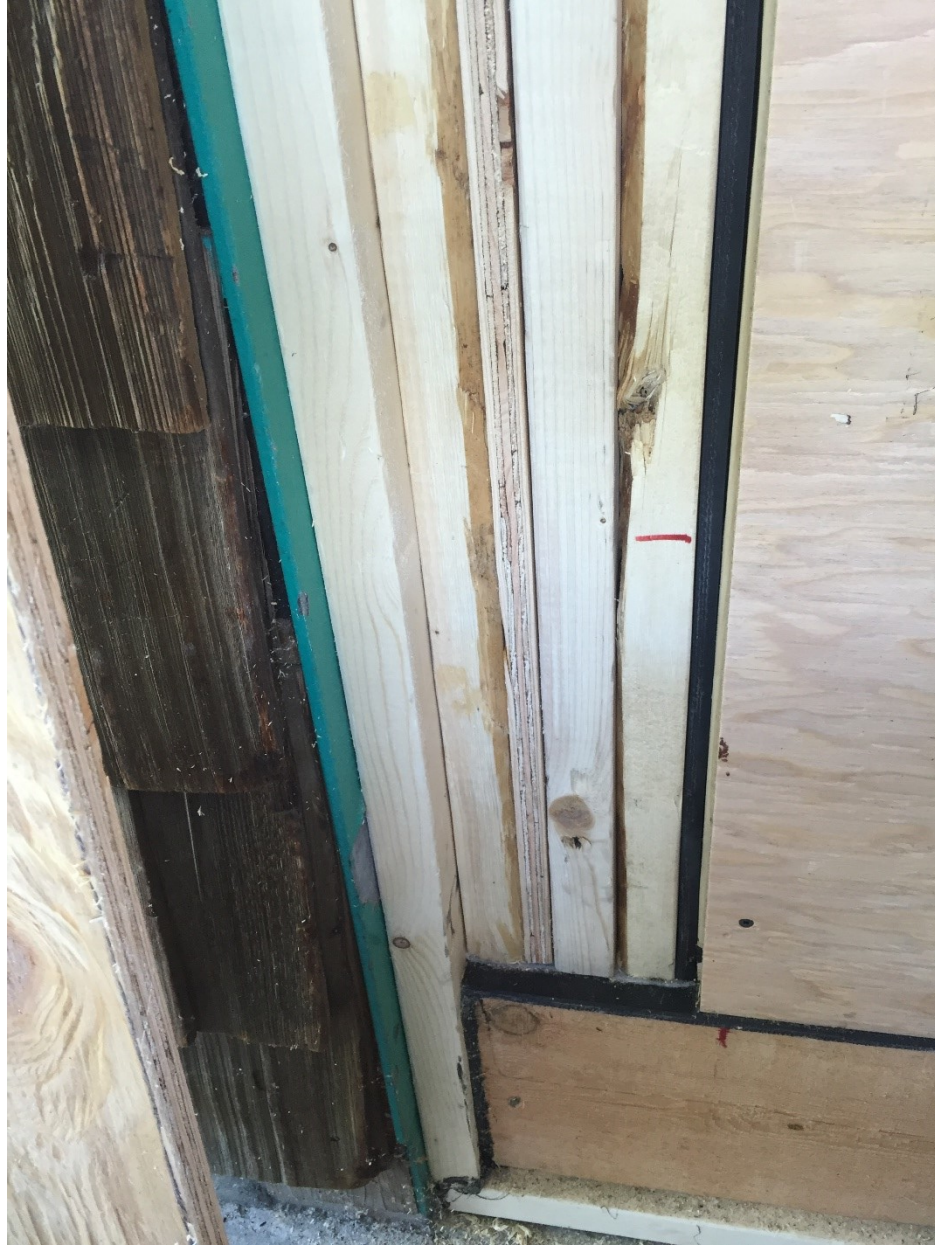
*Figure E.22. Wood pieces filling volume between sub-frame and wall specimen frame.*

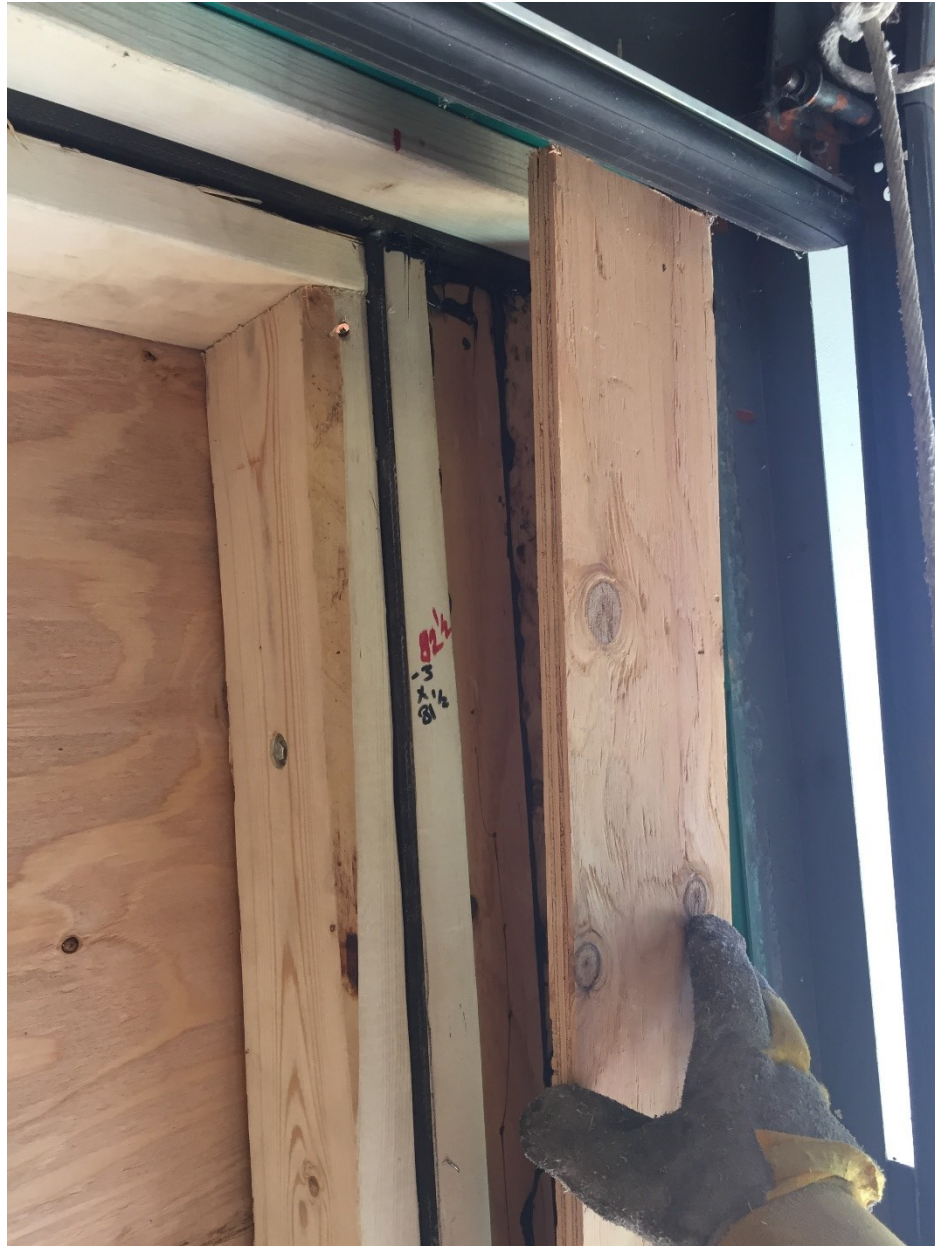
*Figure E.24. Piece of wood board covering the wood filling laterally.*

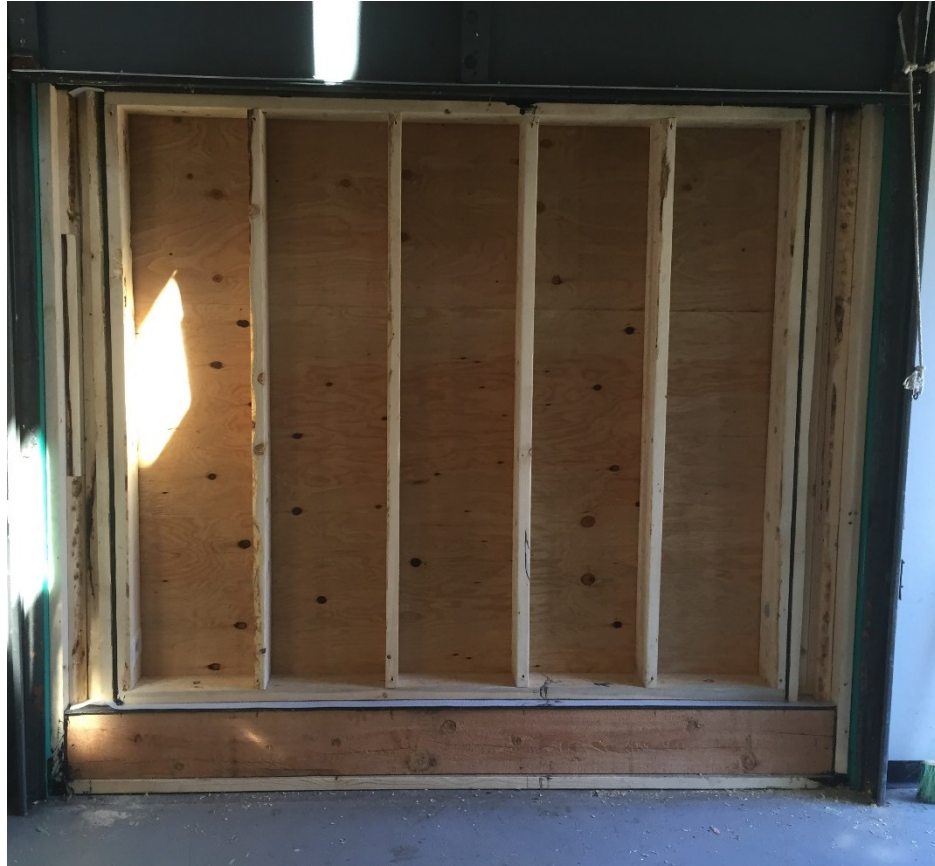
*Figure E.25. Plywood sheathing over wood studs.*
