# **A Field Study on Quality of Three First Nation Homes on the Squamish Urban Reserve of West Vancouver**

A Manuscript-Based thesis  
presented to the British Columbia Institute of Technology  
in fulfillment of the  
thesis requirement for the degree of  
Master of Applied Science  
in  
Building Science

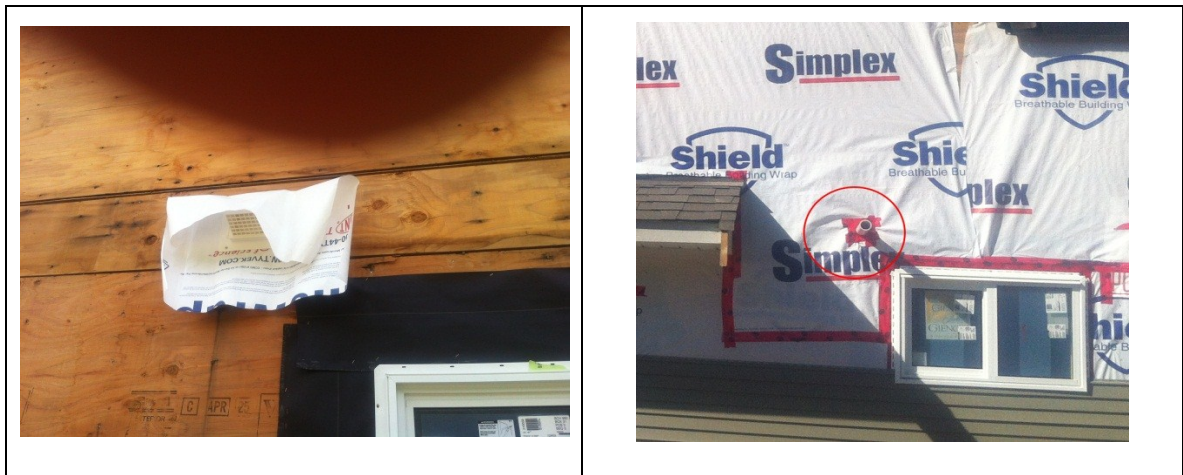
During site reviews, it was noted that window and door rough openings were pre-stripped and waterproofed as discussed in next section, but other penetrations like exhaust vents, hose bibs and exterior electrical boxes were not waterproofed. They were pre-stripped with sheathing membrane only. Electrical meters of House #3 are not pre-stripped at all. The best construction practice is to waterproof these penetrations with self-adhered membrane and seal the leading edges with mastic. This waterproofing detail prevents water ingress into the wall assembly.

Figure 15- Photo 1 shows the exhaust penetration pre-stripped with sheathing membrane  
Photo 2 shows the pipe penetration stripped and sealed with red tape only

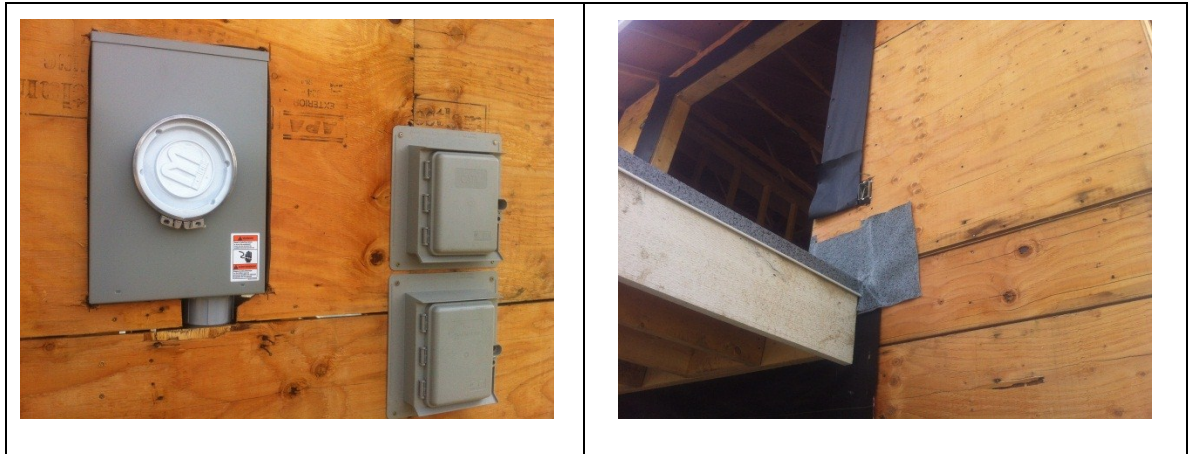
As shown in the Figure 16 photo (#2) below, balcony in House #1 has a vinyl membrane. Membrane has approx. 8" upturn at the saddle joint and building paper is positively lapped with the balcony membrane which is a good practice to prevent water penetration at this critical location. Usually, a diverter/cricket is installed at the saddle joint to divert water away from the joint and drain water at the balcony front edges. The diverter was missing at the balcony.

Figure 16: Photo1 shows the meters are neither pre-stripped with membrane nor waterproofed  
Photo 2 presents the balcony saddle detail

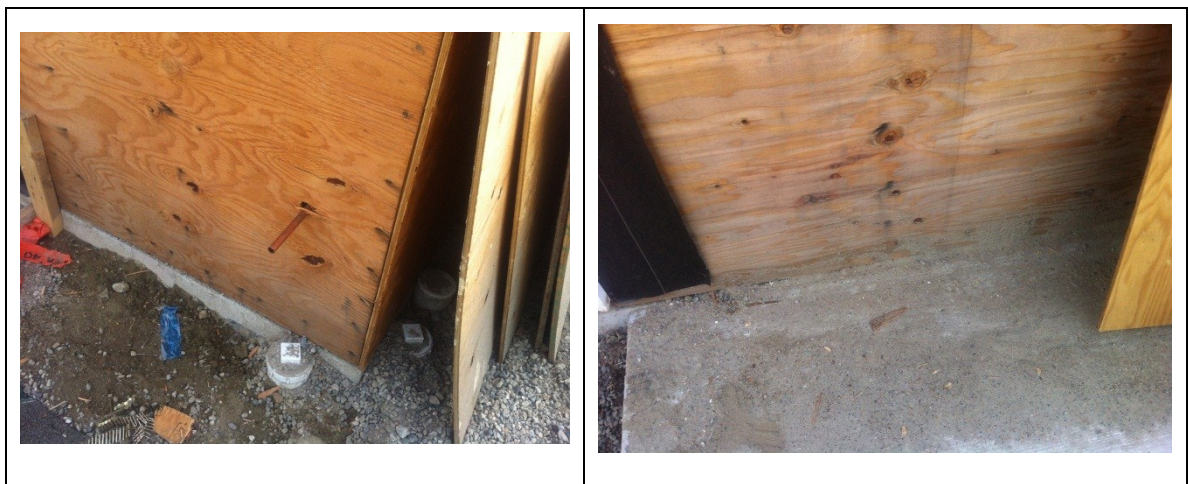
Below grade foundation walls of House #1 and #3 are dampproofed with liquid-applied asphalt material and the concrete slab on grade is formed over 6-mil poly sheet with drainage rock below to prevent moisture penetration from the ground below. But, at the foundation wall to wood frame wall transition, there is no capillary break installed. A gasket is usually installed to prevent moisture ingress from concrete foundation wall to wood (bottom plate of wall).

Figure 17: Capillary break missing at the concrete to wood transition

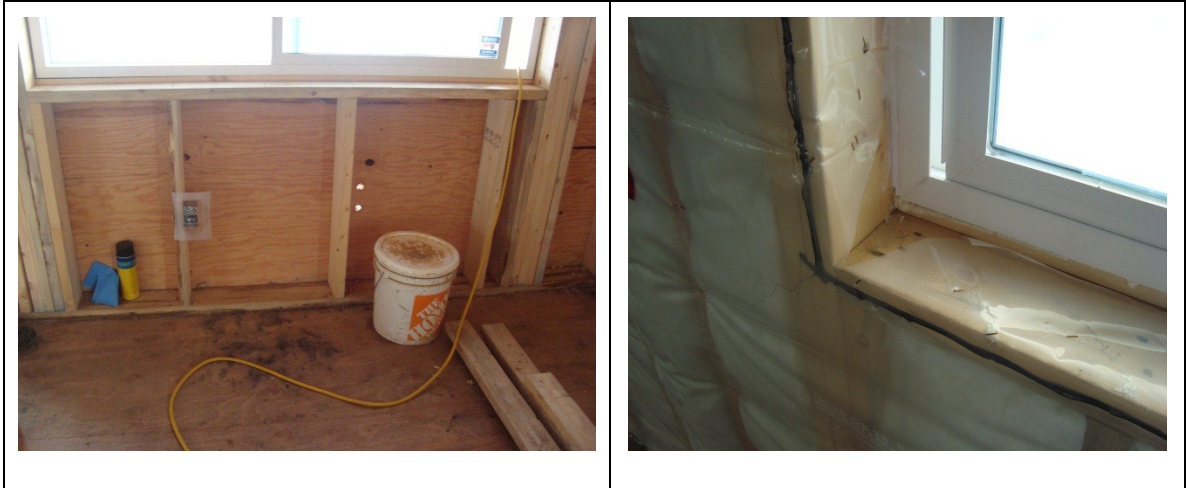
Figure 20: Window sill detail deficiency as there is no weatherproofing (SAM) installed at the sill on three windows

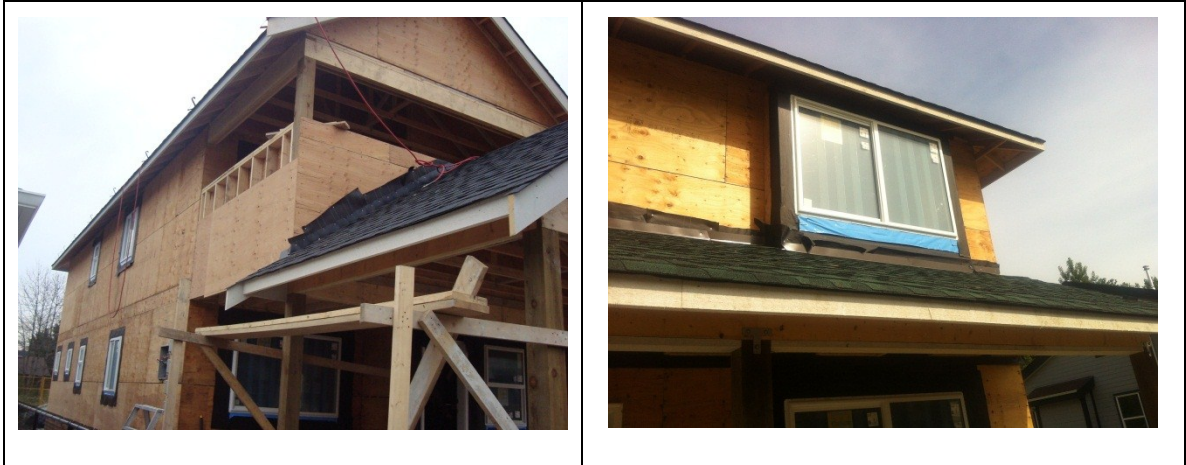
All three houses have sloped roofs and they are covered with asphalt shingles. Roofs have valley flashings to drain water at the intersection of different roof planes. Also, flashing is installed at wall to roof transitions. We noted at one location at the front elevation of House #2 (below the window), flashing is negatively lapped with the sheathing membrane. This is not a good construction practice, since it may lead to water ingress behind the flashing.

Figure 21: Roof details

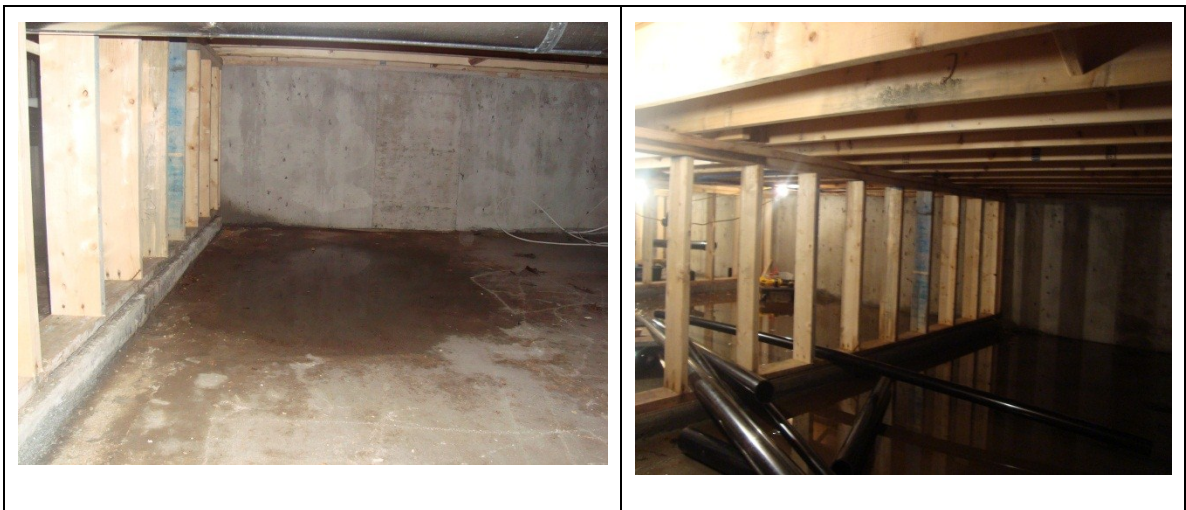
House #1 and House #3 have heated crawlspaces. During construction, large puddles of water were noted on crawlspace floors. The water was evaporated due to the forced air heating in house #3, but House #1 had ponding water after 2-3 months of occupancy. The occupants used extra heaters to get rid of water.

Figure 22: Construction moisture on crawlspace floors

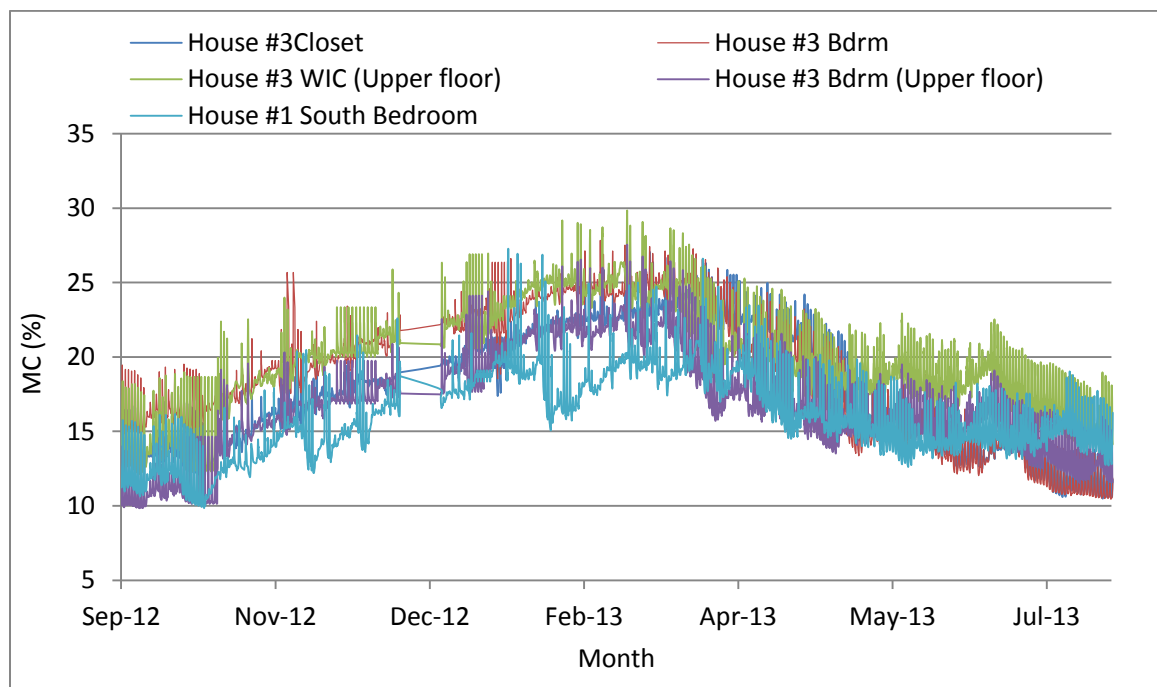
The south elevation of the houses is critical in terms of durability as the wind driven rain comes mostly from South on this reserve. But as shown in Figure 33, MC is lower as compare to other elevations; and moisture dried faster. It should be noted that this elevation has the least number of penetrations. The sensors were placed at the base of the wall whereas on other elevations, they were placed mostly below windows.

Figure 33: Moisture content on South elevation.

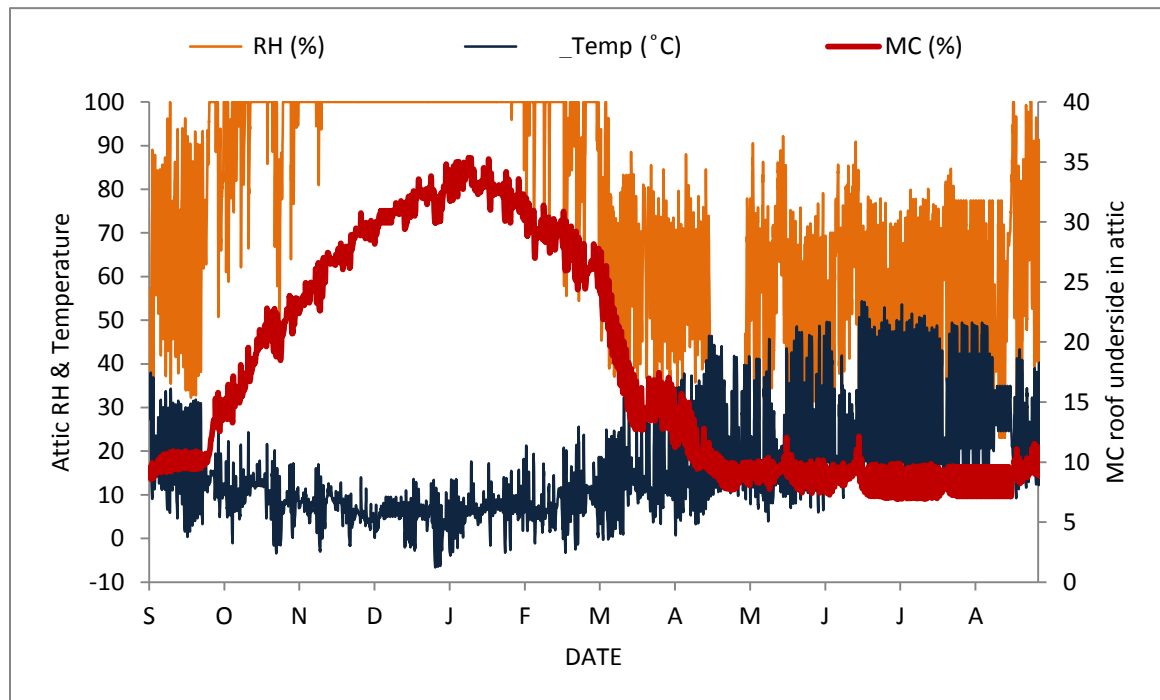
November, and March as shown in Figure 38. Roof sheathing MC readings showed a seasonal wetting and subsequent drying during the warmer seasons, but the wetting period was long and maintained MC above acceptable levels between December and March.

Figure 38: Temperature, RH and MC (roof sheathing) in the Attic of House #1

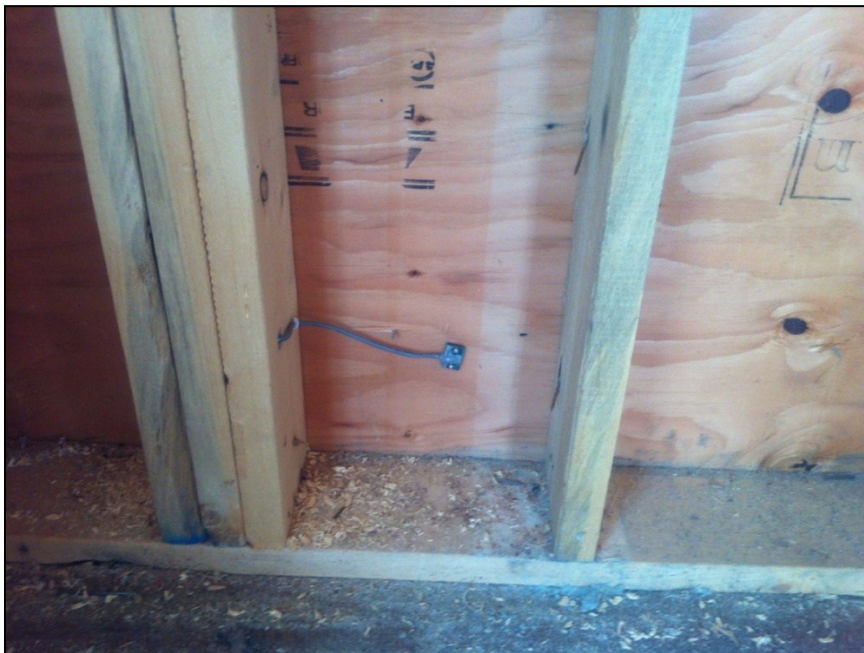
Moisture Content Sensor near the bottom plate below a window

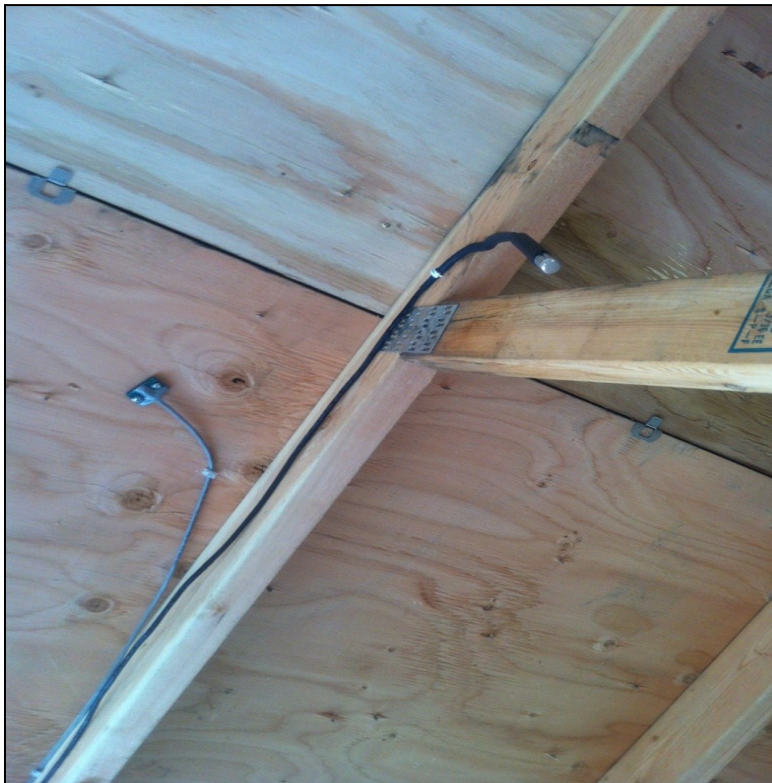
Moisture Content Sensor and Exterior RH/T sensor in the Attic
