# The Deer Lake Recreational Fishery

By,  
Peter Mathews  
2nd Year FWR Student  
Set H  
10 May 2000

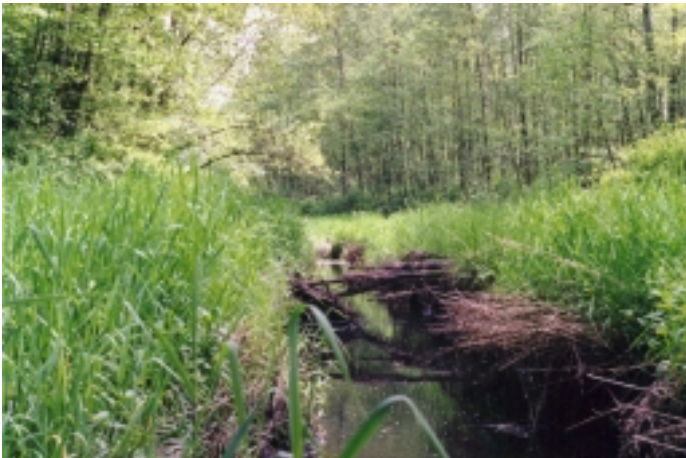
Figure 3. Upper section of Beaver Creek, where bank erosion takes place due to a lack of suitable riparian vegetation.

Beaver creek is located in the western portion of the park (Figure 2.). The headwaters of this creek are located west of Deer lake Park and are fed by urban storm water. Because this is an urban creek flooding is common during storm events, therefore limiting riparian vegetation. Beaver Creek is a low gradient stream and canary reed grass as the predominant riparian vegetation (Figure 3.). Salmonid habitat is poor because of the following factors.

- Poor water quality.
- Limited riparian vegetation.
- Low oxygen levels and high water temperatures in the summer.

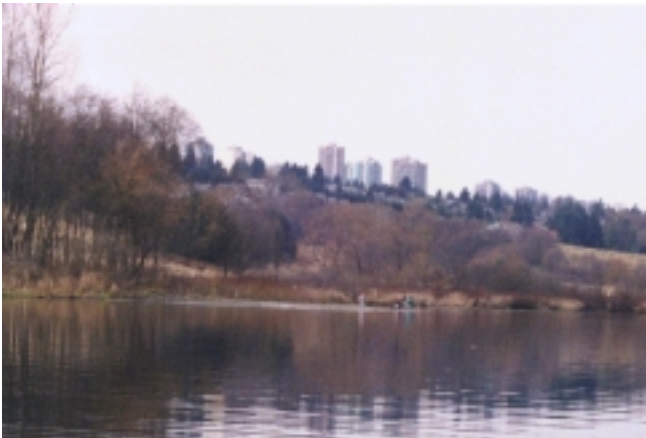
Figure 4. Creek # 11 mouth, where heavy sedimentation has created a sand deposit. This sand bar serves as a beach area for anglers.

Creek # 11 is located in the southwestern portion of the park (Figure 2.). The headwaters of this creek are south of Deer Lake Park and are fed by urban storm water. This stream has a high gradient in its upper reaches and runs through primarily deciduous forest. Heavy sedimentation is made evident by the large sand deposits at the mouth Creek # 11 (Figure 4.). This creek appears to lack the following salmonid habitat requirements:

- Stream complexity.
- A stable flow regime.
- Adequate riparian vegetation in the lower portion.
- Lack of refuge habitat.
- Scouring of spawning gravel's, caused by heavy rainfalls
- Poor water quality due to storm water runoff and suspended sediments.
- Access to the upper portion of the creek.

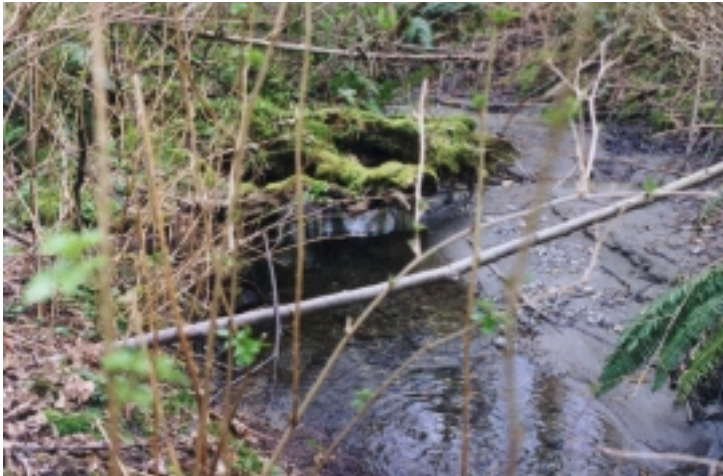
Figure 5. G-type minnow trap location 6, showing salmonid habitat where one rainbow trout parr was sampled.

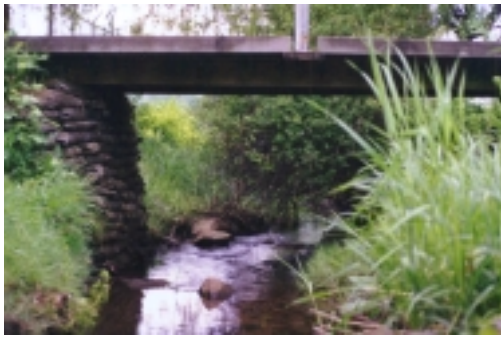
Figure 6. Lower Section of Creek # 16, where rainbow trout have been observed during warm water periods in the summer.

Creek # 16 is located in the eastern region of the park (Figure 2). The entire upper section of this creek is culverted and fed by urban storm water. Rainbow trout have been observed utilizing the lower, open section of this creek during warm water periods in the

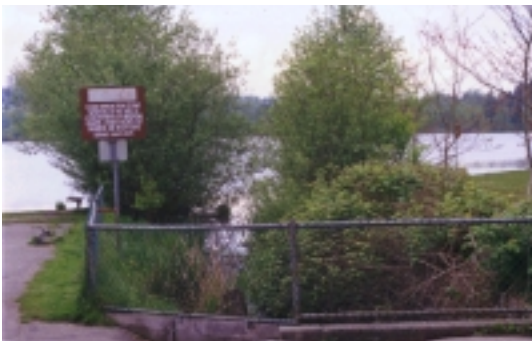
Figure 7. Open section of Buckingham Creek, where rainbow trout have been observed during warm water periods in the summer.

Buckingham Creek is located in the eastern region of the park (Figure 2.). Stocked rainbow trout have been observed utilizing the lower, open section of this creek during warm water periods in the summer (Figure 7.), (Pearson & Diamond 1999). The culverts, artificial channels and cemented rock substrates in this creek make salmonid utilization

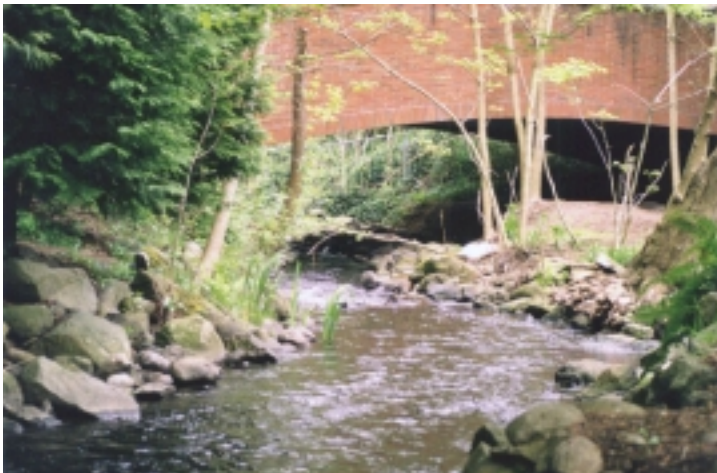
Figure 8. Section of Deer Lake Brook, where spawning gravel's were placed in 1994 and 1995.

Deer Lake Brook is the outlet of Deer Lake, located in the northeastern region of the park (Figure 2.). In 1994, the coarse fish barrier was removed in Deer Lake Brook to allow for the upstream passage of salmonids (Gunn, 2000). In 1994 and 1995 spawning gravel's were placed into Deer Lake Brook and one adult pair of coho salmon was known to utilize these gravel's for spawning (Figure 8.), (Gunn, 2000). Adult rainbow trout and cutthroat trout have been observed in this creek (Pearson & Diamond 1999).

- Spawning substrates are not suitable.
  - Unstable flow regimes.
  - Poor water quality due to storm water runoff and suspended sediments.
  - A lack of stream complexity.
  - Limited riparian vegetation.
- (BCIT, FWR Program)

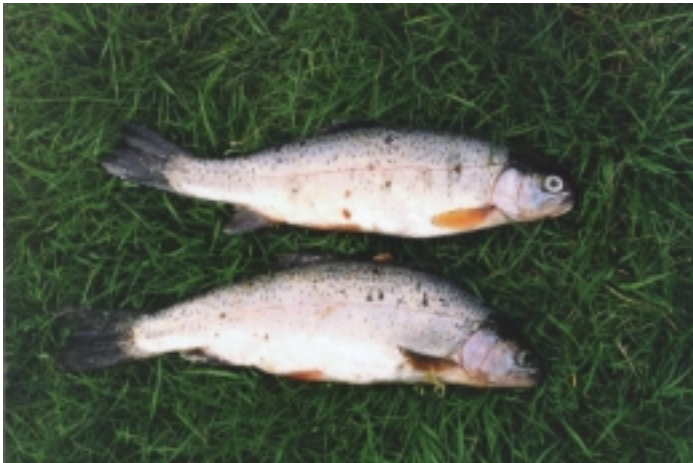
Figure 13. Two rainbow trout caught by angling on March 26th, 2000

Five, two to four hour long angling sessions were conducted. Only one of these sessions produced samples. Two rainbow trout were caught on March 26th in anglers survey zone #1 (Figure 13). The first was ten inches fork length and the second twelve inches fork length. These fish put up a strong fight and through visual examination both fish appeared to be well fed and had a bright silver colour. These fish were covered in open wounds, which appeared to be parasitic.

The two rainbow trout sampled by angling give evidence of an adult population in this system. The success and health of this population is not known.
