Restoration Planning for Urban Salmonid Habitat: Effects of Stormwater Runoff on Water Quality and Benthic Invertebrates

Project Submitted in Partial Fulfilment of the
Requirements for the Degree of
Master of Science

in the
Ecological Restoration Program
Faculty of Environment (SFU)
and
School of Construction and the Environment (BCIT)

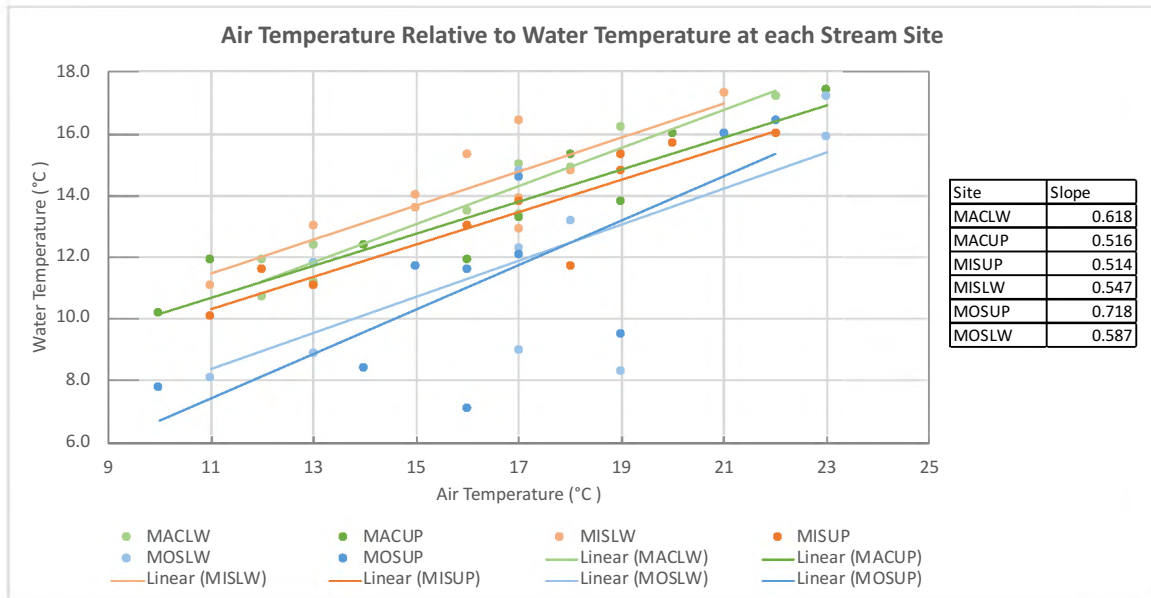
Figure 7. Relative air temperature and water temperatures at each site.

We also measured the concurrent air temperature at each site, which ranged from 10 to 23°C on the dates measured from May to October 2020. There appeared to be no substantial differences between the average air temperatures at each site. We also plotted air temperatures relative to the water temperatures measured (Figure 7).

As shown in Figure 7, all of the trend lines follow a similar pattern. For most stream sites, an increase in 2 degrees of air temperature approximately corresponds with a 1 degree increase in stream water temperature (slope = 0.52). This likely reflects the seasonal pattern of more sun when there are warmer temperatures, as amount of light incident on a stream is a more important factor controlling stream temperature, rather than the air temperature itself (Beschta, et. al., 1987; Teti, 1998). At the Mosquito Creek upper site, the slope of this relationship is slightly greater (slope = 0.72) so an increase in about 1.4 degrees of air temperature corresponds with 1 degree increase in water temperature. This means that as air temperatures increase, the upper Mosquito Creek site has a greater increase in water temperatures compared to the other sites.

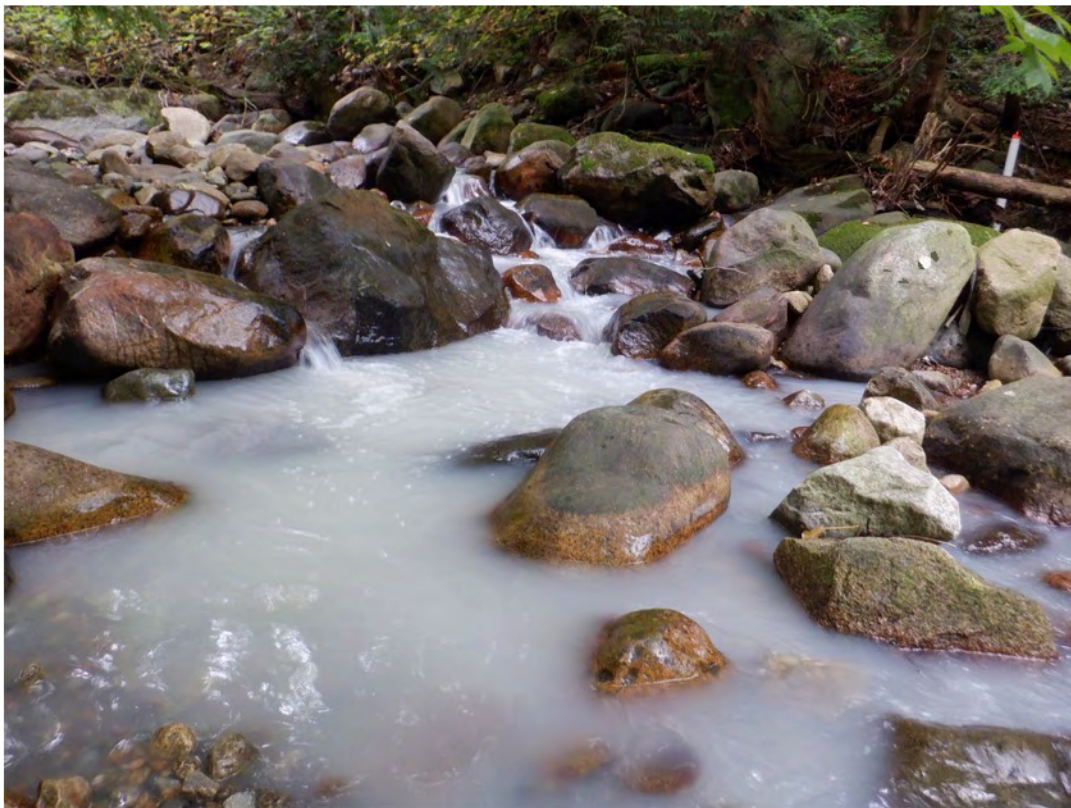
Figure 9. Mission Creek lower site on 1 September 2020 during a point-source pollution event.

The second pollution event observed took place at Mission Creek at the lower site on 1 September, 2020 at approximately 14:05. A substantial amount of a white cloudy substance was observed entering the stream at the upper end of the reach and flowed down to the survey site (Figure 9). The white cloudy water was accompanied by an extremely strong rotten fruit odour. Upon further inspection, a white substance was observed to be coming from a retaining wall at the top of the reach.

Upon further assessment of the area, we determined that the source of this substance was a Safeway on Westview Drive at the top of the ravine, as we saw the same white fluid and recognized the foul-smelling odour in the driveway behind their building. We also observed a garbage truck removing a large dumpster (likely containing rotten produce). After calls with the Emergency Management BC line to report the problem, the City of North Vancouver sent a representative to speak to the Safeway manager. The pollution issue had not been reported previously and was likely a recurring event when produce waste is disposed of and rinse water is washed down the drain (pers. comm. F. Ramsay, City of North Vancouver, 2 September 2020).

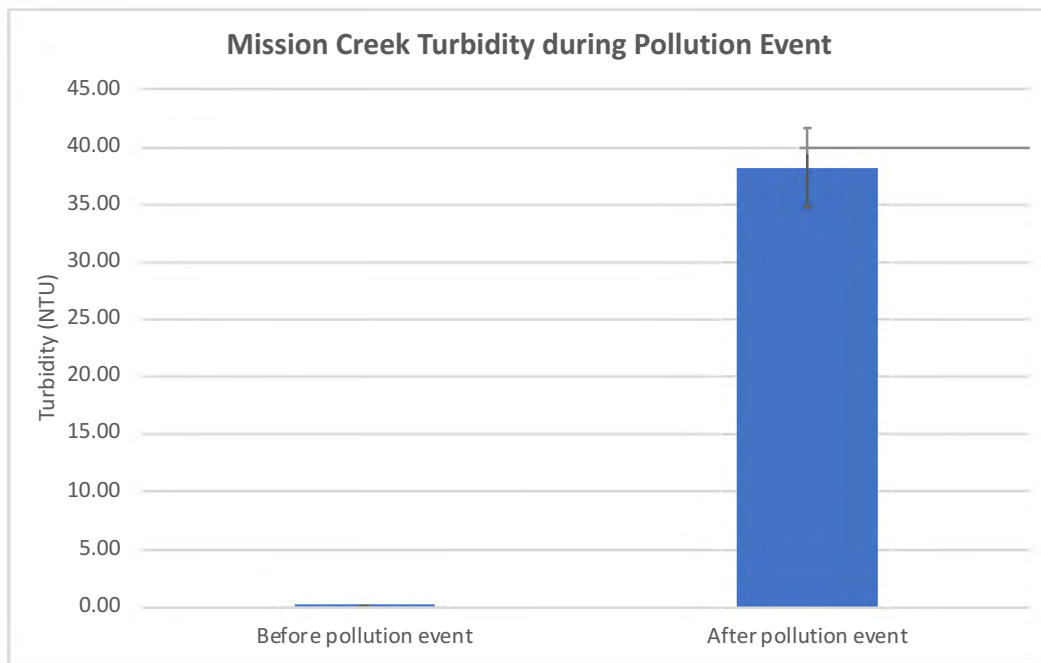
Figure 10. Change in turbidity before and after pollution event on Mission Creek 1 September 2020.

As the event occurred immediately after normal water quality monitoring, we were able to compare water quality before and after this pollution event. In a matter of only 20 minutes, the creek water quality was markedly reduced. The results of this event were a substantial increase in turbidity and conductivity, and an extreme decrease in pH (Figure 10; Table 6). Given that pH is on a log scale, this change represents an increase in the hydrogen ion concentration by over 75,000%. In addition, these measurements were taken at the sampling site, downstream of the pollution entry point so some dilution

Time	Average Turbidity (NTU)	Turbidity SE	Temp (°C)	Conductivity (µS/cm)	pH
Before pollution event	13:42	0.16	0.02	15.3	148.6	7.65
After pollution event	14:05	38.2	3.50	15.4	321.8	4.78

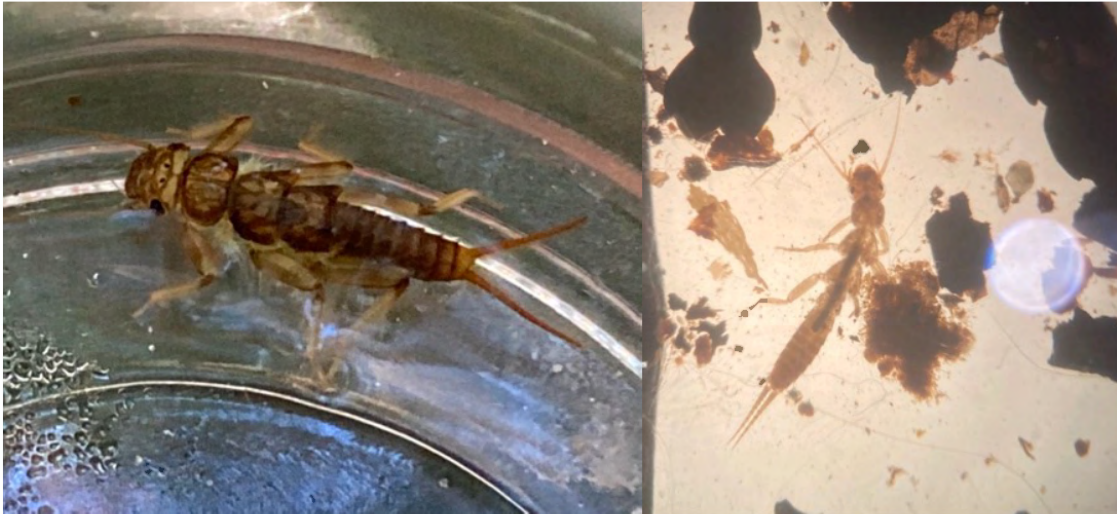
Figure 11. Benthic invertebrate specimens including these stoneflies collected during spring 2020.

Benthic invertebrate samples were collected in the spring on 27, 28, 29 May 2020. Results are available for the four main sites, the Mosquito Creek upper site, Mosquito Creek Lower site, and Mackay Creek upper site and Mackay Creek lower site. In total over 900 invertebrates were examined from the spring samples including at least 30 families of aquatic invertebrates. This encompassed a diverse array of benthic invertebrates including abundant Chironomidae (lake flies) and Naididae (Naidid worms), as well as Chloroperlidae (green stoneflies) and Ameletidae (comb-mouthed minnow mayflies) (Figure 11).

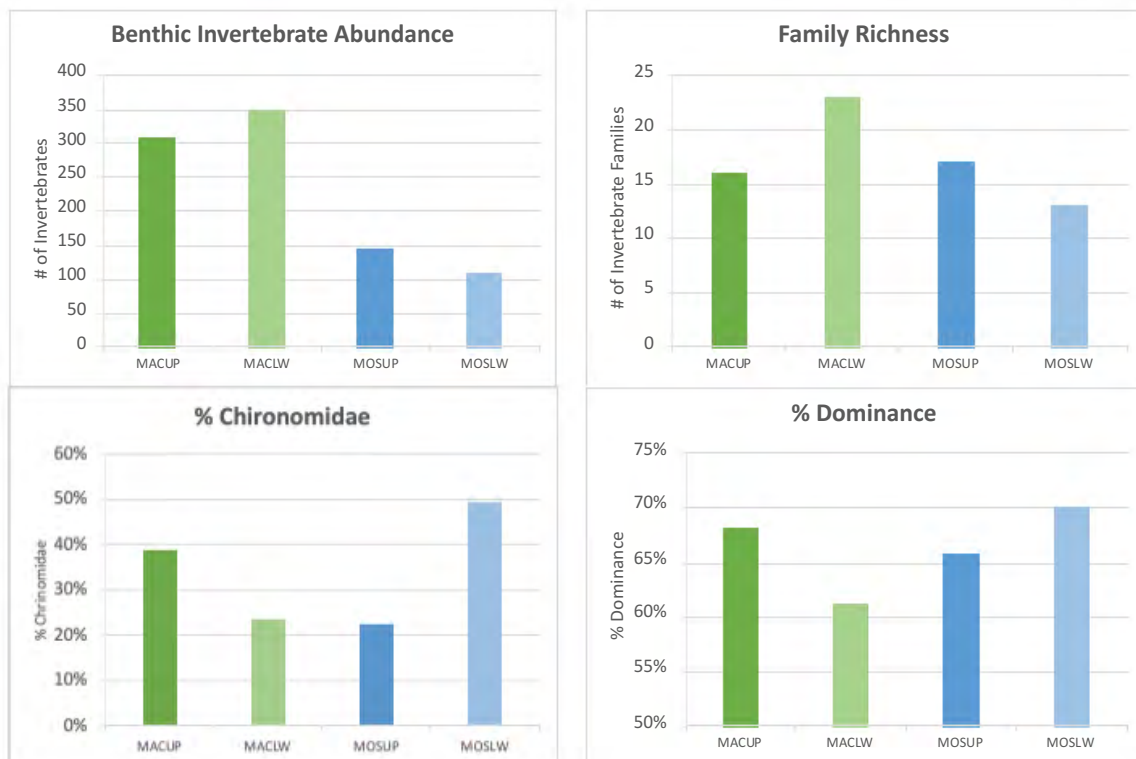
Figure 12. Spring benthic invertebrate metrics: Total abundance, % Chironomidae, total family richness, and % dominance (proportion of top three taxa) for spring invertebrate samples.

Several metrics of benthic invertebrate abundance and diversity were calculated for the spring invertebrate samples (Table 7; Figure 12). The largest number of benthic invertebrates was found in the Mackay Creek lower site, while the lowest abundance was found at Mosquito Creek at the lower site. Total Family Richness was similar across the sites and was slightly lower at the Mosquito Creek lower site and greater at the Mackay creek lower site.

The % Chironomidae represents the proportion of the Chironomidae family in proportion to the whole sample, and was elevated at all sites, particularly the Mosquito Creek lower

site. This is expected to be higher at polluted sites as Chironomidae are tolerant of pollution. However, Chironomidae are also found at healthy stream sites to some extent. The % Dominance metric measures the proportion of the top three taxa so high dominance suggests a less diverse community. The % Dominance was generally high across all sites; however, at Mackay Creek this included a rather high proportion of Ephemeroptera. There was also a decrease in dominance going downstream at Mackay Creek but an increase going downstream at Mosquito Creek.

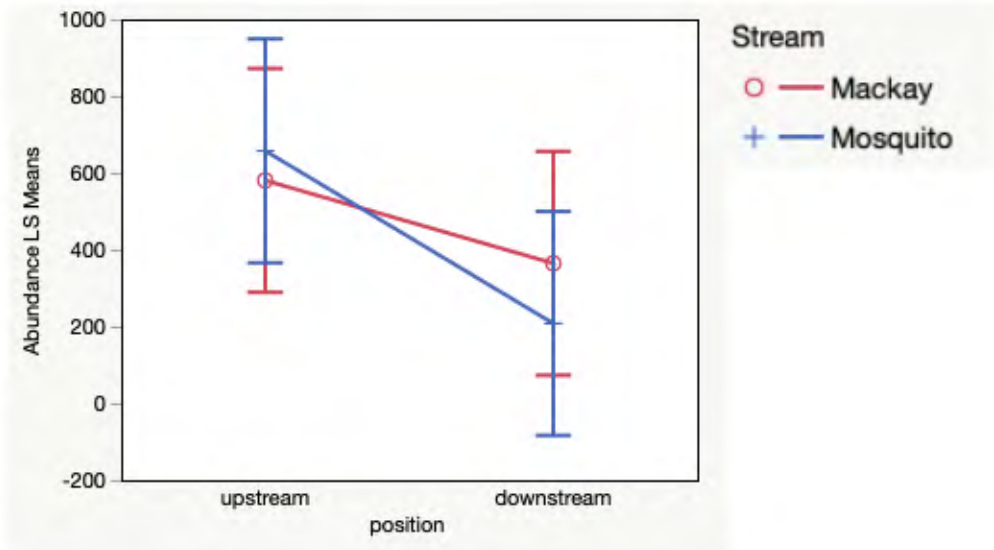
Figure 15. Least squares means plot for the two-factor Anova model of abundance based on stream and position.

different in abundance. Based on the combined results including the t-tests this suggests there may be an impact on benthic invertebrate abundance. However, based on the ANOVA results, we cannot completely rule out that the differences aren't due to some other factor, such as natural progression downstream, as was also found at the Mackay Creek control.

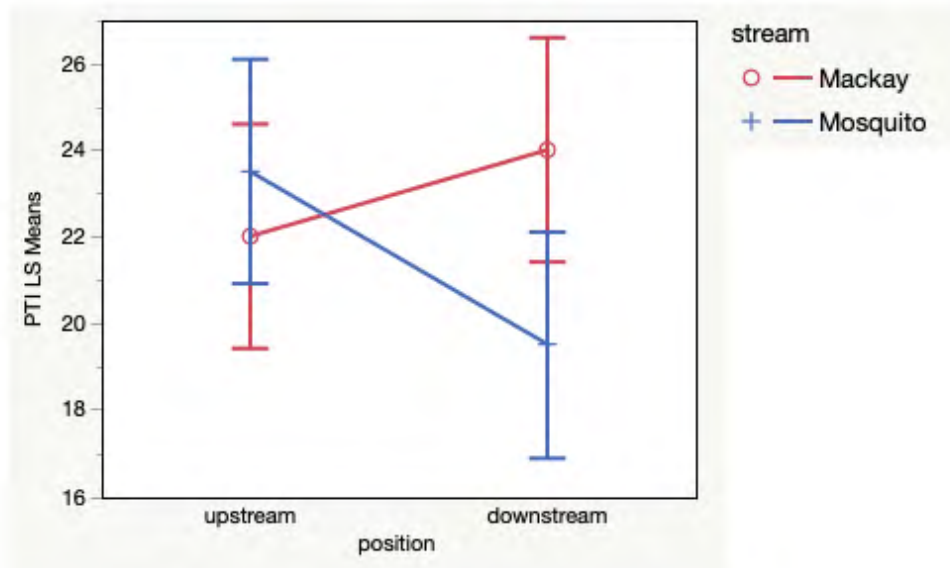
Figure 17. Least squares means plot for the two-factor Anova model of PTI based on stream and position for fall benthic invertebrates.

Statistical Analyses were completed to determine the significance of these patterns using a two sample t-test to compare Mackay Creek sites, the Mosquito Creek sites, and a two-factor Anova using the factors position (upstream/downstream) and stream (Mackay/Mosquito) and the interaction term positionXstream.

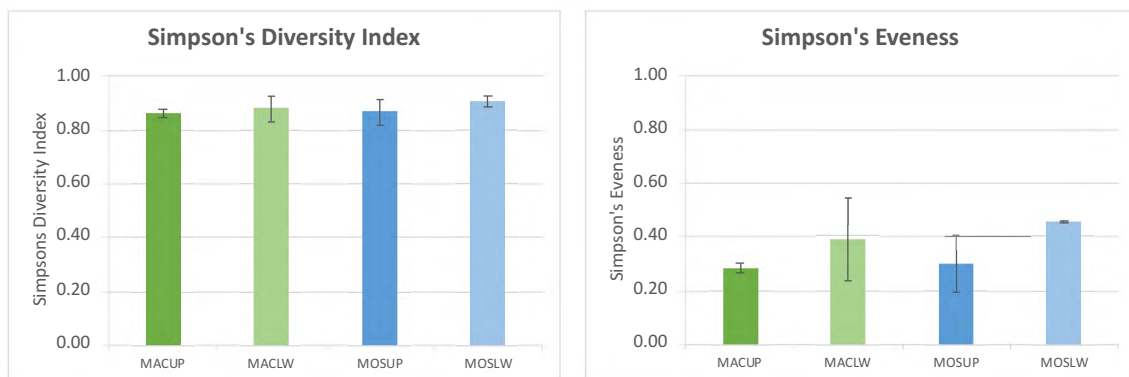
Figure 18. Diversity Indexes for Fall Benthic Invertebrates: Simpson’s Diversity Index and Simpson’s Evenness. Error bars show standard error.

Simpson’s Diversity Index, calculated as 1-D, may range from 0 to 1, with greater values indicating greater diversity. Average diversity was high at all sites, reflecting the large number of families observed in each sample. Simpson’s Reciprocal Index is calculated as 1/D; the lowest value for this index is 1 and the highest value is equal to the number

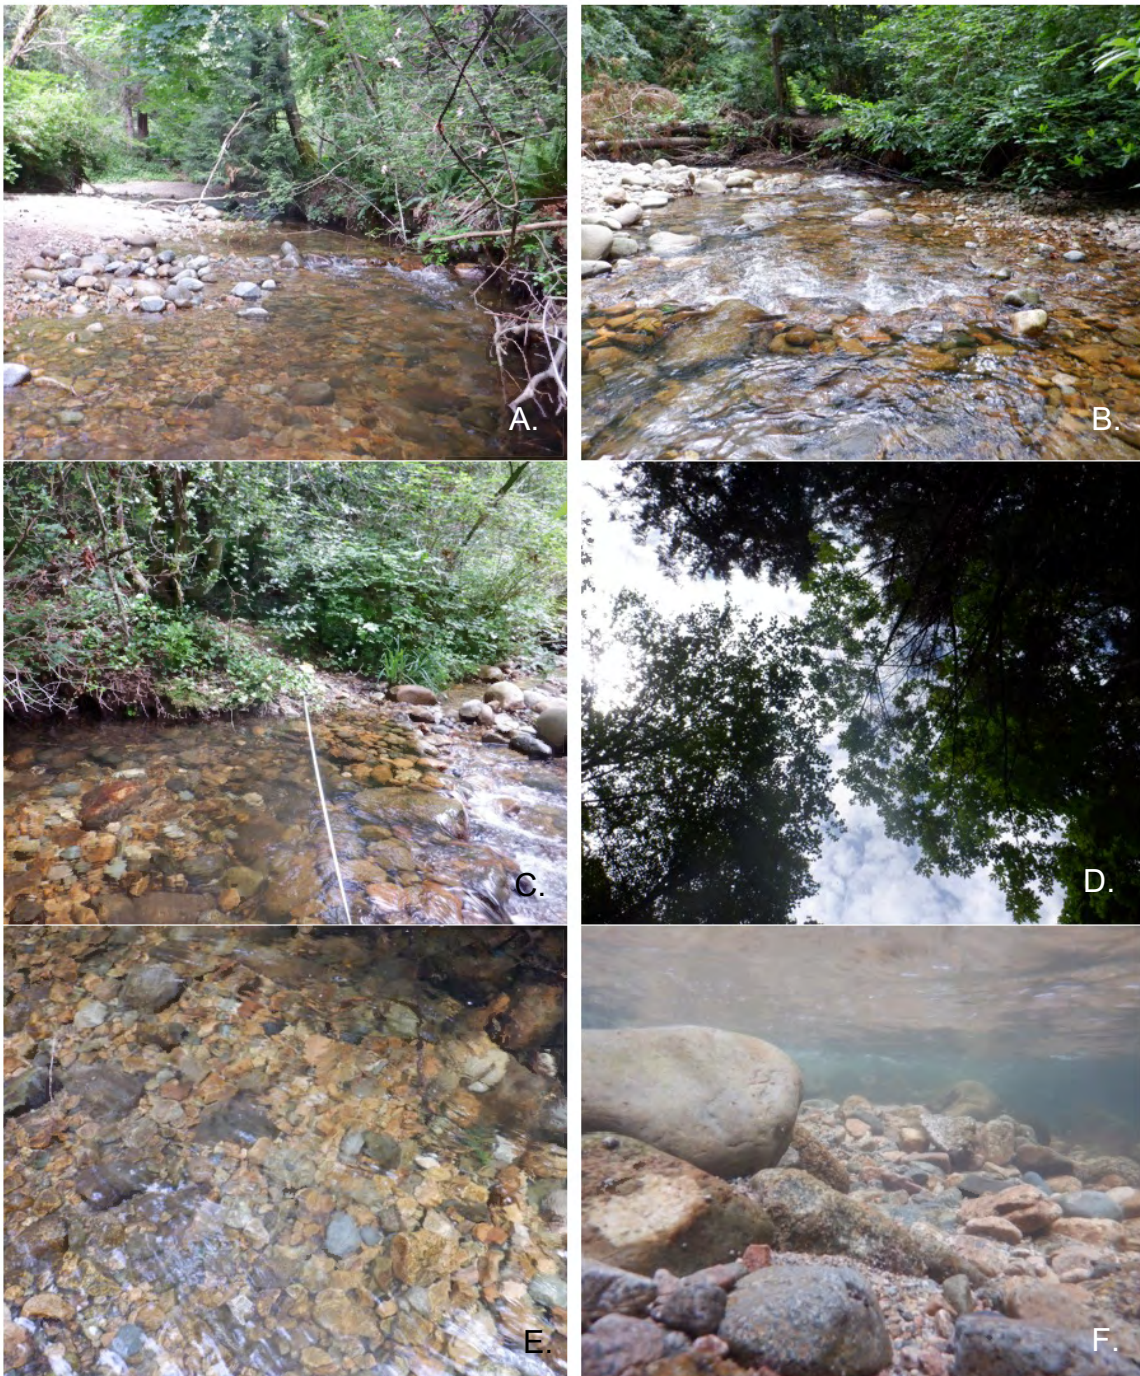
Figure B1. Mackay Creek upper site photos. A. upstream. B downstream. C. Across D. Canopy cover. E. Substrate. F. Underwater.

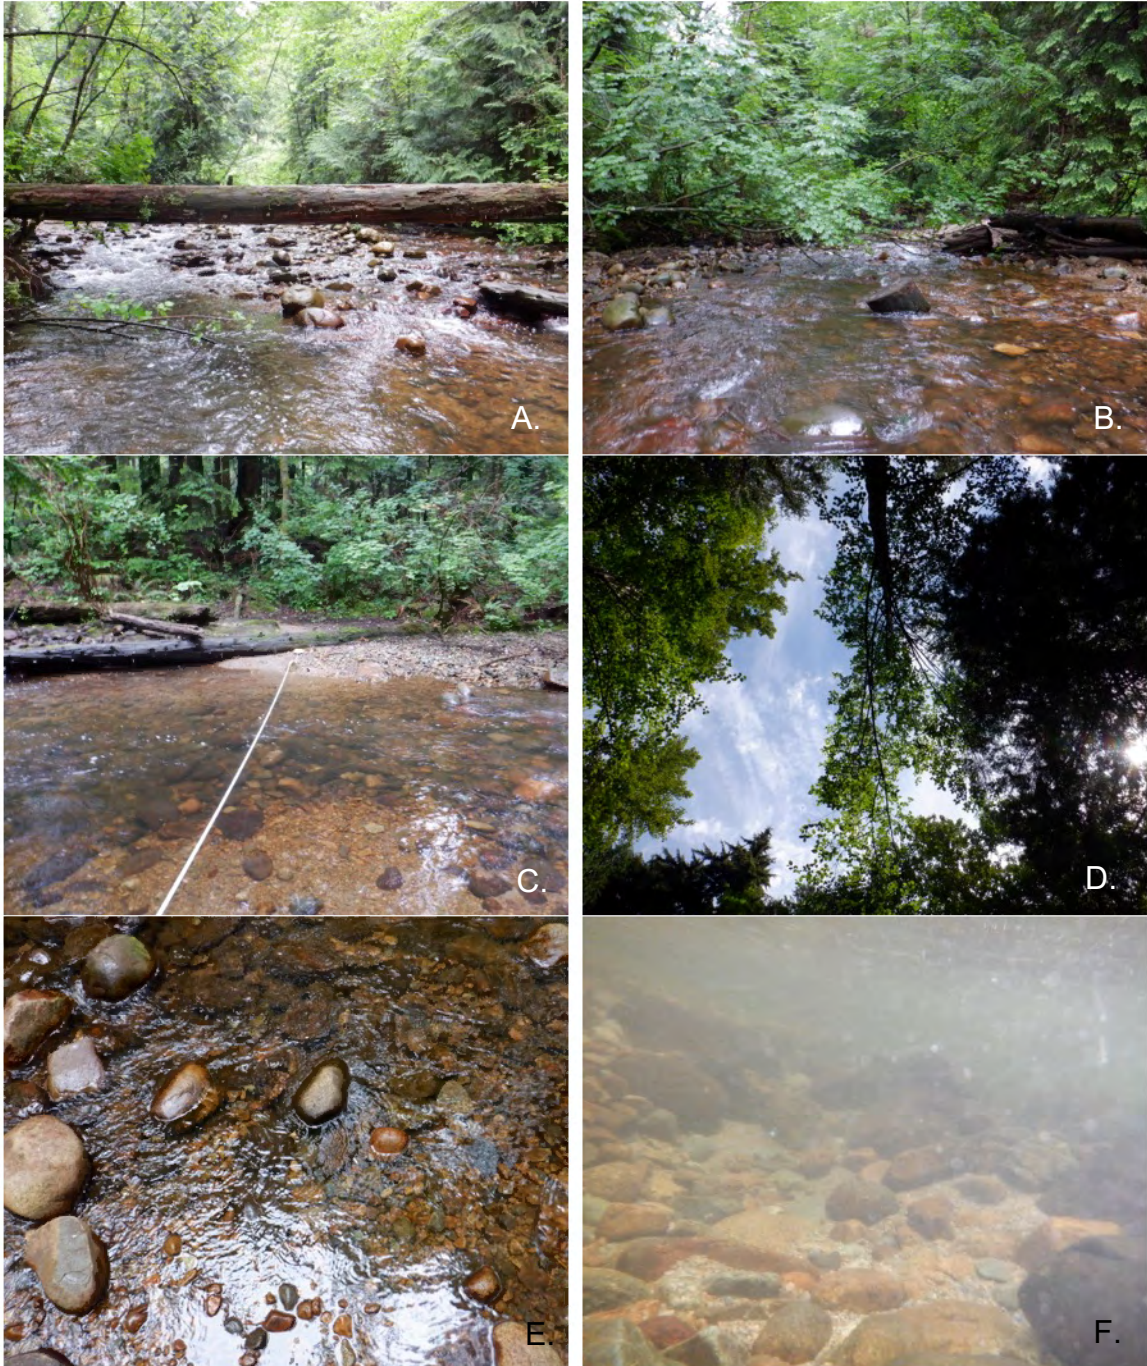
Figure B2. Mackay Creek lower site photos. A. upstream. B downstream. C. Across D. Canopy cover. E. Substrate. F. Underwater.

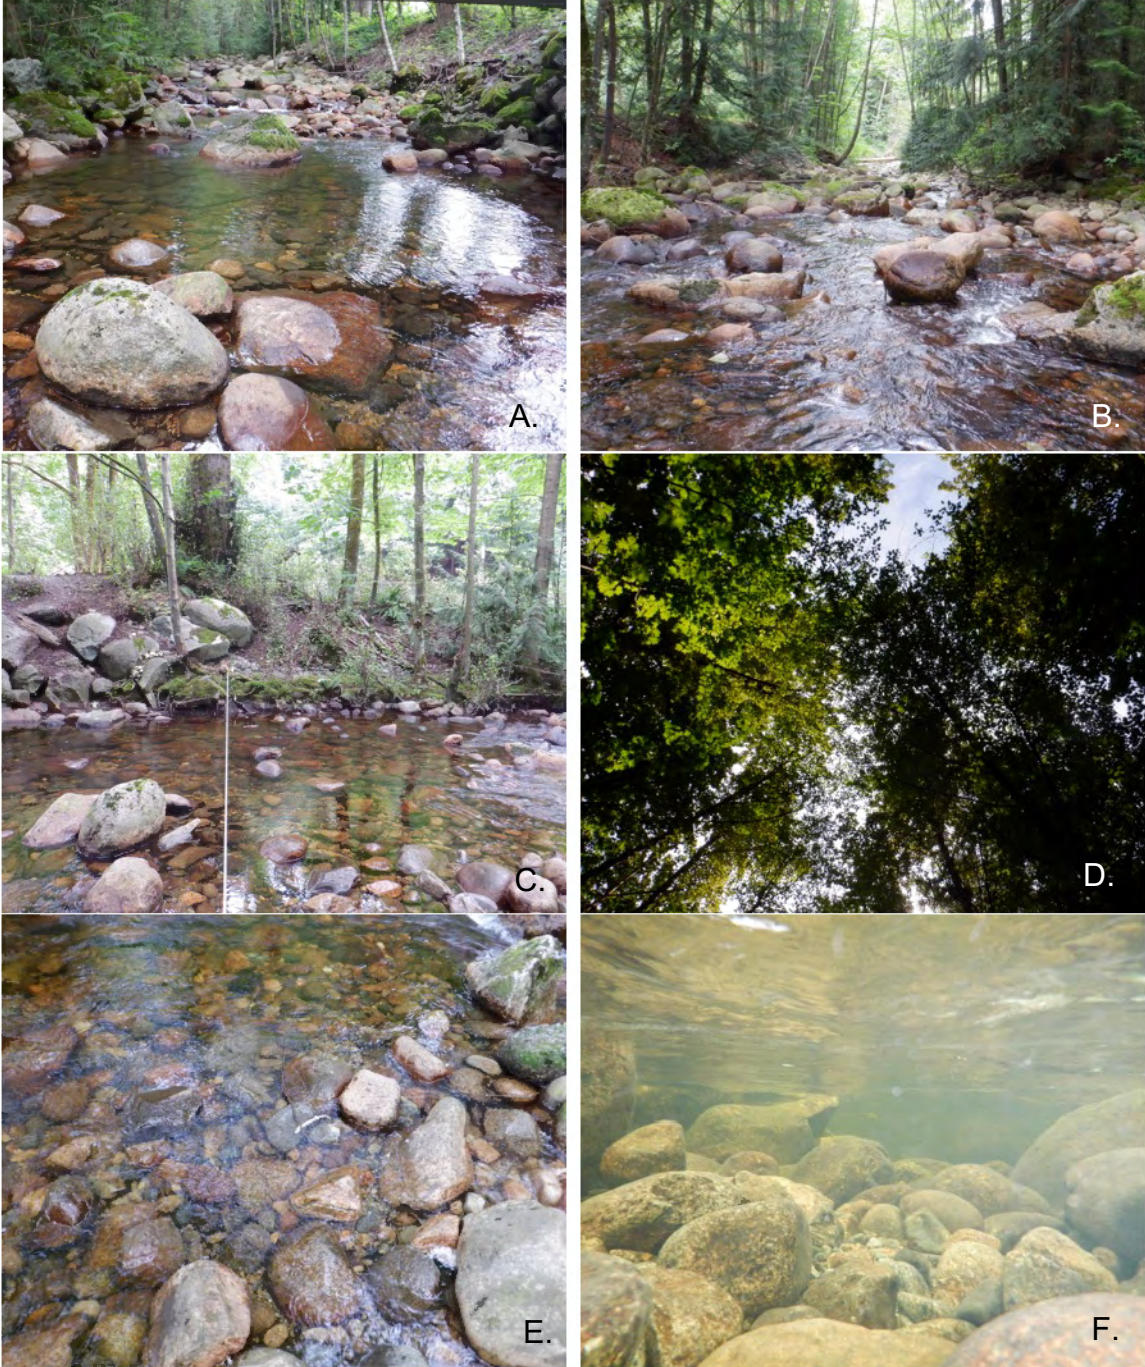
Figure B3. Mosquito Creek upper site photos. A. upstream. B downstream. C. Across D. Canopy cover. E. Substrate. F. Underwater.

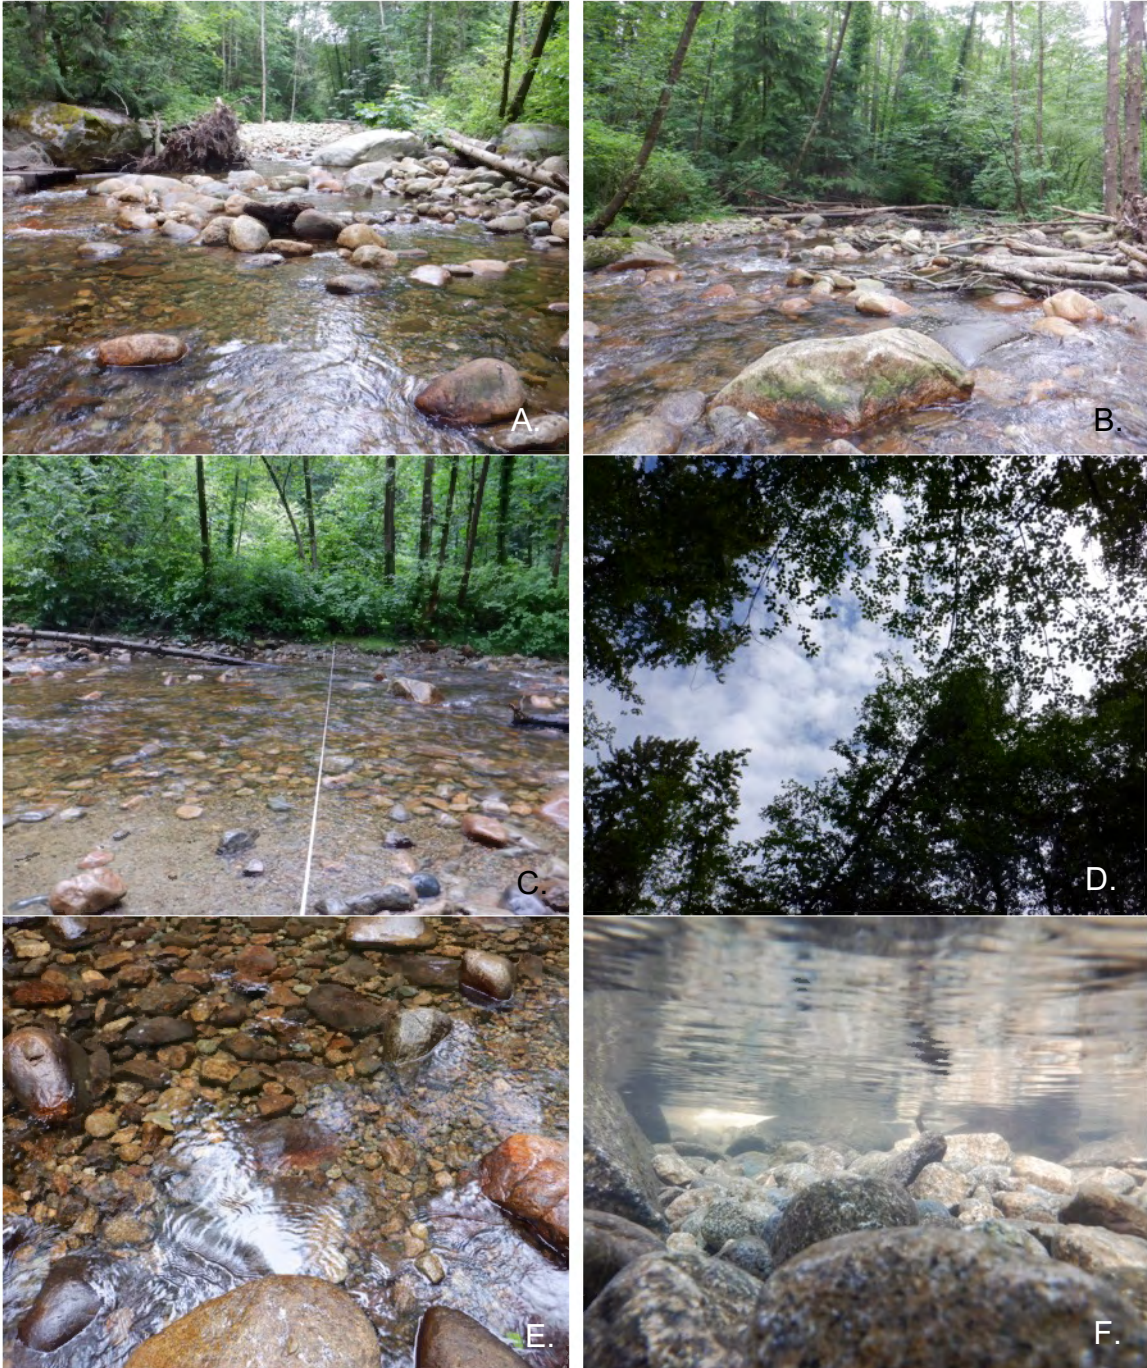
Figure B4. Mosquito Creek lower site photos. A. upstream. B downstream. C. Across D. Canopy cover. E. Substrate. F. Underwater.

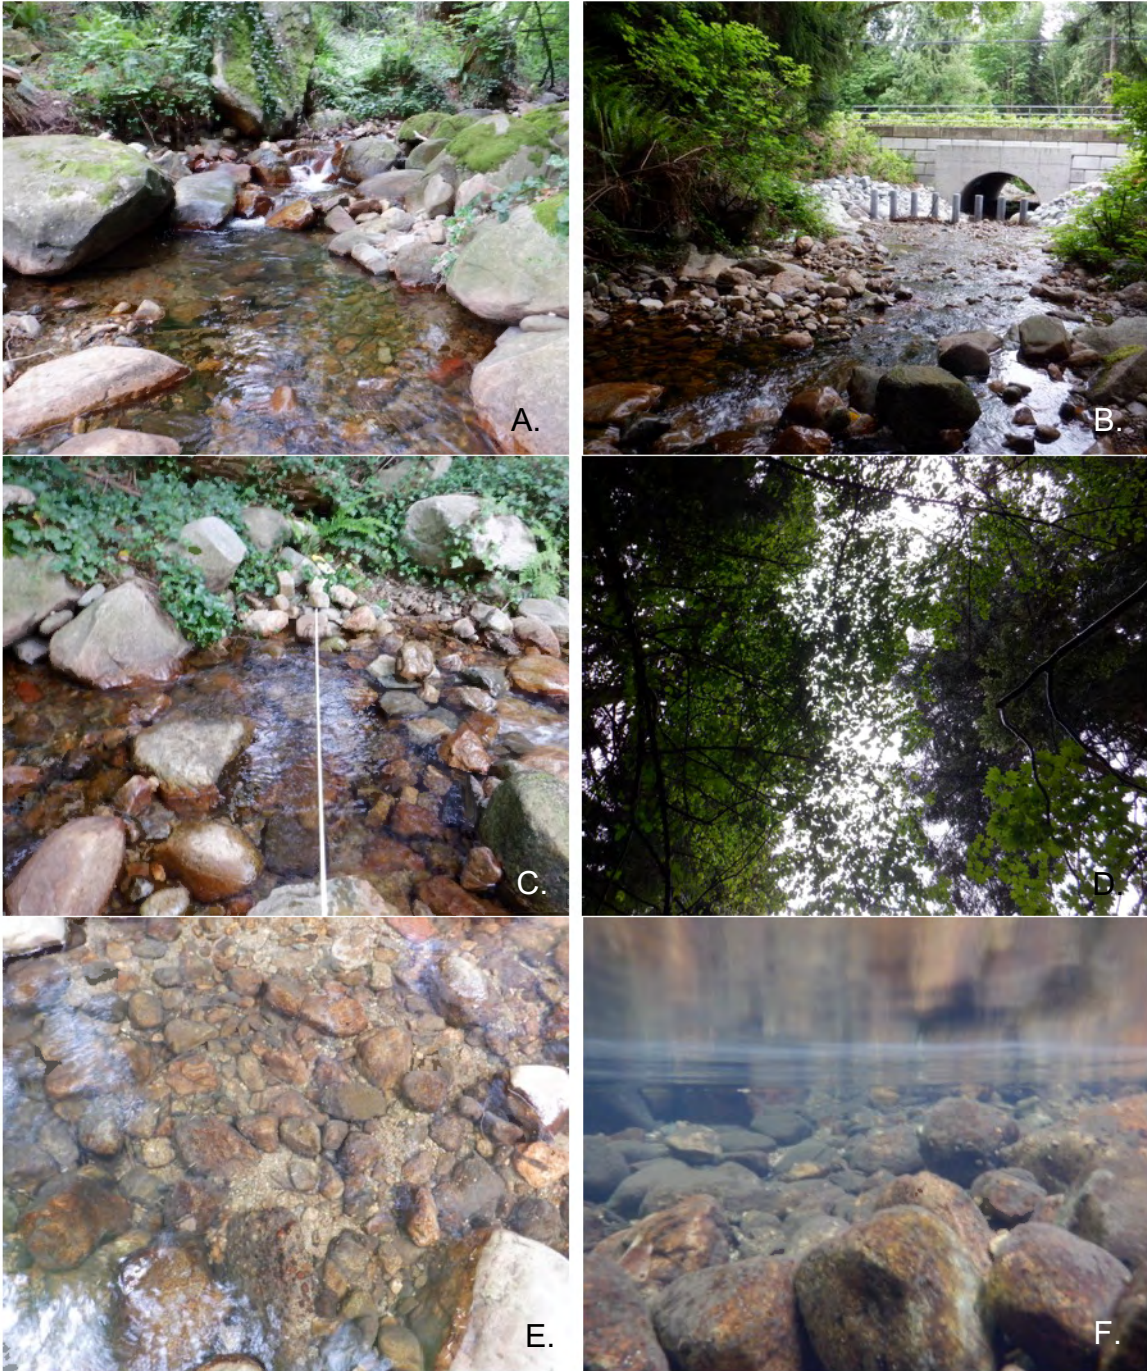
Figure B5. Mission Creek upper site photos. A. upstream. B downstream. C. Across D. Canopy cover. E. Substrate. F. Underwater.
