# **Brunette Watershed Fish Sampling Study**

**2003 – 2004**

**City of Burnaby  
Burnaby Lake Systems Project**

**Cole Smith  
Manny Johnson**  
Fish, Wildlife, and Recreation

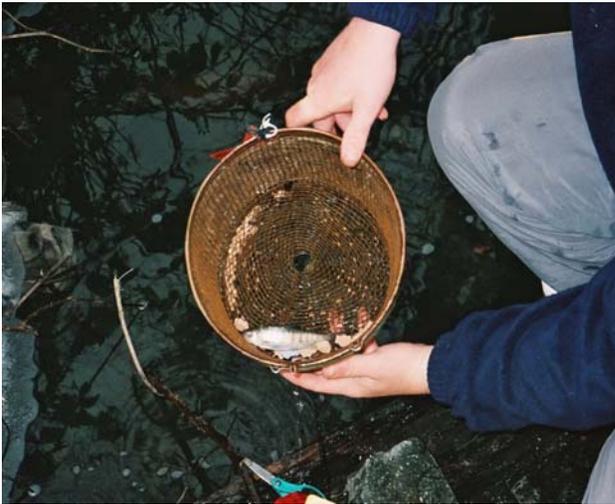
Fig 1. Coho caught in a minnow trap

Locations were selected by finding in stream debris to act as anchor points. Traps were secured using rope or string and baited with cat food. Pools were at a depth of at least 50 cm to limit the chance of fish mortality. Traps were checked within a twenty four hour period. All fish were removed and analyzed.

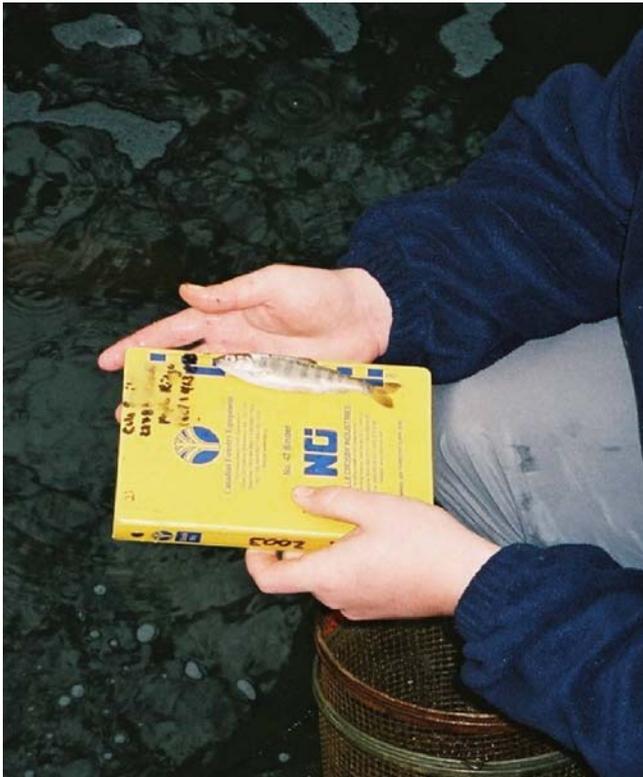
Fig 2. Coho caught and being measured

Fish were analyzed according to species, length (cm), and were examined for any pre-existing clips or marks. Upon arriving on site, fish were removed from traps and placed into a temporary holding tank. Each individual was then removed from the tank and placed on a measuring board and data were entered into log books. Any salmonids that did not have an existing fin clip were given an adipose clip and released. Fish were processed as quickly as possible to minimize undue stress and reduce the chance of mortality.

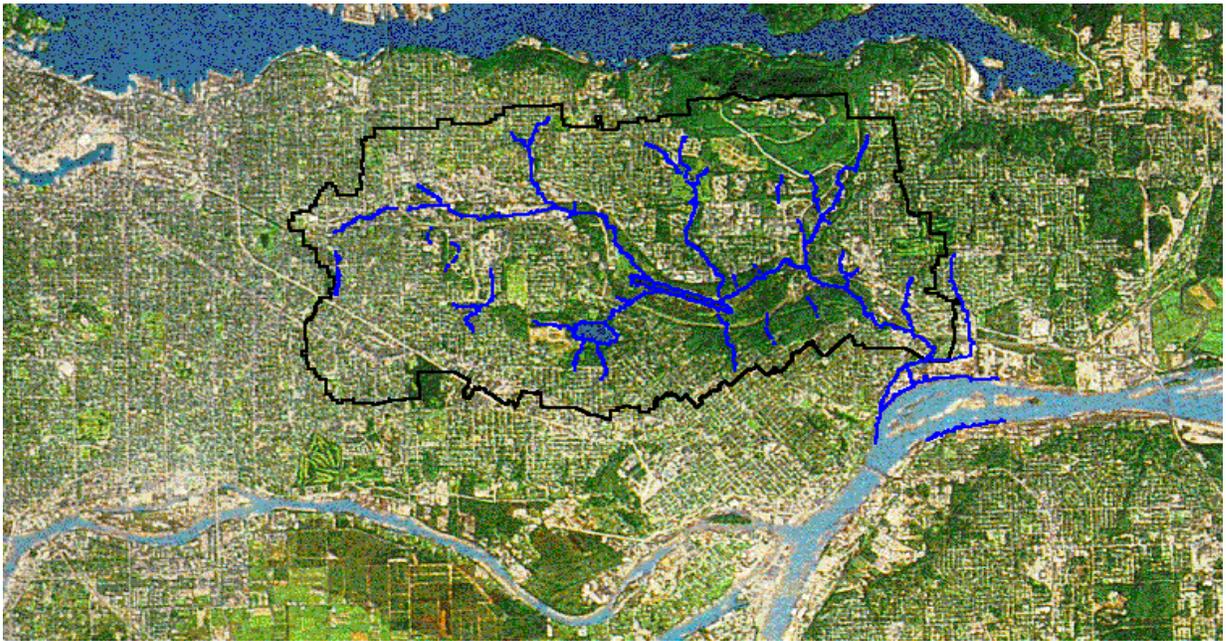
Fig 3. A satellite image of the Brunette watershed

The Brunette Watershed is located mostly within the City of Burnaby but also extends into Coquitlam, New Westminister, Vancouver, and a small portion of Port Moody. The Brunette Watershed contains a network of creeks as well as two lake systems. Beginning from Vancouver Still Creek flows east and drains into Burnaby Lake. Many smaller creeks drain into Still creek, such as Chub, Guichon and Darnley creeks. Deer Lake is also part of the watershed; and is connected to Burnaby Lake by Deer Lake Brook.

Burnaby Lake begins to narrow to the east. Draining from the lake towards the Fraser River through the Cariboo Dam is the Brunette River. The Brunette River also has other creeks entering before it conflues the Fraser River.
