# **Restoring Hydrological Connectivity in the Guichon Creek Watershed through Wetland Creation**

Project Submitted in Partial Fulfillment of the  
Requirements for the Degree of  
Master of Science

in the  
Ecological Restoration Program

SIMON FRASER UNIVERSITY  
BRITISH COLUMBIA INSTITUTE OF TECHNOLOGY  
2017

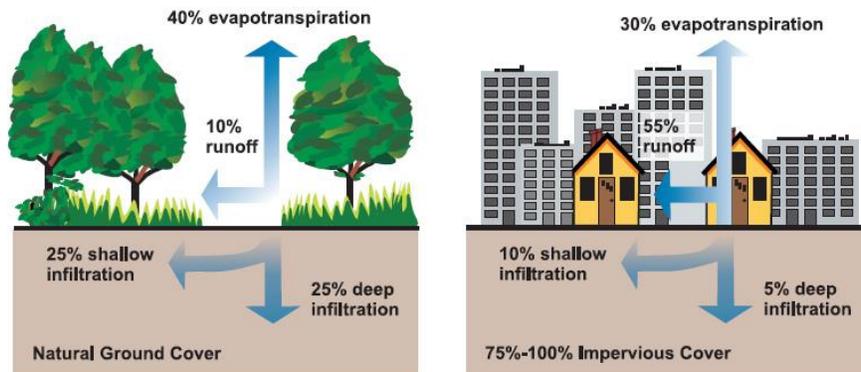
**Figure 1-1:** The effects of impervious cover on watershed hydrology (USEPA, 2003)

Impervious areas create an increase in the amount of runoff and a decrease in the amount of infiltration (Figure 1-1, 1-2). Subsequently, receiving water bodies in urban areas are subject to higher flow rates and higher volume of runoff than undeveloped areas. If the receiving streams are not capable of handling these hydrological changes, this can result in flooding, bank erosion, and degradation of in-stream habitat. Decreased infiltration also reduces groundwater recharge and reduces the amount of baseflow in streams.

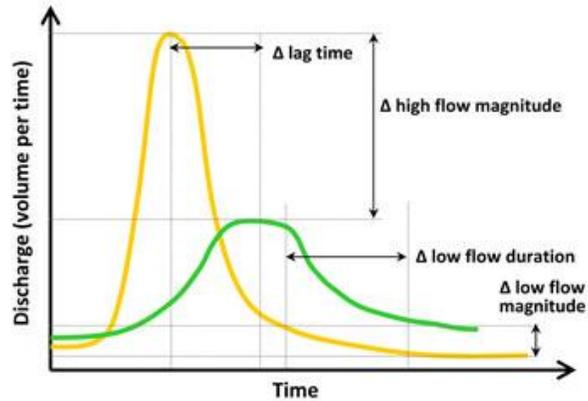
**Figure 1-2:** Theoretical hydrographs of a rural stream (green) and urban stream (yellow) after a storm event (USEPA, 2016)

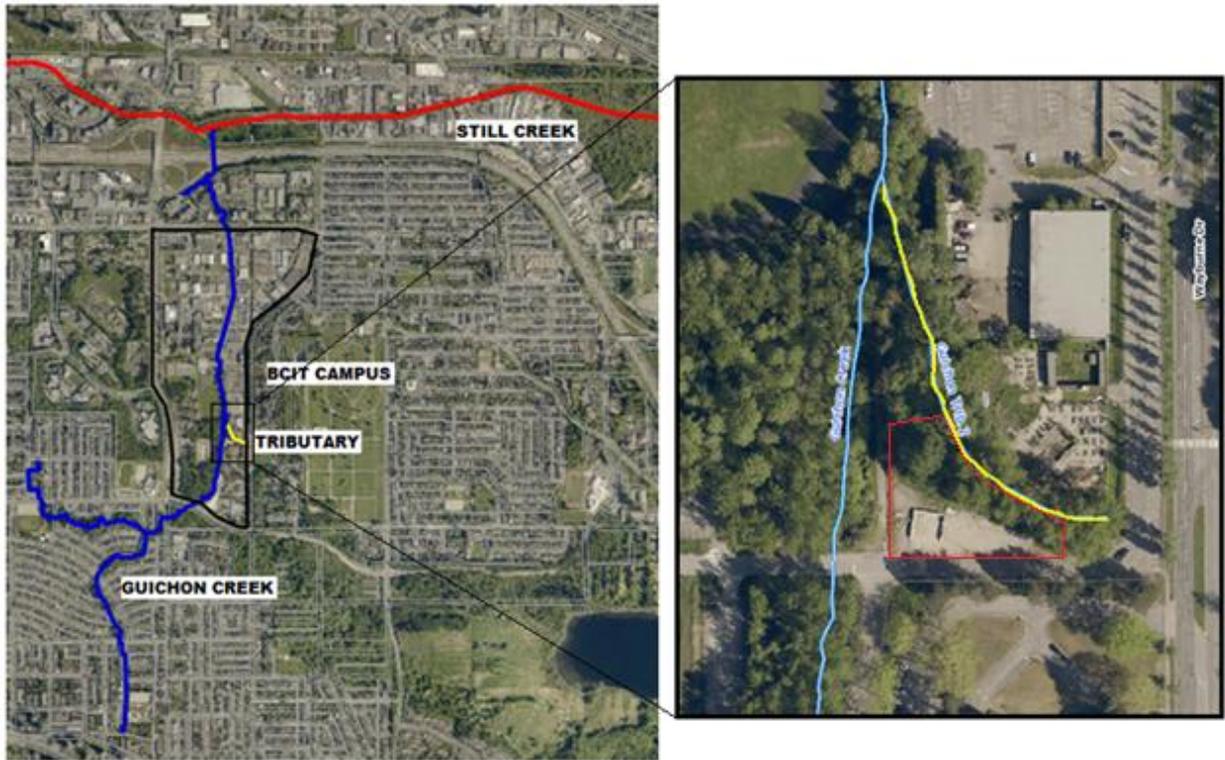
**Figure 2-1:** Location of the restoration site (red outline), Guichon Creek (blue), tributary (yellow), and Still Creek (red) in Burnaby, British Columbia

Guichon Creek is one of the larger tributaries in the Still Creek watershed. Guichon Creek flows north through the BCIT campus before flowing into Still Creek just north of the Trans-Canada Highway. The southern portion of Guichon Creek has been the subject of restoration efforts from the Rivers Institute, BCIT, and the City of Burnaby since the 1970's. The northern section of Guichon Creek still remains underground for approximately 700 metres, until the northern side of Canada Way. This project will focus on restoration of a site adjacent to Guichon Creek located on the BCIT campus (Figure 2-1).

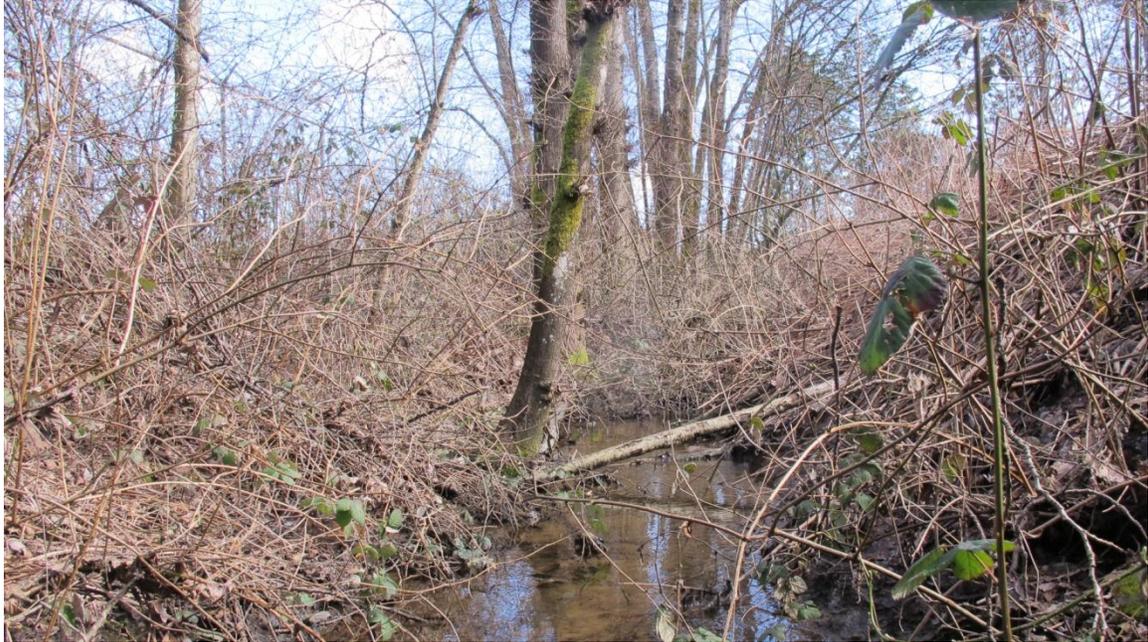
**Figure 2-2:** Guichon Creek tributary at stormwater culvert, facing west, Burnaby, British Columbia.

The tributary enters the campus through a storm culvert underneath Wayburne Drive at the southeast side of campus (Figure 2-2). This stormwater outfall receives runoff from the residential neighbourhood to the east and has a catchment area of approximately 10.5 hectares, based on aerial imagery and storm sewer data from the City of Burnaby. It flows for 150 metres through a small channel before entering Guichon Creek.

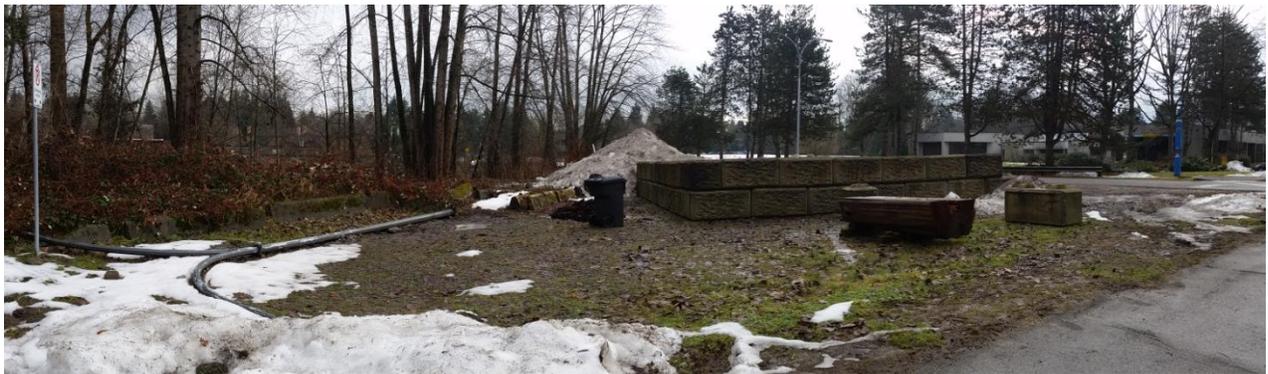
**Figure 2-3:** Decommissioned parking lot on restoration site, facing southeast from northwest corner, Burnaby, British Columbia

The project site outlined is approximately 2,000 m<sup>2</sup>. The triangular parcel of land between the tributary and Carey Avenue is a decommissioned parking lot, approximately 700 m<sup>2</sup>, which is currently used to store construction materials and concrete blocks (Figure 2-3). This is an ideal site for restoration since it will turn an unused parking lot into a wetland, which will remove impervious area, expand the riparian area of Guichon Creek, improve the water quality of the runoff, and create a storage and infiltration area. There is also an opportunity to create habitat for wildlife, such as amphibians.

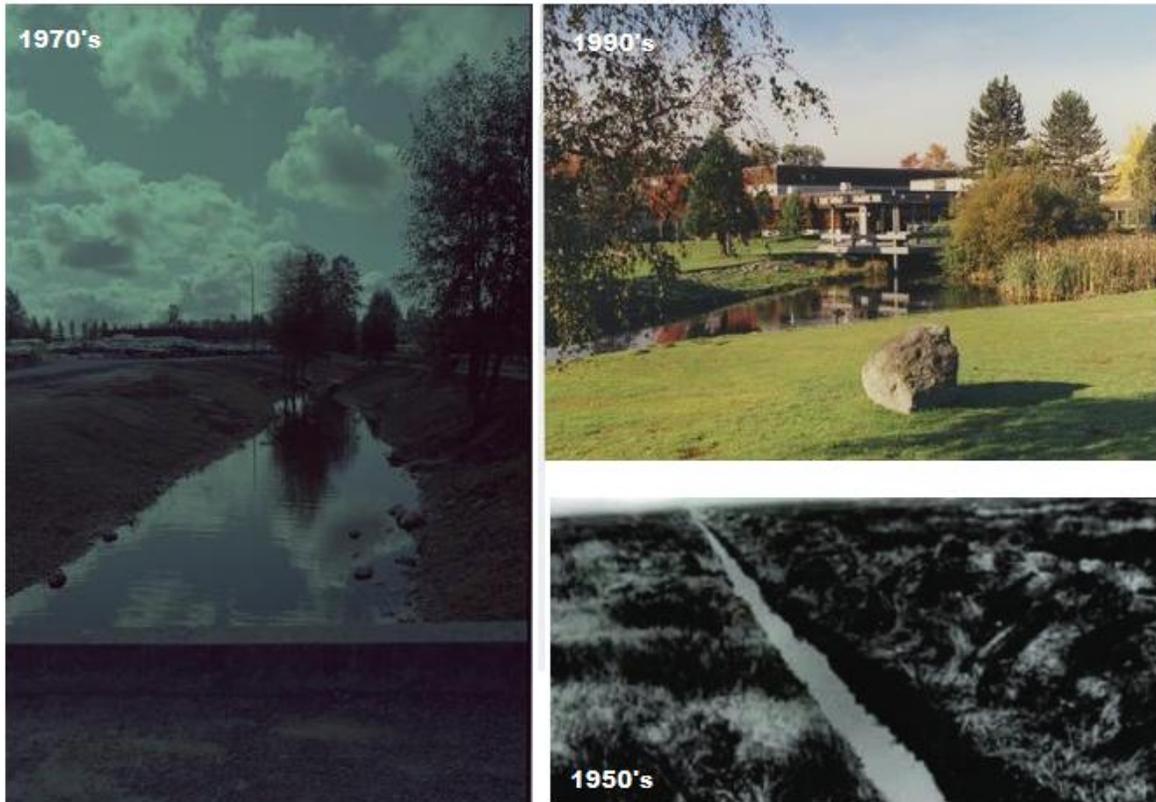
**Figure 2-4:** Historical photos of Guichon Creek (BCIT Archives)

Guichon creek has gone through various stages of rehabilitation from when it was a straightened channel in the 1950's (Figure 2-4).

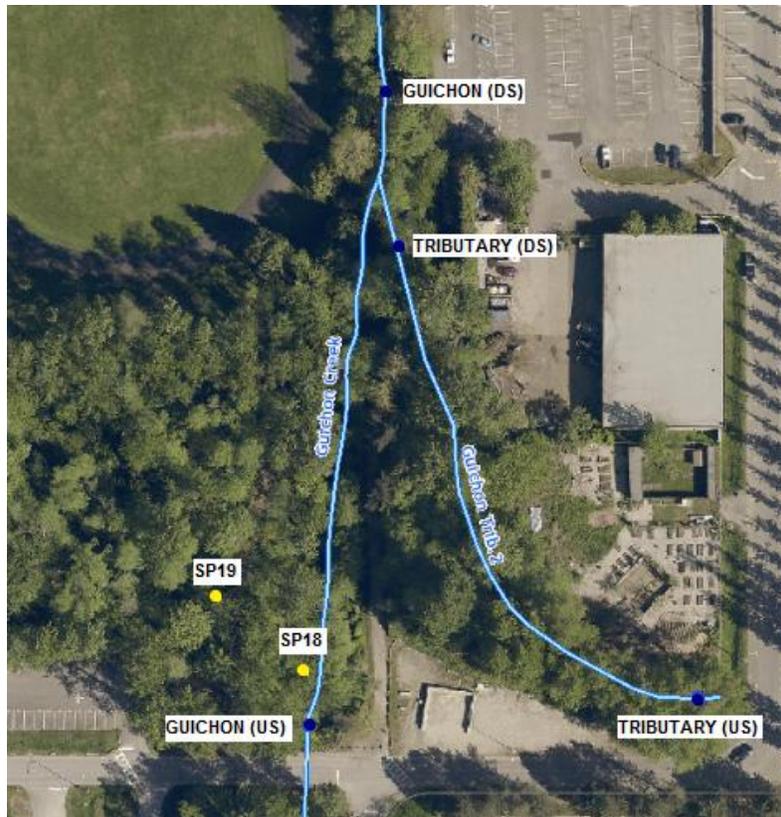
**Figure 2-5:** Soil pits (yellow) and water quality sampling (blue) locations

Two soil pits were dug by students in the RENR 1130 class in the area just west of Guichon Creek in November 2016 (Figure 2-5). The water table was approximately 70 cm below the ground level and mottles and gleying were observed in the lower horizons of the soil, suggesting the soil experiences fluctuating saturated conditions (Biebighauser, 2011). Due to project timing, additional soil pits were not able to be completed on site to find the water table during the seasonally low period. Full soil descriptions can be found in Appendix A.

Water quality was measured at four different sites within Guichon Creek and the tributary (Figure 2-5). The YSI Professional Plus water quality meter was used to measure temperature, pH, dissolved oxygen (DO), conductivity and salinity. Sampling events occurred on sunny days when it had not rained or snowed in a few days, but there was snow on the ground. Water quality results are shown in Table 2-1.

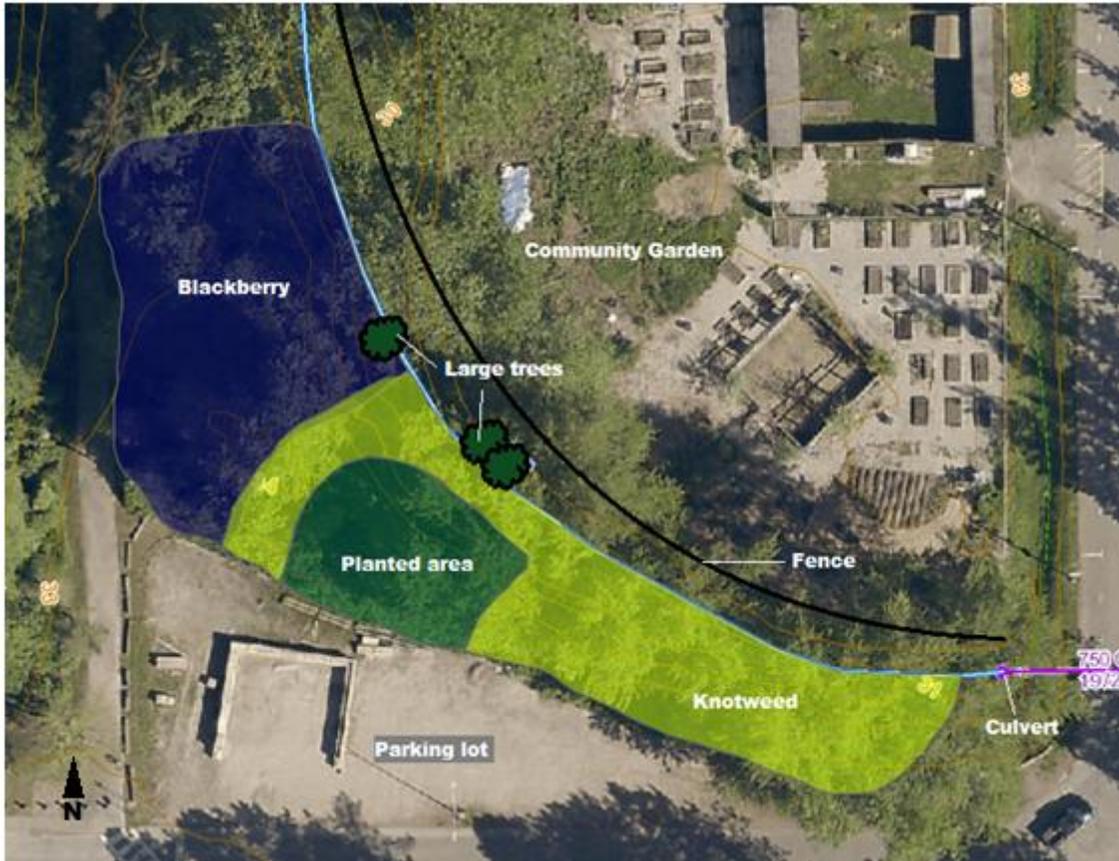
**Figure 2-6:** Site layout and vegetation polygons of restoration site in Burnaby, BC

Himalayan blackberry was also present surrounding the proposed wetland. The most dominant patch is located downstream of the wetland. It is currently being managed by manual removal every 2 weeks (Caldicott, pers. comm., March 5, 2017). The knotweed patch is approximately 600 m<sup>2</sup> and the blackberry patch was approximately 500 m<sup>2</sup> (Figure 2-6, 2-7).

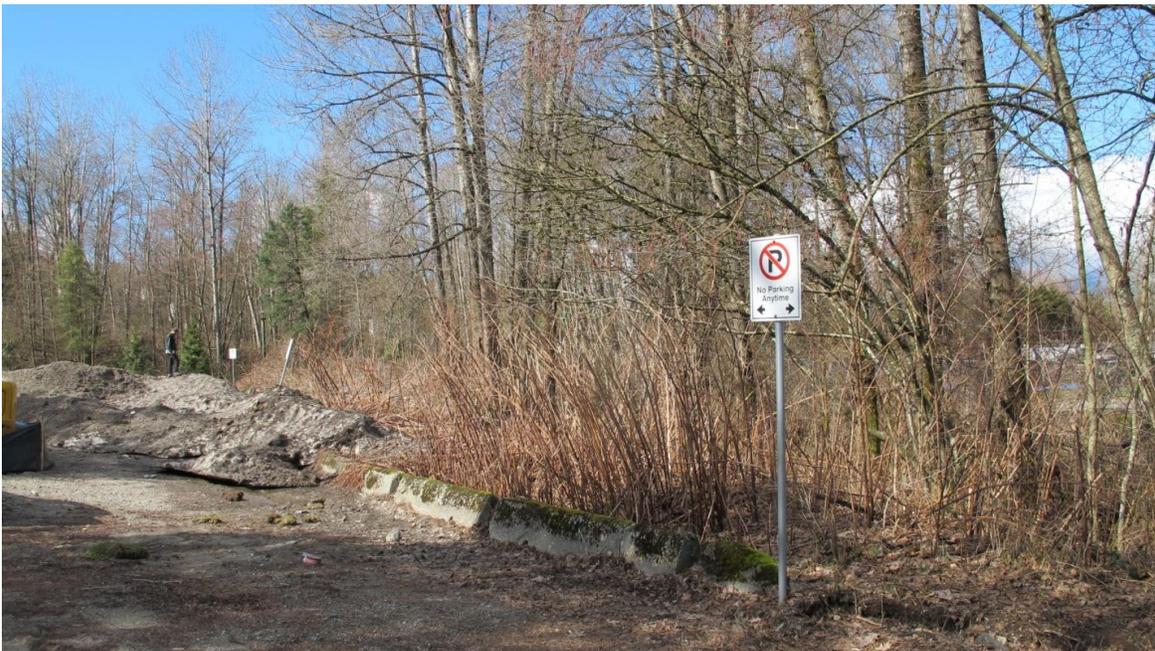
**Figure 2-7:** Knotweed patch at southeast corner of restoration site in Burnaby, BC.

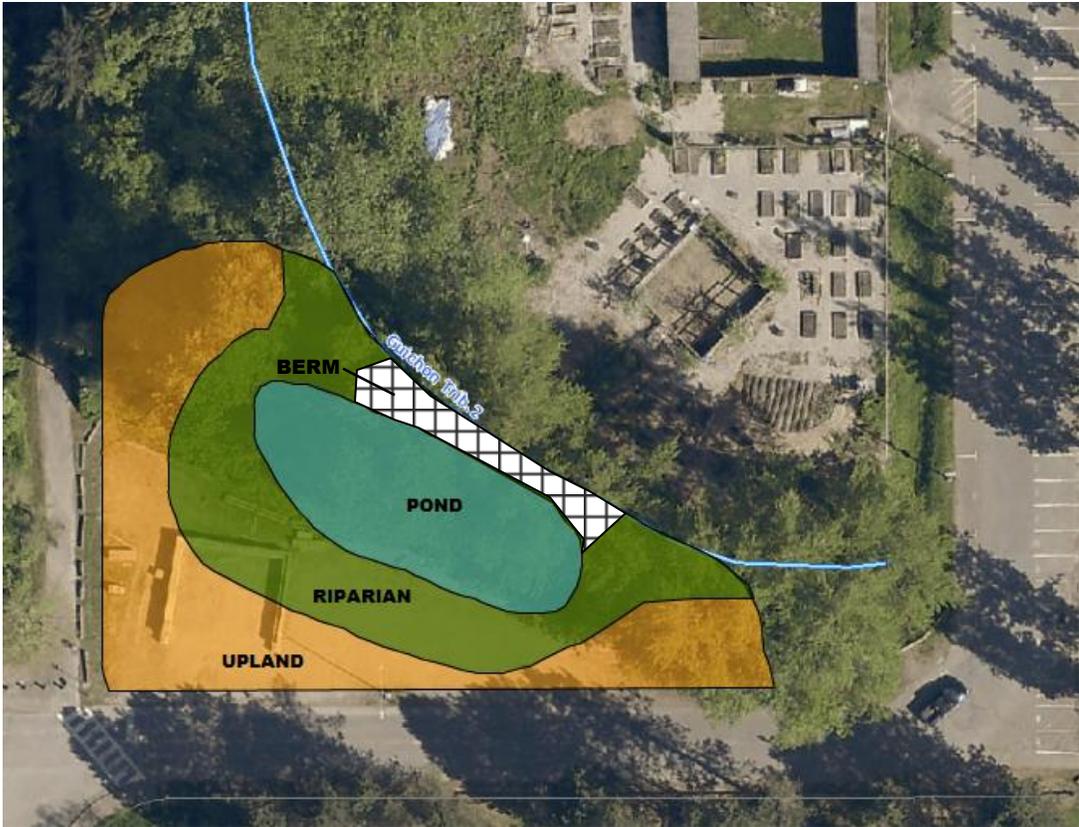
**Figure 4-1:** Layout of restoration site in Burnaby, BC

maintained, with the addition of a natural outlet structure. The wetland and riparian footprint will be approximately 1200 m<sup>2</sup> in size, with the deepest area at 1 metre and a storage capacity of 600 m<sup>3</sup> when completely full. With the water just filling the wetland area (400 m<sup>2</sup>), the deepest point would be 0.6 metres and hold approximately 150 m<sup>3</sup>. Storage volume for collecting stormwater runoff should be 40 m<sup>3</sup> to 100 m<sup>3</sup> for each hectare of impervious area (Wagner et al., 2008). Based on aerial imagery, there is approximately 7 hectares of impervious area in the catchment area, making the wetland a sufficient size.

The upland buffer area will be approximately 800 m<sup>2</sup> and surround the riparian area (Figures 4-1, 4-2).

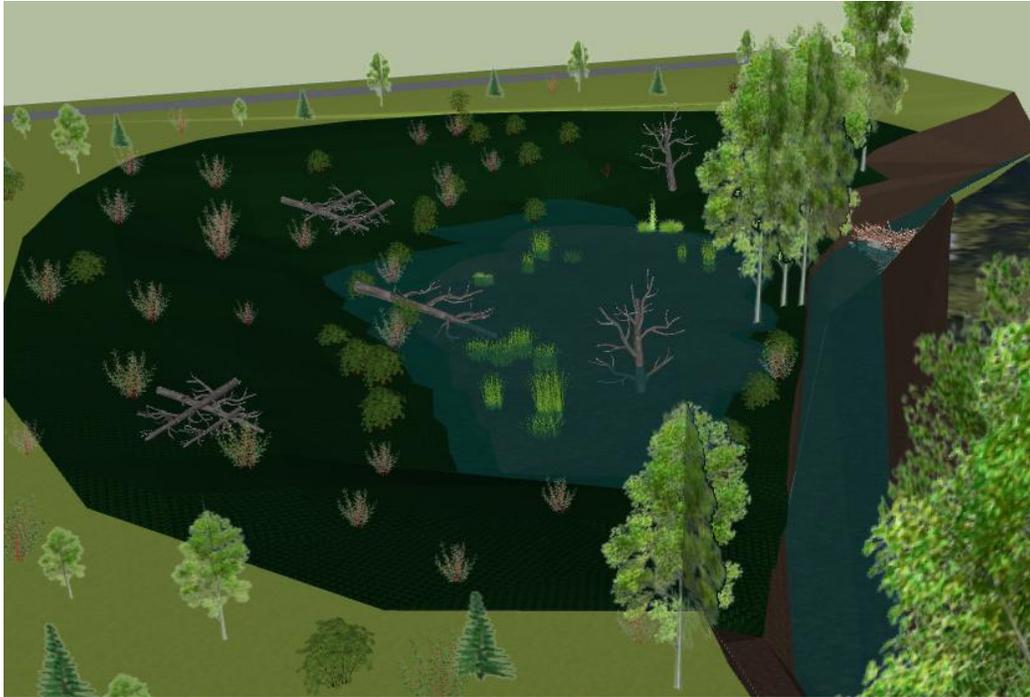
**Figure 4-2:** Three dimensional rendering of wetland layout with a water depth of 0.3 metres

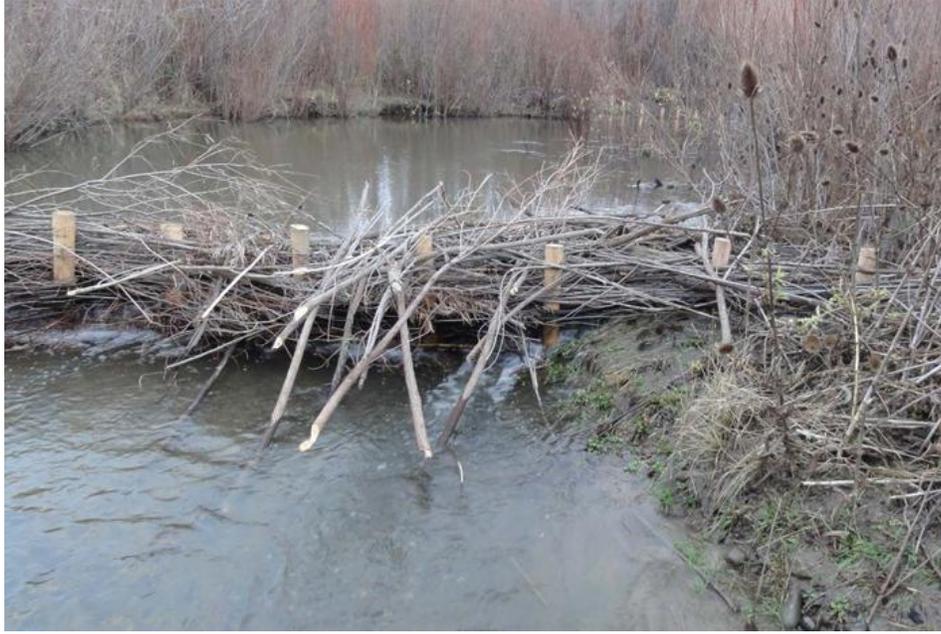
**Figure 4-3:** Natural flow control structure made to mimic the functions of a beaver dam (Pollock et al., 2012)

The downstream section of the tributary will have a natural in-stream structure that will allow for continuous flow, while also raising the water level upstream (Figure 4-3). This type of structure has been implemented in other successful restoration projects where biologists have mimicked beaver dams (Podolak et al., 2016). This will provide a more natural water control structure that raises water levels, increases groundwater recharge, and dissipates flow energy. It will also cause the water to pool behind it and spill over the berm and into the wetland. The top of the structure will be constructed at 1 metre, so that it can also act as a spillway in very high flows and prevent flooding of the surrounding areas. Rocks and boulders will be added to the base of the dam to increase ponding upstream.

Wooden stakes will be pounded into the tributary, approximately 0.5 metres apart, with 1 metre above the bottom of the stream. Brush from trees that will be removed from the excavation site can be used to form the dam.

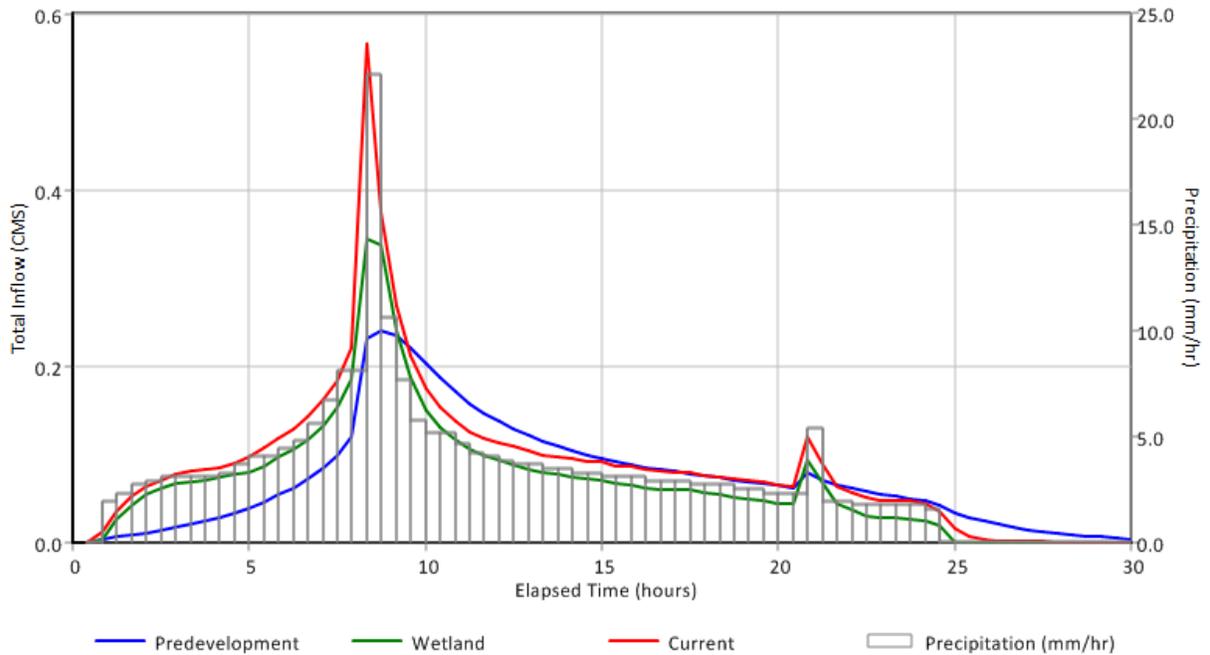
**Figure 4-4:** EPASWMM hydrograph comparison for three land use scenarios in a 10-year storm 24-hour storm event

The rainfall data used in the model was taken from the BCIT Stormwater Management Report. Since the wetland occupies a small area relative to the catchment area, a 10-year storm with 24-hour duration was used for modelling (Figure 4-5). Catchment modelling parameters are available in Appendix D.

Due to the nature of the outlet structure and the fact the wetland is only partially covered by a liner, the wetland modelling scenario is a very rough estimate.

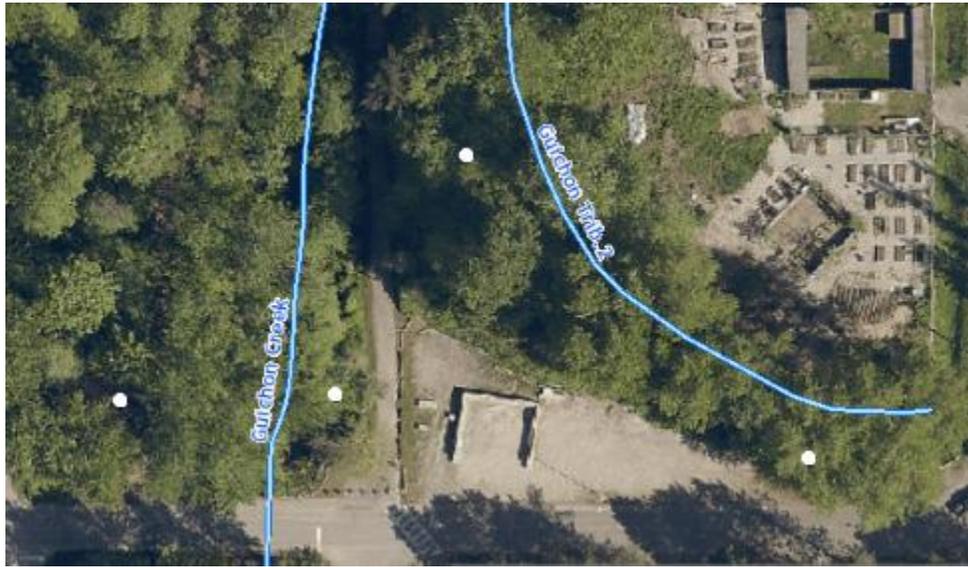
**Figure 4-6:** Suggested groundwater monitoring locations on restoration site

Piezometers were not installed on site to monitor groundwater levels. To have an accurate prediction of the wetland hydrology, groundwater levels should be monitored. The hydrogeology of the site was inferred from mottling in the soils surrounding the site. Installing monitoring wells would allow for the comparison on groundwater levels before and after the project is implemented (Figure 4-6). Since one of the goals of creating this wetland is increasing groundwater infiltration, they would be necessary to monitor if this goal is being achieved.

Three wells are located to the north, west and east of the site to determine groundwater levels and direction of flow. One is located on the west side of Guichon Creek, which will be out of the zone of influence of the wetland. This will serve as a control site to account to year to year fluctuations.
