**The effects of canopy closure on precipitation
throughfall: Ecological restoration considerations
for Spanish Bank Creek**

Project Submitted in Partial Fulfillment of the
Requirements for the Degree of
Master of Science

in the
Ecological Restoration Program

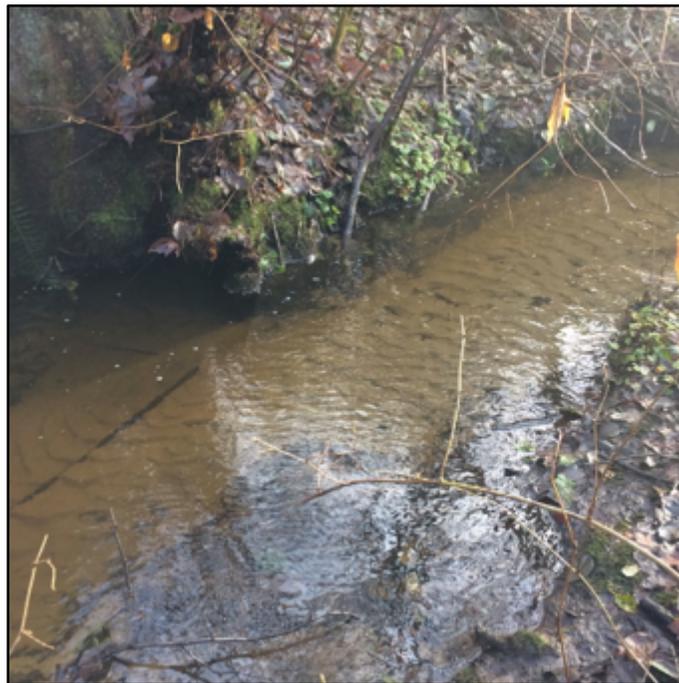
Figure 2: A thick layer of inorganic sediment has accumulated behind a downed tree that has fallen across Spanish Bank Creek. Longitudinally, this sediment has accumulated for approximately 15 m upstream of the downed tree (Reynolds, 2016).

A significant quantity of inorganic sediment appears to be present within the lower reaches of Spanish Bank Creek that are north of NW Marine Drive (*Figure 2*). This sediment can negatively affect fish and invertebrates, hinder stream productivity, and impede fish passage (Birtwell, 1999; Suttle, *et al.*, 2004). The watershed of Spanish Bank Creek has experienced significant ecological disturbance due to historic logging and

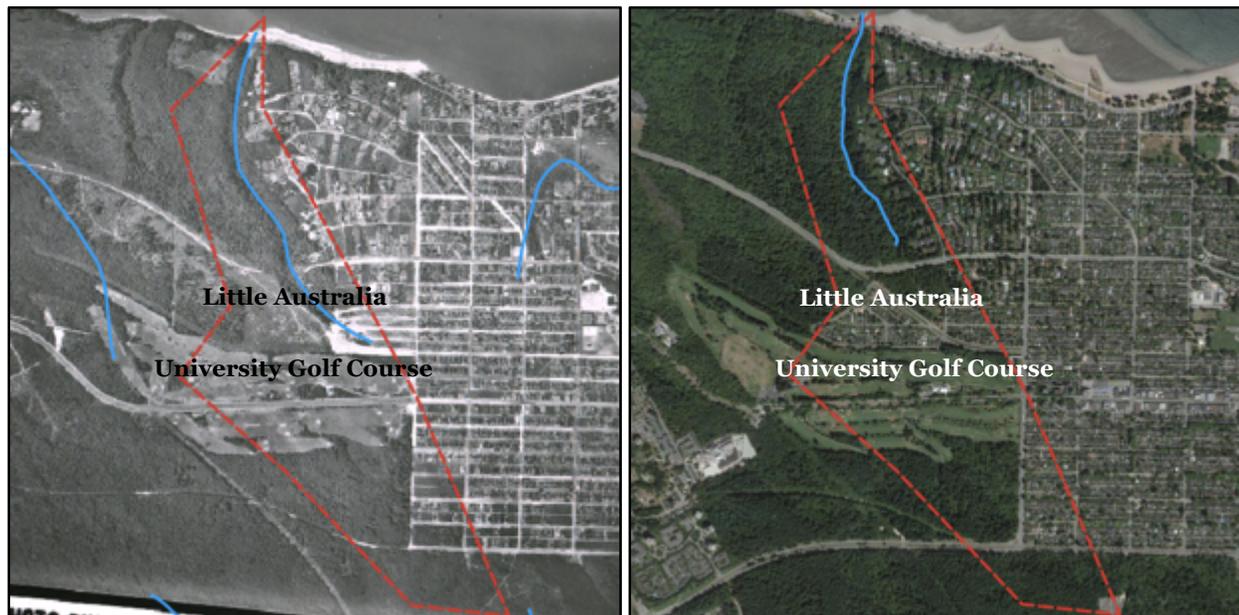
Figure 3: Comparison between a 1932 airphoto and a current satellite image. The historic stream course of Spanish Bank Creek has been superimposed on the airphoto (left), and the current extent of Spanish Bank Creek has been superimposed on the satellite image (right). The approximate historic watershed extent is outlined in the dashed red line. Urbanization has encroached into the watershed, and Spanish Bank Creek has been shortened from approximately 1.5 km in length to its current length of 1.025 km (QGIS Development Team, 2009).

Between 1907 and 1908 the framework for establishing the University of British Columbia was organized, and in 1910 the final location of the UBC campus was determined (Kahrer, 1991). Two million acres of land were endowed to UBC to develop funds for the university. This agreement was revised in 1923 under the University Loan Act. The two million acres across British Columbia (BC) were substituted for 2,900 acres surrounding the UBC campus. These 2,900 acres constitute the current day extent of the PSRP and the unincorporated community of the University Endowment Lands (Kahrer, 1991). Urban areas such as the residential neighbourhood of Little Australia and the University Golf Course have steadily encroached into the watershed, resulting in Spanish Bank Creek being shortened significantly from its historic extent (*Figure 3*).

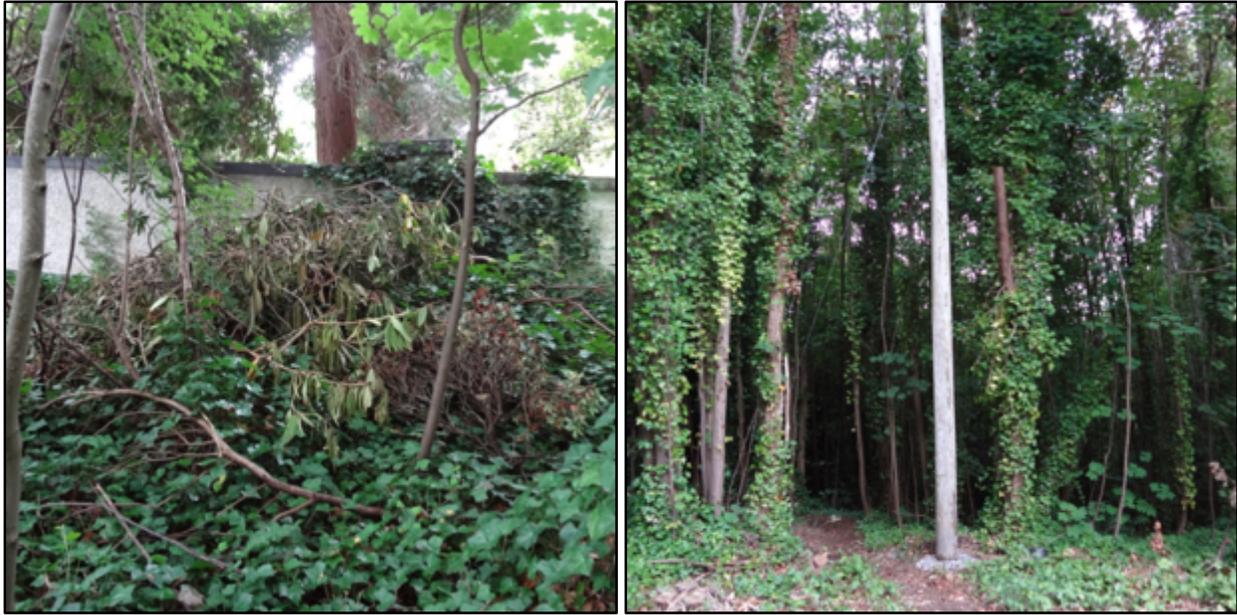
Figure 4: Sources of invasive species in the watershed of Spanish Bank Creek. Garden clippings have been dumped over the fence from a private residence into the watershed of Spanish Bank Creek (left). This general area is highly invaded with invasive *Hedera* (right; Reynolds, 2016).

A particularly abundant invasive species within the watershed of Spanish Bank Creek is *Hedera*. On 8 July 2016 I identified a potential source of invasive species entering the watershed. It appears that the home owner or residential landscape crews have been dumping garden clippings over their fence into the watershed (*Figure 4*). This is a cheaper and faster alternative to hauling the clippings to the transfer station. There is a subsequent lack of vegetative species diversity (Biggerstaff and Beck, 2007) at this location of the watershed. In addition, there is also miscellaneous refuse including old bikes, bags, and furniture, indicating the use of this location as a dumping site for more than just garden clippings. Several footpaths navigate this section of the watershed, leading down to the ravine of Spanish Bank Creek and terminating once the terrain steepens and the vegetation thickens. There are several other residences along the eastern edge of the watershed that are also dumping their garden clippings into the ravine of Spanish Bank Creek.

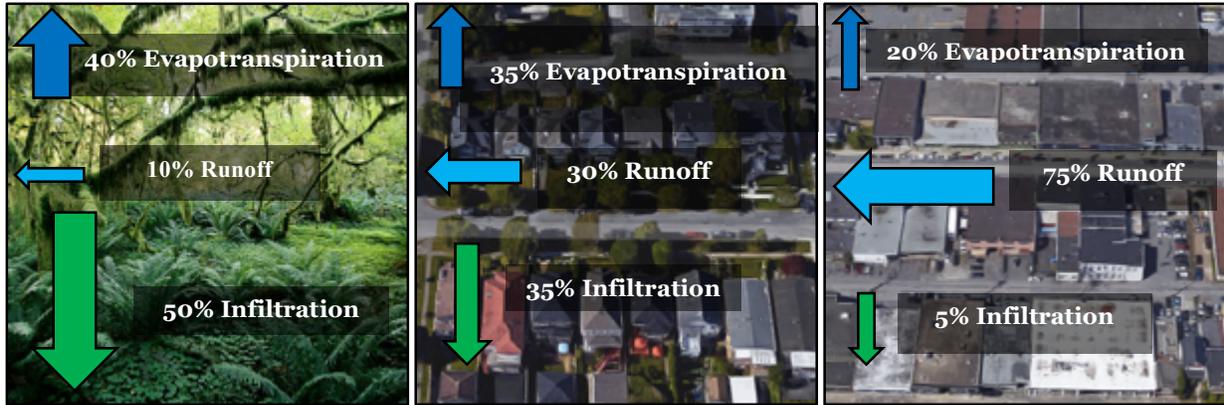
Figure 5: Runoff volume increases with expansion of impervious surfaces (Adapted from Stephens *et al.*, 2002). Natural forests have 0% impervious surfaces and approximately 10% runoff (left; Eastcott and Momatiok, 2014). Residential use areas have approximately 30 – 50% impervious surfaces and 30% runoff (middle; Google Maps, 2017). Commercial use areas can have up to 100% impervious surfaces and approximately 75% runoff (right; Google Maps, 2017).

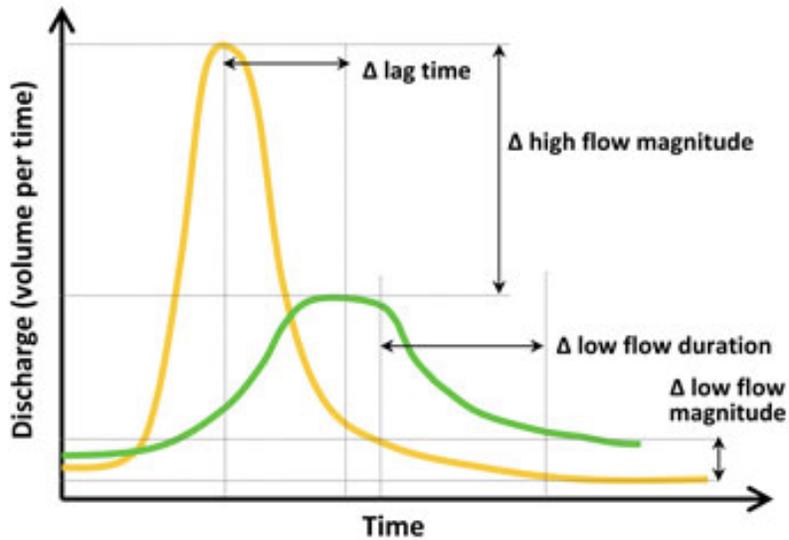
Figure 6: A typical hydrograph for streams derived from rural and urban runoff (US EPA, 2016). Generally, urban runoff produces streams that experience a greater total discharge, a greater peak flow, and a more rapid increase in discharge in response to a precipitation event (yellow line) compared to streams derived from rural runoff (green line). Urban runoff streams also typically have a lower base flow compared to rural runoff streams (Liu *et al.*, 2014; Lefrançois, 2015).

While logging in the PSRP has not occurred in nearly a century, land-uses are constantly evolving in response to socioeconomic patterns. Approximately 5% of BC is suitable or available for development (Stephens *et al.*, 2002). Limited land for development, when combined with projected population growth, will result in rural areas becoming suburban, and urban areas developing further. This will increase land imperviousness (Chabaeva *et al.*, 2004). Therefore, it is likely that the residential areas around the watershed of Spanish Bank Creek will experience further development and increased imperviousness in response to socioeconomic fluctuations. This will result in increased runoff and decreased infiltration into the soils of the forest around Spanish Bank Creek (*Figure 5*). The effect that this has on stream hydrology is demonstrated by a comparison of hydrographs from a stream derived from urban runoff, and a stream derived from rural runoff (*Figure 6*).

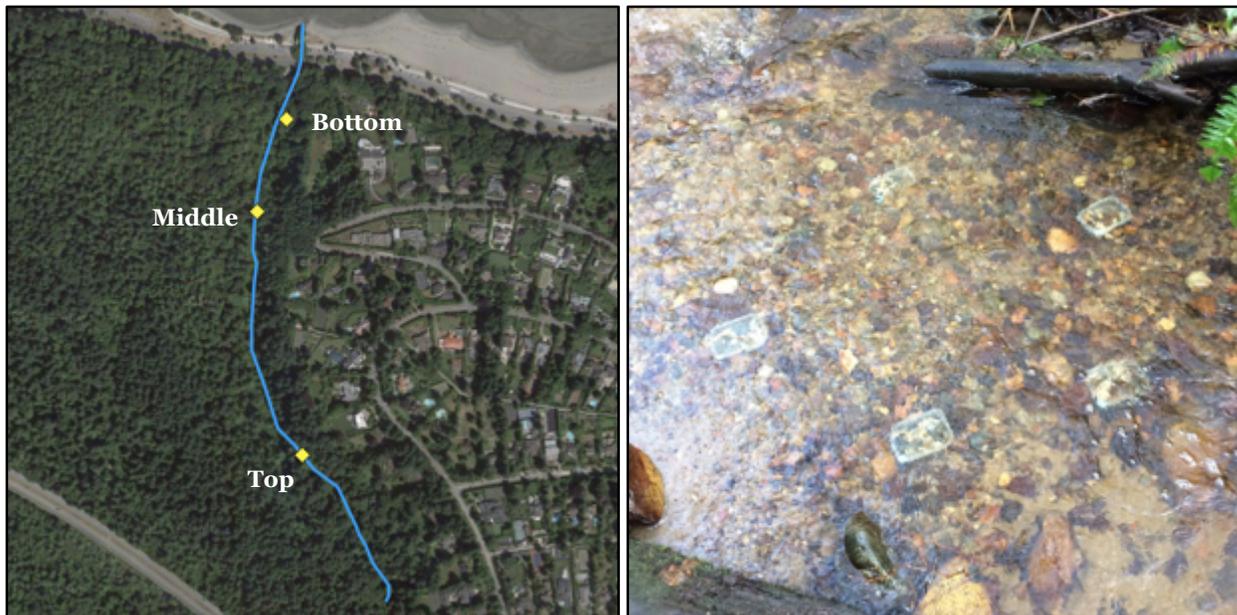
Figure 7: Fifteen sediment accumulators were installed in Spanish Bank Creek. The sediment accumulators were installed in Spanish Bank Creek at locations denoted as top, middle, and bottom (left; QGIS Development Team, 2009). Five accumulators were installed at each of the locations, for a total of 15 accumulators (right; Reynolds, 2016).

As mentioned in 2.4.3 *Topography*, the results of the rebar staking and mapping of runoff inputs into Spanish Bank Creek indicate the downward movement of soils to lower elevations of the watershed. To quantify the rate of sediment loading into Spanish Bank Creek, I installed 15 sediment accumulators in Spanish Bank Creek. Before installation I drilled fifteen 0.16 cm holes into the bottom of each container and then filled them with clean 1.9 cm crushed gravel for drainage and to create void interstitial spaces. On 14 November 2016 the sediment accumulators were installed in Spanish Bank Creek at three locations throughout the length of the stream (*Figure 7*). Five of the accumulators were installed at each of the three locations, totalling 15 sediment accumulators. The tops of the containers were installed to be flush with the natural grade of the stream. At each of the three locations, the five containers were placed in a pentagon formation with approximately 40 cm between each of the containers.

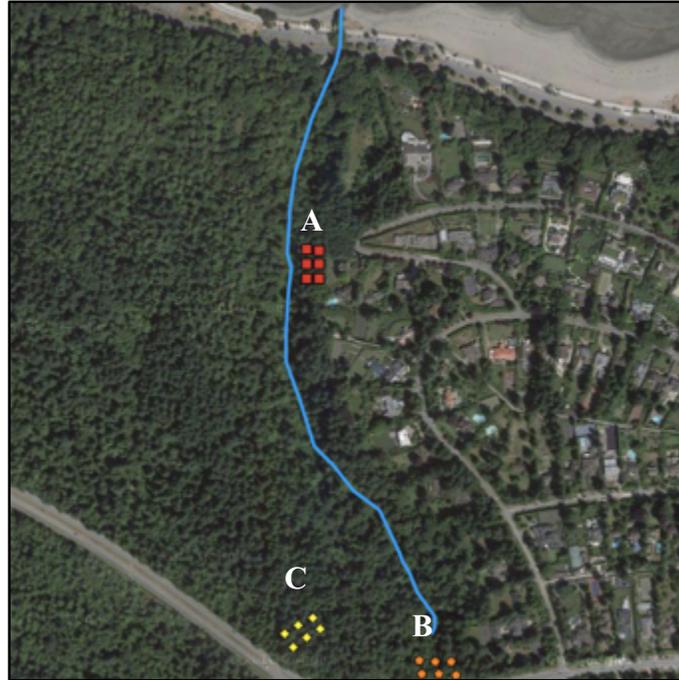
Figure 8: From each of the three study locations, A, B, and C, I measured canopy closure and precipitation throughfall. Data was collected between 28 November 2016 and 4 December 2016 (QGIS Development Team, 2009).

I established three locations within the watershed of Spanish Bank Creek to collect canopy closure and precipitation throughfall data (*Figure 8*). At each of the three locations, six measurement sites were set up, for a total of 18 measurement sites. The measurement sites were set up in a two-by-three grid formation at each location, with 25 m between each site, as approximated by my handheld Garmin Global Positioning System unit.

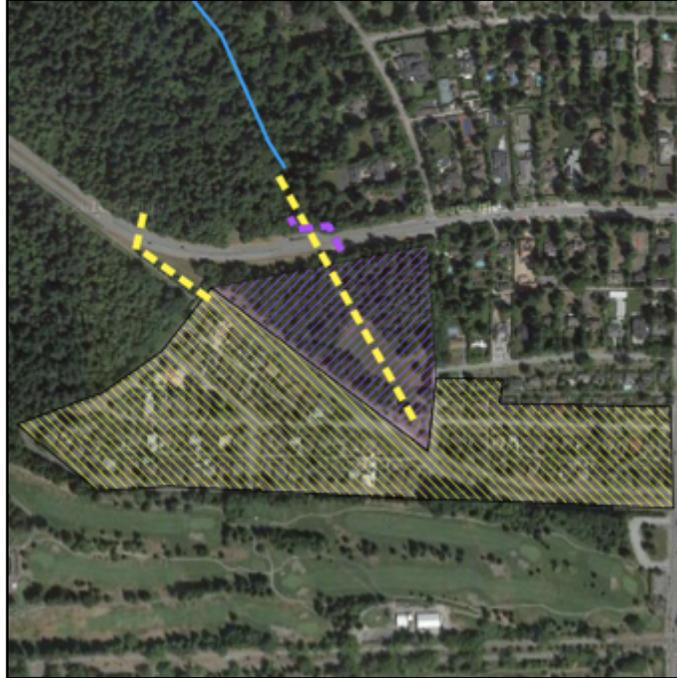
Figure 9: Three culverts drain into the watershed of Spanish Bank Creek. These culverts are indicated by the dashed lines. The polygons indicate the approximate areas that the culverts drain and are paired to the culverts according to colour. The yellow polygon is 12.8 ha, and the purple polygon is 4.7 ha (QGIS Development Team, 2009).

the watershed (*1.6.2 Urban Encroachment*). Currently, there are three culvert outfalls that drain into the watershed of Spanish Bank Creek (*Figure 9*). The primary culvert input of Spanish Bank Creek is a 341.6 m-long culvert that discharges just north of Chancellor Boulevard. This culvert receives inputs from the University Golf Course, and also drains 12.8 ha of Little Australia (A. Galbraith, personal communication, 25 November 2016). In addition, this culvert has penetrated the groundwater table somewhere along its 341.6 m length. This is supported by results from water quality testing (*2.4.5 Water quality*). A secondary culvert drains the north-west corner of Little Australia. This culvert outfall terminates at a ditch just north of Chancellor Boulevard, and the water drains into the forest. The water from this culvert appears to infiltrate into the forest floor except during significant or sustained rainfall events, where a rill has formed in the forest floor. Where this rill meets the steeper slopes of the ravine of Spanish Bank Creek a gully has formed. A third culvert drains a 4.7 ha park that is just north of Little Australia. Just below this culvert's outfall the forest floor is a mosaic of concrete slabs that were probably placed there in an attempt to mitigate erosion (Kahrer, 1991). As a result of these culverts directing storm water in the watershed, discharge in Spanish Bank Creek is tightly coupled to precipitation events. This has led to concerns regarding water quality associated with storm water and golf course drainage (DFO, 1999).

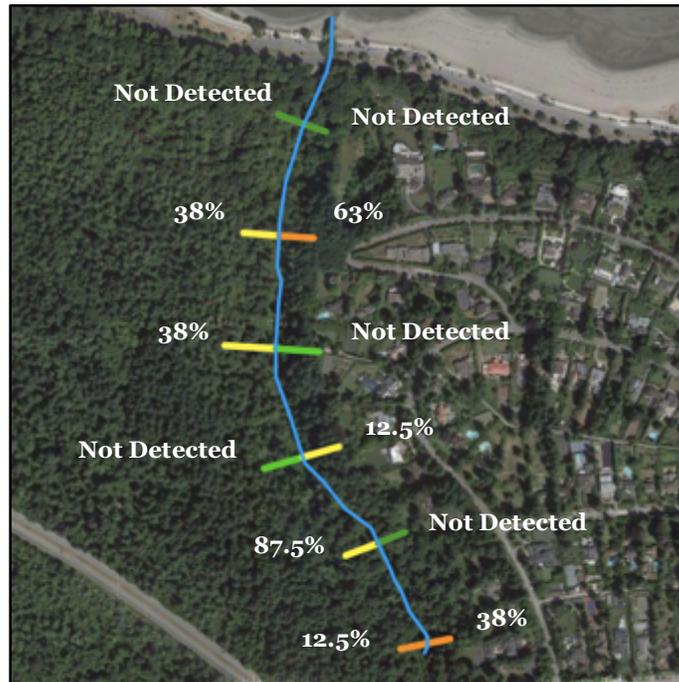
Figure 10: *Hedera* was mapped along transects through the ravine of Spanish Bank Creek on 30 November 2016. Transects are colour coded corresponding to percent ground cover of *Hedera* along transects. Tree coverage of *Hedera* is labelled as a percent or not detected (QGIS Development Team, 2009).

Hedera was present along nine of the twelve transects sampled throughout the watershed (Figure 10). Of these nine transects, *Hedera* was present in the tree layer along seven transects. This means that *Hedera* was found along 75% of the transects, and was in the canopies of trees along 58% of the transects. Of the transects with *Hedera* present, 78%

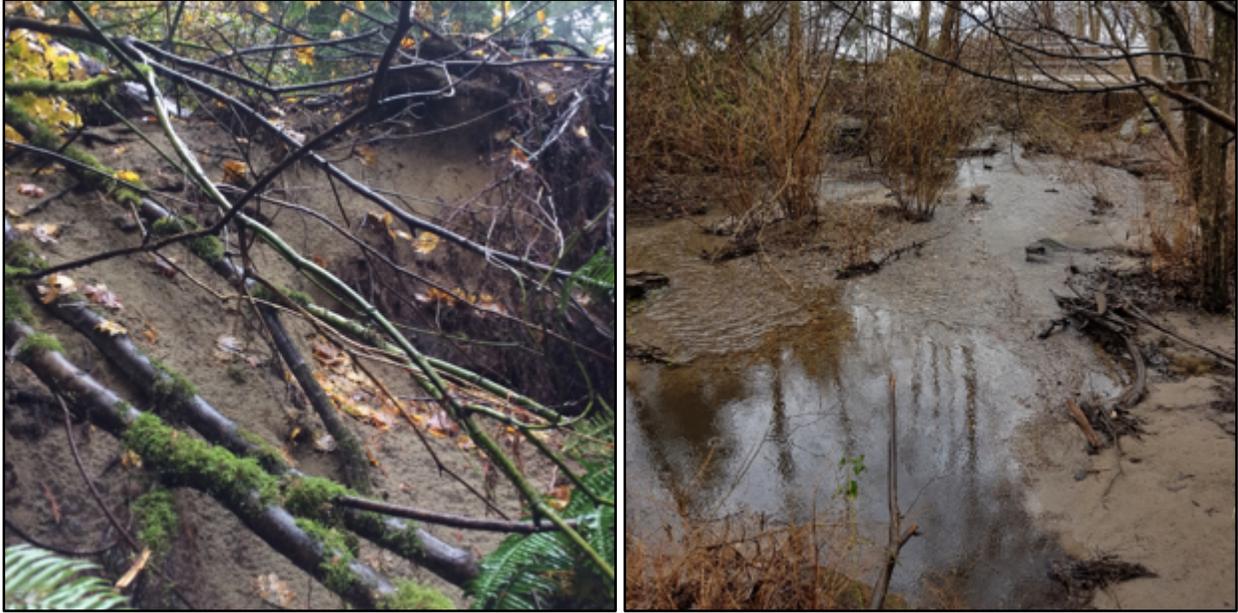
Figure 11: Soils throughout the watershed are eroded and transported to lower elevations. An upturned root wad from a downed tree exemplifies the sandy soils throughout the watershed of Spanish Bank Creek (left). Significant supply of sediment modifies channel morphology (right; Reynolds, 2016).

Soils throughout the watershed of Spanish Bank Creek appear to be largely composed of glaciofluvial sands (Figure 11; GVRD, 2000; Clague *et al.*, 1998; Clague, 1975). As described in the Udden-Wentworth scale of particle sizes, these glaciofluvial particles are likely between 0.5 – 2 mm in diameter (coarse sand to very coarse sand; Figure 13, left). According to the Hjulstrom curves (Figure 13, right), mean flow velocities greater than approximately 0.1 m/s will entrain nearly all particles within this diameter interval.

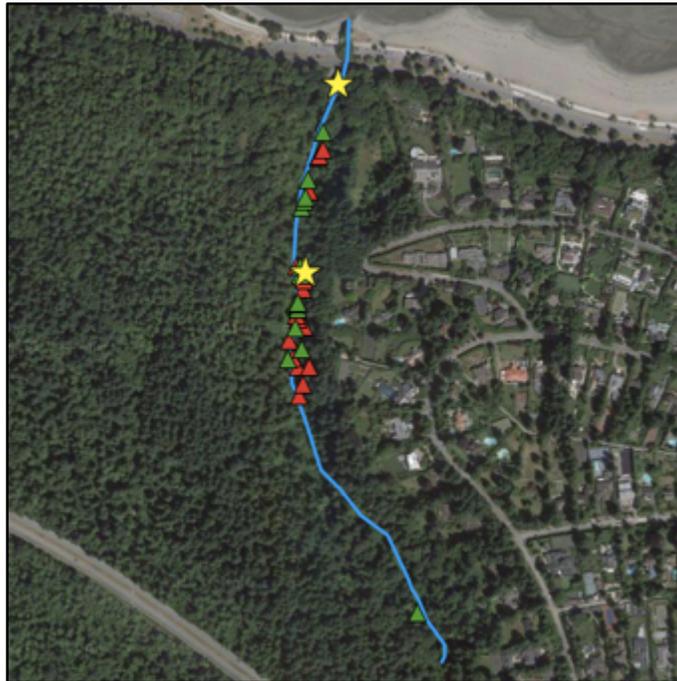
Figure 12: A map of inputs into Spanish Bank Creek. Green triangles represent the 14 runoff inputs from bank left, red triangles represent the 18 runoff inputs from bank right. Yellow stars represent the two drainage pipe inputs into Spanish Bank Creek. Field work was conducted on 4 November 2016 (QGIS Development Team, 2009).

From the streambank mapping, total of 34 inputs were identified (*Figure 12*). Of these 34 inputs, 32 were derived from runoff, and two were derived from drainage pipe outfalls that drain into Spanish Bank Creek. The 32 runoff inputs were likely derived from upslope rills and gullies that are present throughout the watershed. The majority of these rills and gullies are located a significant distance from culvert outfalls. This indicates that the hydrological input that is causing these rills and gullies and associated runoff inputs is derived from precipitation.

This restoration treatment will be conducted in accordance with the objective to mitigate watershed runoff and associated transport of sediment into Spanish Bank Creek. Live staking will be conducted where the 32 runoff inputs enter Spanish Bank Creek (*Figure 12*) as the upslope rills and gullies meet the gentler slopes of the stream's floodplain. The primary species to be used for the live staking will be *Salix spp.* and black cottonwood because of their tolerance for moist conditions (Green and Klinka, 1994; Polster, 2014). Installation of live stakes at each of the 32 runoff inputs into Spanish Bank Creek will require 250 black cottonwood cuttings, and 250 *Salix spp.* cuttings.

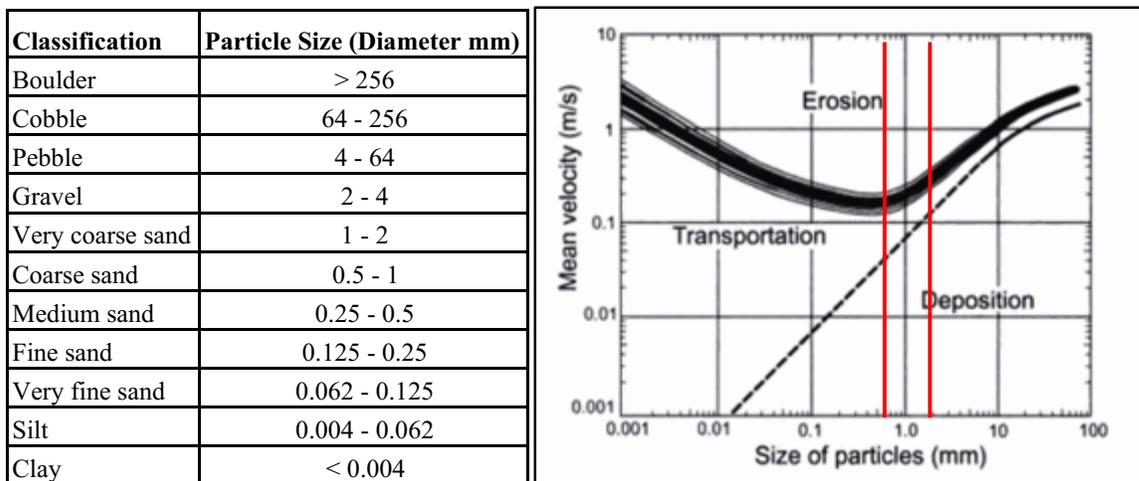
Figure 13: The Udden-Wentworth scale and Hjulstrom curves (Wentworth, 1922; Gordon *et al.*, 2004). The Udden-Wentworth scale of particle size classification (left), indicates that the sandy soils around Spanish Bank Creek are likely 0.5 – 2 mm in diameter. According to the Hjulstrom curves (right), particles of these dimensions, as illustrated between the vertical red lines, will be transported or eroded by flow velocities greater than approximately 0.1 m/s.

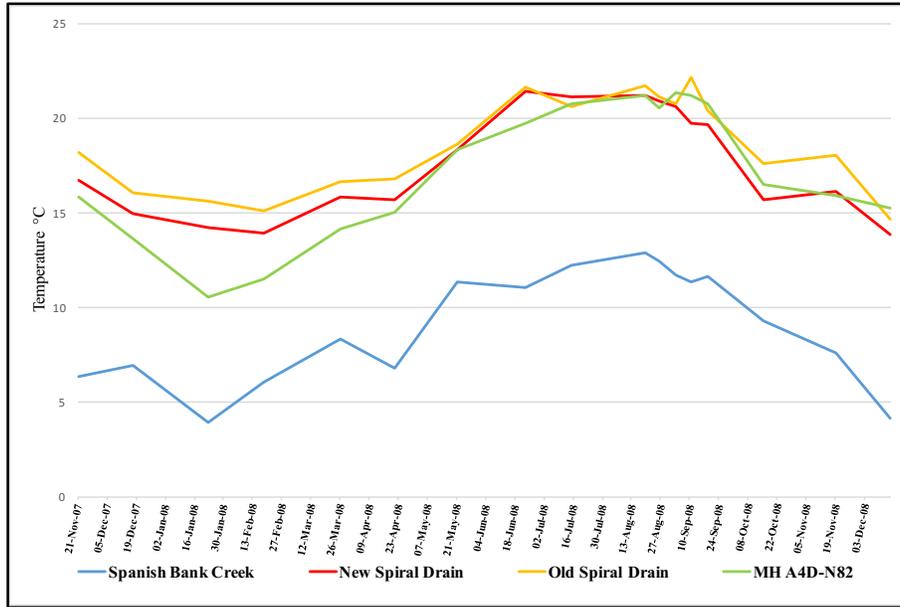
From the 17 samples, temperature in Spanish Bank Creek was significantly cooler than temperatures recorded at three nearby storm drains over the 14 months (*Figure 14*). Mean temperature in Spanish Bank Creek was 9.0 °C, with a range of 3.9 – 12.9 °C. Mean water temperature measured at three nearby storm drains was 17.6, 18.5, and 17.2 °C, and ranged from 10.5 – 22.1 °C. These results indicate that it is likely that there are groundwater inputs into Spanish Bank Creek that moderate stream temperature year-round. This is supported by the fact that Spanish Bank Creek flows year-round despite a lack of precipitation inputs throughout many summer months.

Figure 14: Temperature measured in Spanish Bank Creek and three nearby sites from November 2007 to December 2008.

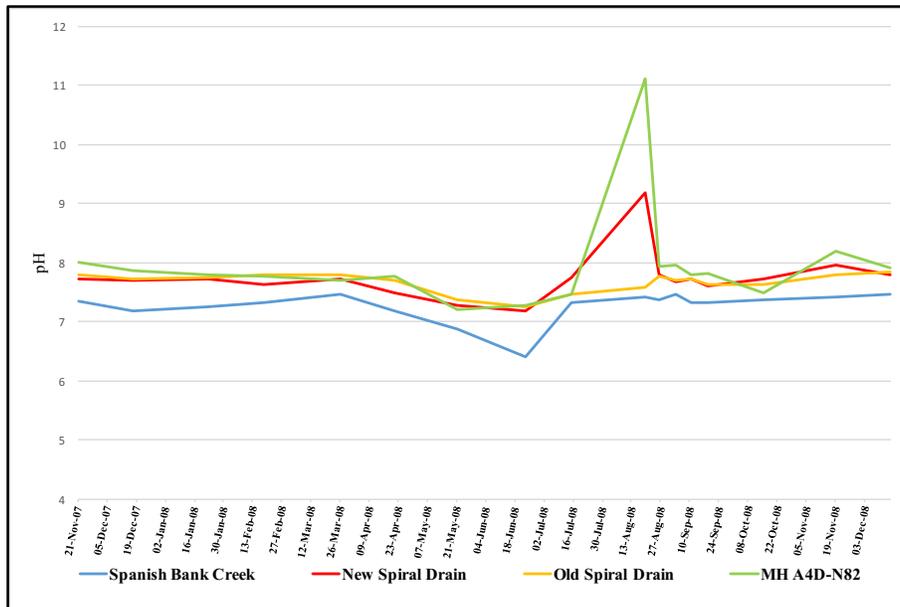
The mean pH recorded in Spanish Bank Creek was 7.3, with a range of 6.4 to 7.5 (*Figure 15*). The optimal pH range for Pacific salmon is between 6.5 – 8.5 (OWEB, 1999). Only

one measurement was below the optimal lower limit between 2007 and 2008. This indicates that pH within Spanish Bank Creek from November 2007 to December 2008 was not a limit to production for salmonids. Lastly, each pH measurement from Spanish Bank Creek was less than pH measured at each of the other three storm drains. This is explained by the fact that many forests are characterized by acidic soils due to decomposition of organic matter (Forestry Commission, 2011).

Figure 15: pH measured in Spanish Bank Creek and three nearby sites from November 2007 to December 2008.

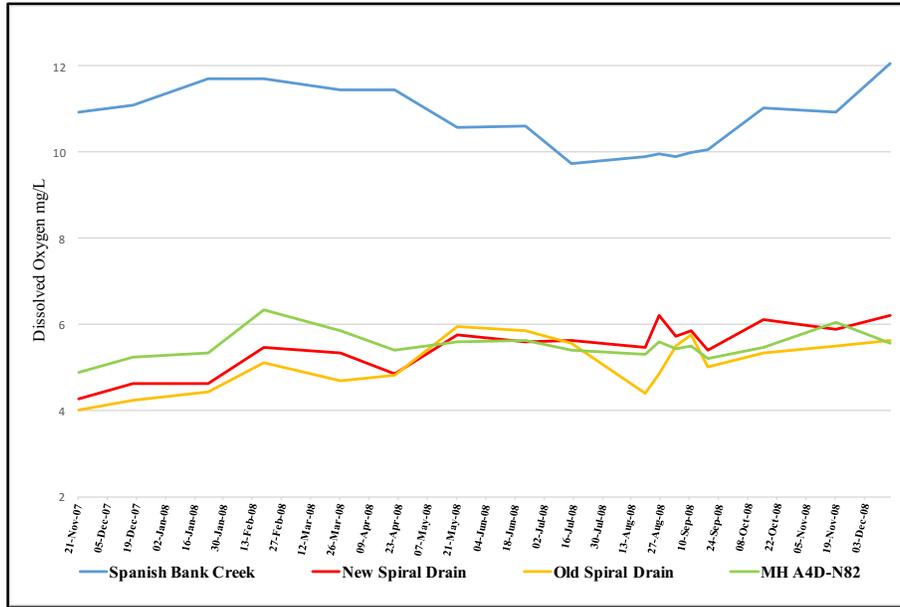
Mean dissolved oxygen measured in Spanish Bank Creek was 10.8 mg/L, with a range of 9.7 – 12.0 mg/L (*Figure 16*). Salmonid embryos display slight production impairment below 9.0 mg/L (Carter, 2005). This means that levels of dissolved oxygen in Spanish Bank Creek from November 2007 to December 2008 were well within the optimal range for salmonids.

Figure 16: Dissolved oxygen measured in Spanish Bank Creek and three nearby sites from November 2007 to December 2008.

From November 2007 to December 2008, dissolved oxygen measured in Spanish Bank Creek was significantly greater than dissolved oxygen measured in the three nearby storm drains. This is likely due to the extensive riffle zones throughout Spanish Bank Creek (2.4.6 *Fish Habitat Assessment Procedure*) that aerate the flowing water.

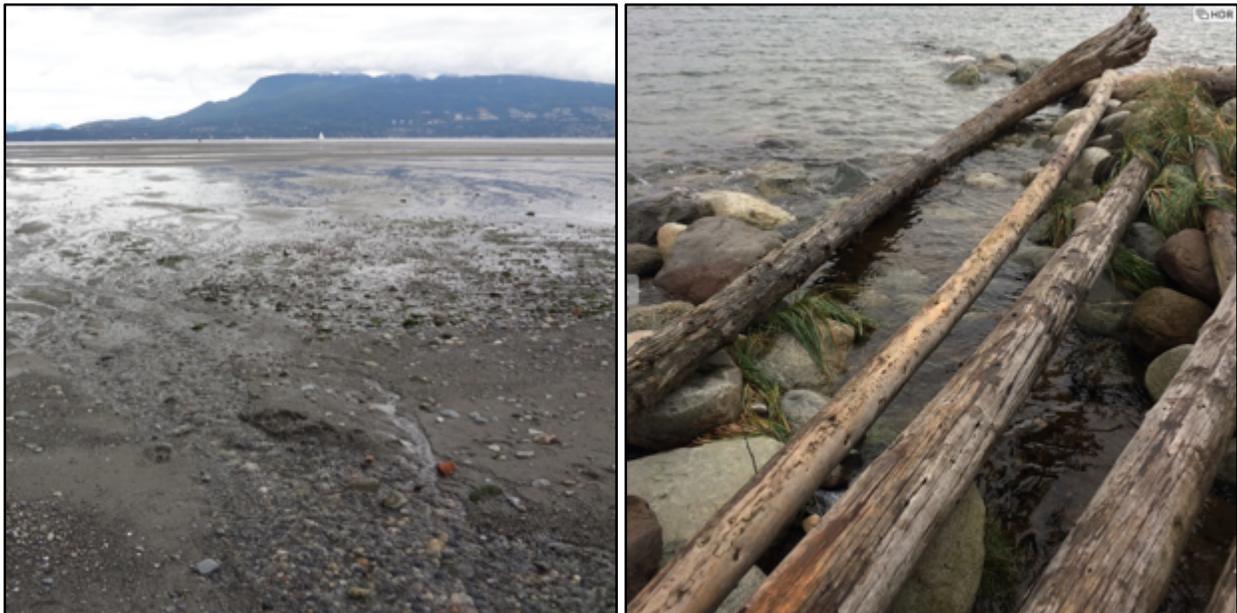
There were three potential barriers to fish passage identified within Spanish Bank Creek. The first potential barrier is at the mouth of Spanish Bank Creek (*Figure 17*). Access to Spanish Bank Creek from Burrard Inlet is only possible during high tides.

Figure 17: Oceanic tides render Spanish Bank Creek inaccessible except during high tides. At low tide the ocean recedes several kilometers and Spanish Bank Creek is inaccessible (left). Only at high tides is Spanish Bank Creek accessible from Burrard Inlet (right; Reynolds, 2016)

Following the recommendations of Page and Eymann (1994), restoration to the lower reaches of Spanish Bank Creek was conducted to re-grade the mouth of the stream to 4.7 m above chart datum. This means that between September to December (approximately when Pacific salmon return to their natal streams) 2016, 21% of the total days had a high tide that was equal to or greater than 4.7 m chart datum (*Table 4*). Assuming a water

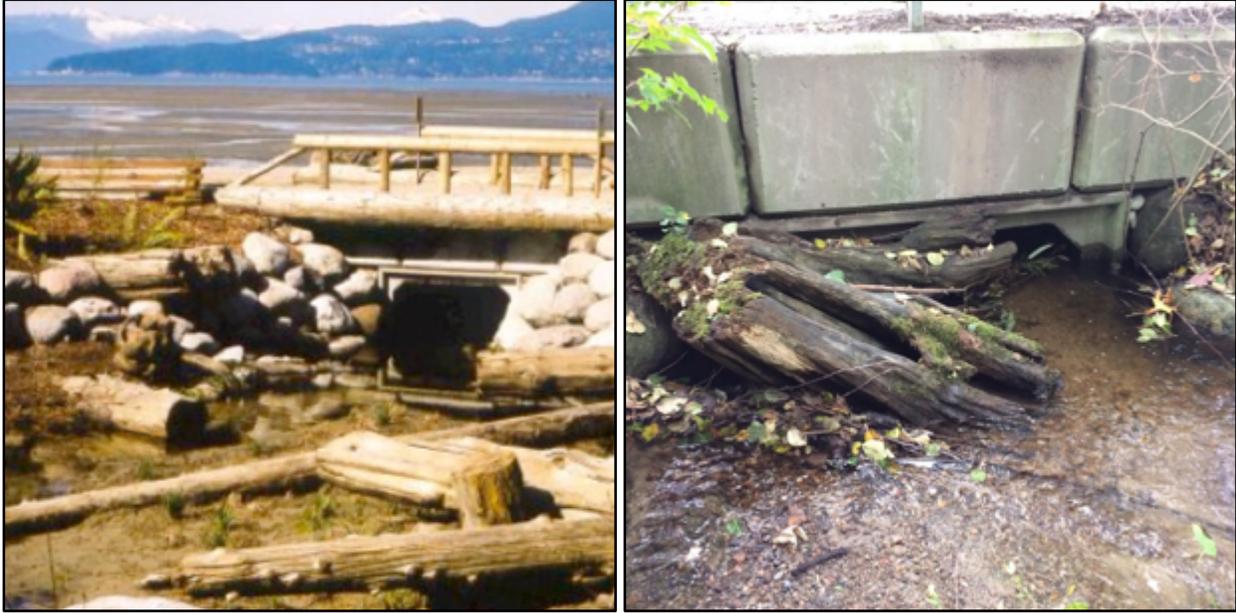
The second possible impediment to fish passage was identified at the lower reaches of Spanish Bank Creek below NW Marine Drive (*Figure 18*). As Spanish Bank Creek is aggrading at the lower reaches (*2.4.4 Sediment Transport*).

Figure 18: The lower reaches of Spanish Bank Creek have been filled with sediment. Installed in 2000, the concrete box culvert pictured above is 6 m long, 1.2 m tall, and 1.8 m wide (left; Hollick-Kenyon, 2002). After 16 years only a fraction of the culvert is passable due to build-up of sediments (right; Reynolds, 2016).

The culvert pictured above is 1.2 m tall and 1.8 m wide. Assuming that the culvert was installed to 1978 British Columbia culvert design guidelines of installation of the culvert 0.31 m below grade (Dane, 1978), 26% of the culvert cross-section would have been buried in the substrate. I recorded measurements of the north and south end of the culvert on 3 March 2017. On the south end of the culvert, approximately 50% of the width of the culvert has been blocked by a cedar stump that is buried in the substrate. In the thalweg to the right of the stump the distance from the substrate to the top of the culvert was 0.6 m. This corresponds to approximately 75% of the culvert cross-section being buried in sediment or blocked by the cedar stump.

at the north end of the culvert was measured at 0.04 m, thereby constituting a possible barrier to adult returning salmon. If the cedar stump was not blocking approximately 50% of the south end of the culvert then it is likely that the distance from the substrate to the top of the culvert, as well as water depth would be more similar to measurements recorded from the north end of the culvert.

The second location of sediment removal at the lower reaches of Spanish Bank Creek is at the culvert under the footbridge (*Figure 18*). Sediment removal will be conducted to increase the depth of water in the culvert to at least 0.23 m under low flow times of the year, as recommended by Dane (1978). For context, water depth at the culvert under the footbridge was 0.04 m on 3 March 2017.

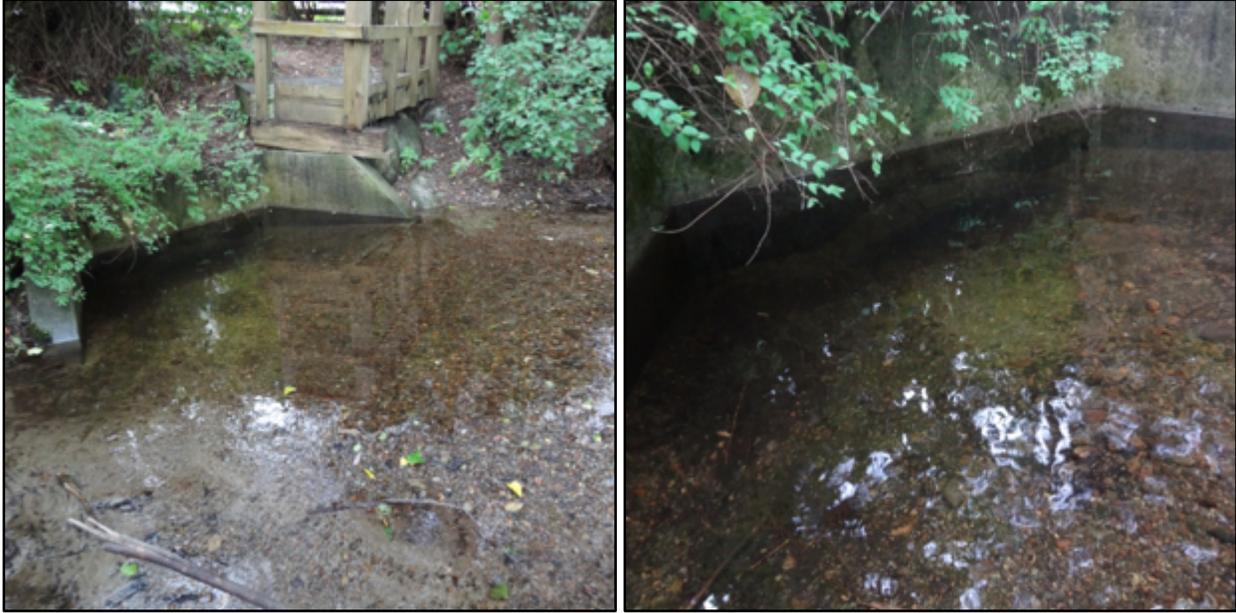
Approximately 20 m upstream from the concrete box culvert is a wood stave culvert that is 0.90 m in diameter and 20 m in length. This culvert extends under NW Marine Drive. The downstream (north) end of the culvert terminates at a pre-cast concrete headwall (*Figure 19*). Access to the culvert has been impeded by accretion of sediment. Measured on 16 March 2017, the height from the thalweg substrate to the top of the inside edge of the culvert was 0.40 m. This corresponds to 43% of the total cross-sectional area of the culvert that is passable by fish. This measurement assumes that the thalweg is a representative depth for all measurements along the profile of the substrate within the culvert. However, the thalweg typically scours into the substrate, resulting in deeper water depths compared to stream sections not within the thalweg. Therefore, it is probable that there is less than 43% of the total cross-section of the culvert that is passable by fish. If the culvert was installed to 1978 British Columbia culvert design guidelines (Dane, 1978) and the culvert was installed 0.31 m below grade, then 70% of the total cross-sectional area of the culvert was initially passable by fish. Compared to this design parameter, only 61% of the cross-sectional area of the culvert is now passable by fish.

Figure 19: A pre-cast concrete headwall was installed at Spanish Bank Creek. The pre-cast concrete headwall is located at the north end of the wood stave culvert that spans under NW Marine Drive (left). Accretion of sediment has filled in the lower reaches of Spanish Bank Creek, thereby impeding flow through the wood stave culvert (right; Reynolds, 2016).

Lastly, due to the greater stream velocities associated with winter precipitation events it is likely that some the sediment at the mouth of the culvert was washed out around the approximate time of measurement. Over the summer low-flow months, decreased stream velocities result in less tractive forces entraining and washing out sediments, thereby resulting in a potentially greater proportion of the culvert that is blocked by sediment. To fully understand how culverts with impeded flow respond to changing watershed conditions will require monitoring (*3.6.4 Culvert Metrics*).

There are three primary locations where sediment will be removed from the lower reaches of Spanish Bank Creek (*Figure 26*). The first location is just north of the pre-cast concrete headwall of the culvert that spans under NW Marine Drive, as seen in *Figure 19*. Removal of sediment will be conducted to increase water flow and fish passage through the culvert. On 16 March 2017, water depth in the thalweg of the north end of the culvert was 0.4 m. The culvert itself is 0.9 m in diameter. This indicates that sediment was blocking more than 50% of the cross-section of the culvert. It is likely that sediment will further block the culvert during summer low flow periods. As recommended by Dane (1978), water depth in culverts should be maintained above 0.23 m for fish passage. If sediment continues to accumulate at the lower reaches of Spanish Bank Creek, fish passage at this culvert could be further impeded. To ensure fish passage through this culvert, water depth along the substrate profile should be maintained at a depth greater than 0.45 m at the pre-cast concrete headwall.

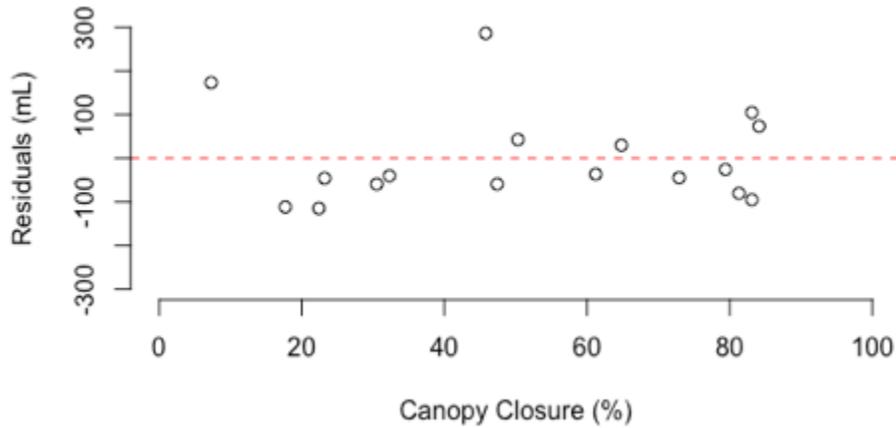
Mean canopy closure was 50% across all measurement sites with a range of 7 – 84%. Mean precipitation throughfall was 359 mL, with a range of 159 – 684 mL. Histograms indicate that residuals were approximately normally distributed, with no apparent heteroscedasticity (*Figure 20*). The p-value for the F-statistic was less than 0.05 (*Table 5*). Thus, the null hypothesis can be rejected. The calculated R^2 coefficient value was 0.4. These results indicate that the relationship between canopy closure and precipitation throughfall is significant, and that the linear regression model accounts for

Figure 20: A plot of residuals indicates that data is approximately normally distributed, with no apparent heteroscedasticity.

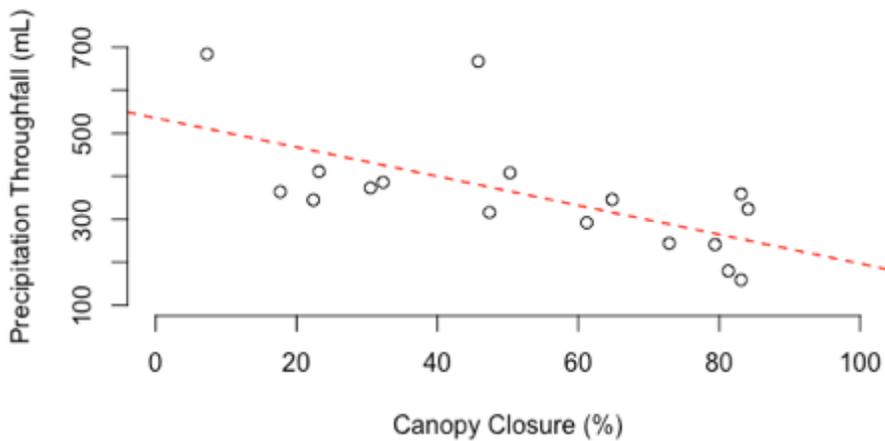
approximately 40% of the variability in the data. In addition, these results suggest a negative relationship between canopy closure and precipitation throughfall. As canopy closure increases, precipitation decreases (*Figure 21*).

Figure 21: A plot of the relationship between canopy closure and precipitation throughfall, as measured at the three locations, A, B, and C, in the watershed of Spanish Bank Creek.

This restoration treatment will be conducted in accordance with the objective to reduce *Hedera* in tree canopies throughout the watershed of Spanish Bank Creek. My research on the relationship between canopy closure and precipitation throughfall indicates that there is a negative relationship between canopy closure and precipitation throughfall in the watershed of Spanish Bank Creek. Reduction of *Hedera* from the canopies of trees throughout the watershed will mitigate the deleterious effects that *Hedera* has on native vegetation, thus increasing canopy closure of native tree species over time. As a result, this will decrease precipitation throughfall, and decrease rainsplash erosion due to a diminished rate of precipitation input that directly impacts the forest floor. In addition, a denser canopy results in greater slope stability (Keim and Skagset, 2003).

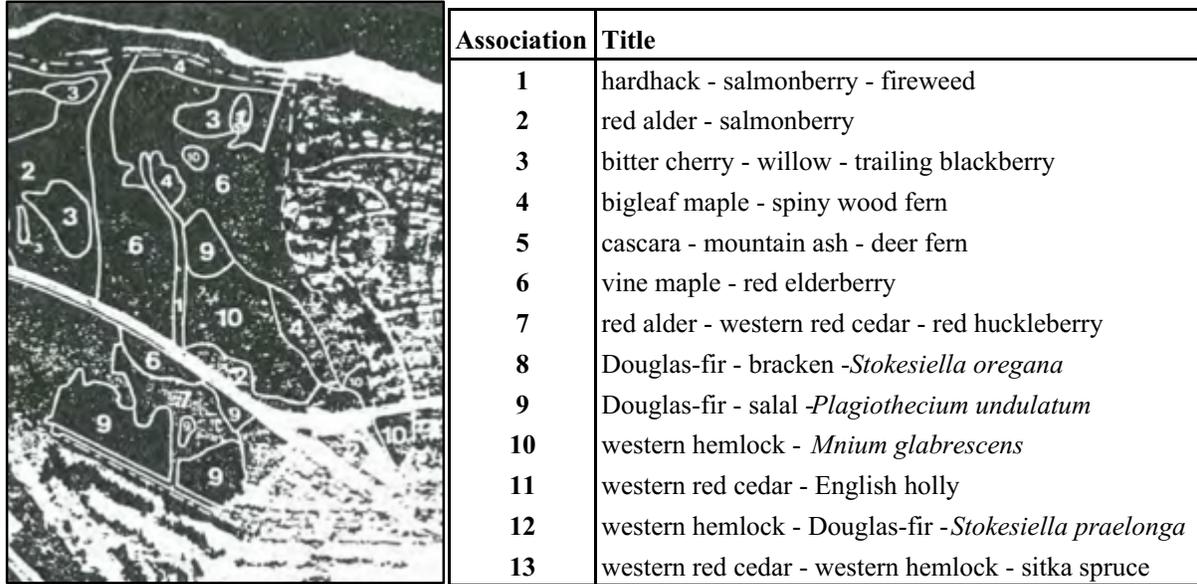
In 1983 and 1984, Thompson (1985) conducted field surveys throughout the PSRP to determine the vegetative associations within the park. Twenty associations were identified and mapped (*Figure 22*). The numbers 1 – 13 correspond to vegetative associations ranking from early succession to late succession.

Figure 22: Vegetation associations throughout the PSRP were mapped in 1982 and 1983 by Thompson (1985; left). Within the watershed of Spanish Bank Creek, these associations range from hardhack, salmonberry, and fireweed (1) to western hemlock, *Mnium glabrescens* (10; right; Thompson, 1985).

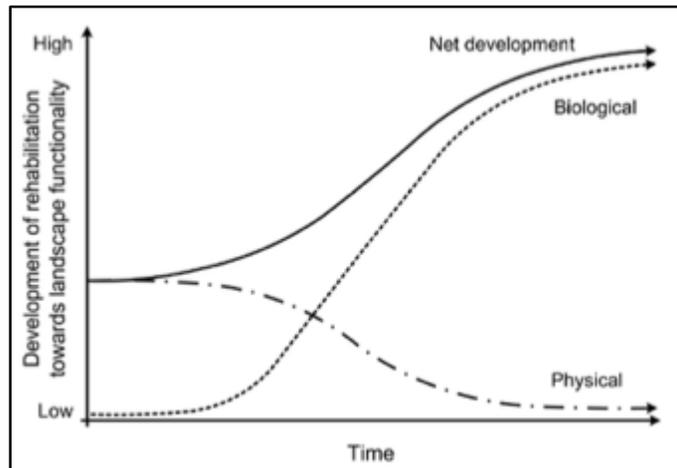
However, in conjunction with a resilient forest, vegetation in the watershed must be restored towards a self-replacing native composition. Successful restoration can be described as initial physical enhancement such that further restoration can be replaced by self-sustaining biological processes (Tongway and Ludwig, 2011; *Figure 23*). In

Figure 23: Restoration is often described as physical enhancement such that biological processes can eventually continue the restoration process (Tongway and Ludwig, 2011). Net ecological development continues after physical enhancement ceases.

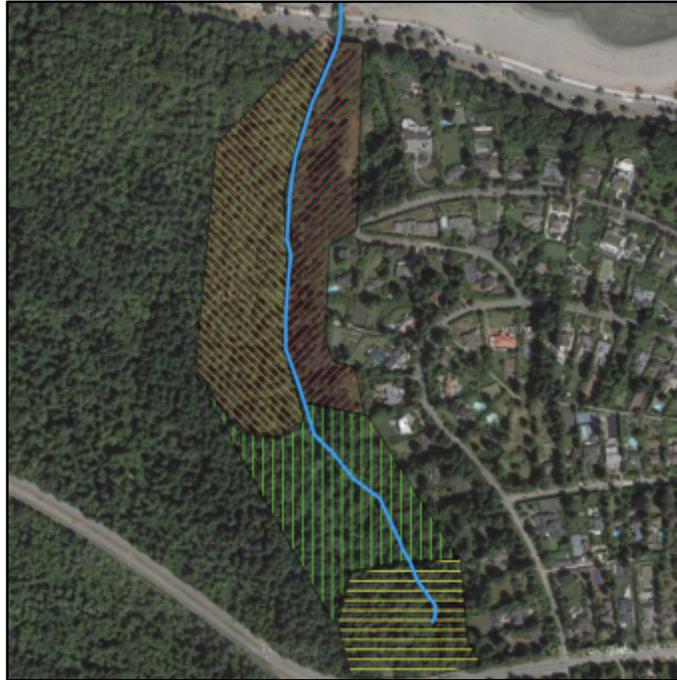
Specifically, reduction of *Hedera* from tree canopies will occur every year for five years, will target tree stands within and on the periphery of the ravine of Spanish Bank Creek (*Figure 24*). Ideally, every tree throughout the watershed of Spanish Bank Creek will be treated each year. However, this is unrealistic. Instead, this restoration treatment will occur every year, with the objective to treat every tree throughout the watershed of Spanish Bank Creek at least once by year five.

Figure 24: Priority treatment locations for removal of *Hedera* from the canopies of tree throughout the watershed of Spanish Bank Creek. The first priority is the red polygon that is approximately 4 ha. The second priority the orange polygon that is approximately 6.4 ha. The third priority is the yellow polygon that is approximately 3 ha. The last priority is the green polygon that is approximately 5.3 ha (QGIS Development Team, 2009).

Table 9: Metrics-of-success for the three phases of restoration treatments. Metrics-of-success will be assessed after one year, three years, and five years. For a map of the priority areas for severing climbing *Hedera* vines (*Figure 24*). Rates of live cutting survival range from < 30% survival to 100% survival based on a range of parameters (Goldsmith *et al.*, 2014).

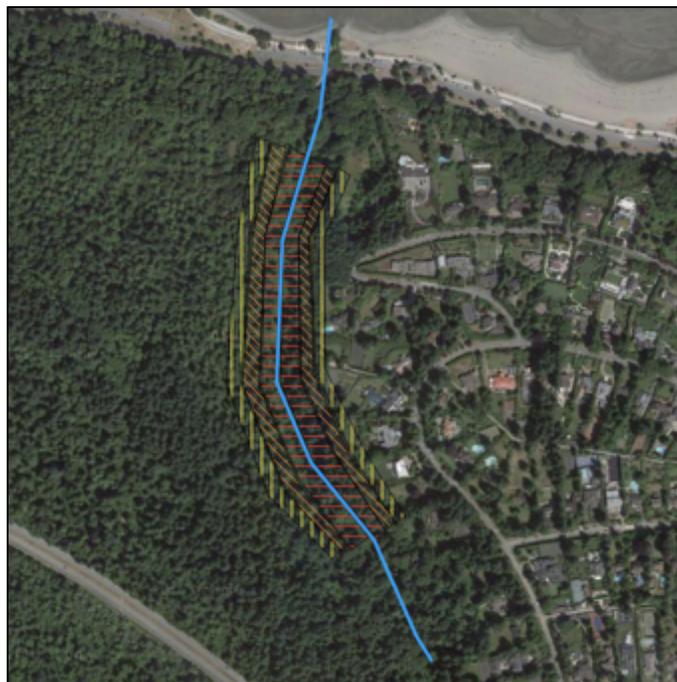
A total of 2,500 live cuttings will be required to complete all three soil bioengineering techniques at each of the 32 runoff inputs into Spanish Bank Creek and associated rills, gullies, and locations of runoff initiation (*Figure 25*). If *Salix spp.* and red-osier dogwood cannot be sourced, black cottonwood can be used for all the soil bioengineering techniques due to its ability to survive in a range of moisture conditions (Green and Klinka, 1994). The live cuttings should be soaked in water for 48 hours prior to installation, and should be planted immediately after removal from soaking (Hunolt *et*

Figure 25: Location within Spanish Bank Creek where the soil bioengineering techniques will be installed. Brush layers will be installed upslope (yellow polygon), live gully breaks will be installed midslope (orange polygon), and live stakes will be installed downslope (red polygon) along the edge of Spanish Bank Creek (QGIS Development Team, 2009).

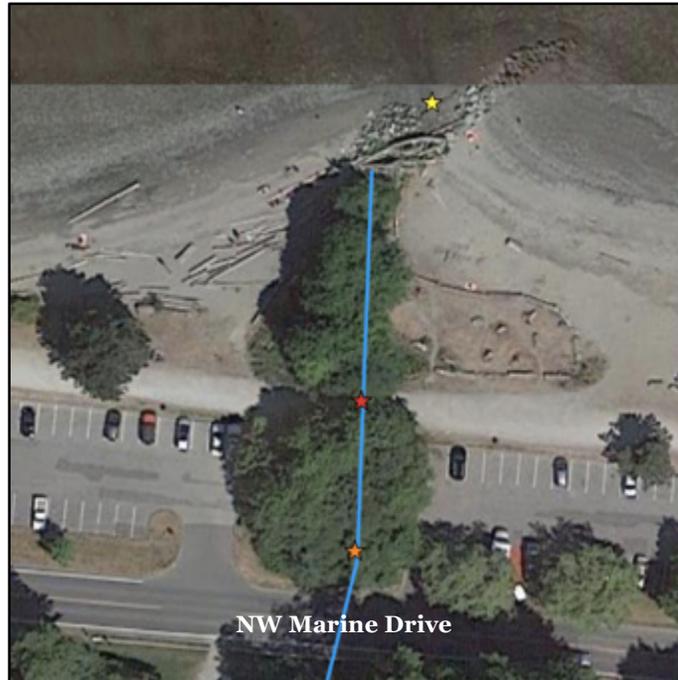
Figure 26: Locations of sediment removal for the lower reaches of Spanish Bank Creek. The first priority is the culvert under the footbridge (red star). The second priority is the pre-cast concrete headwall at the north end of the wood stave culvert (orange star), and the last priority is the mouth of Spanish Bank Creek to re-grade the lower reaches of Spanish Bank Creek (yellow star; QGIS Development Team, 2009).

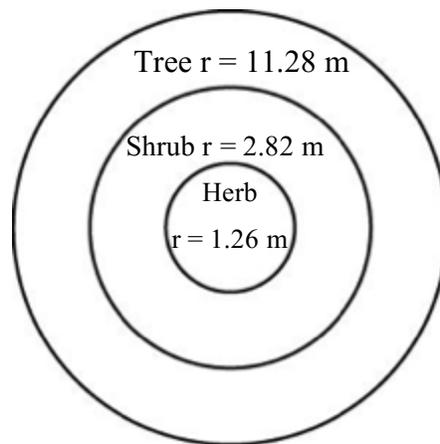
Figure 27: Variable-radius circular plots will be used to quantify vegetation composition at the tree, shrub, and herb layer throughout the watershed of Spanish Bank Creek. These surveys measure percent cover, as well as presence/not detected for vegetation species.

In accordance with reduction of *Hedera* cover from trees throughout the watershed of Spanish Bank Creek, as well as the use of soil bioengineering techniques to mitigate runoff, there will be a change in the vegetation assemblages in the watershed over time. To quantify these changes, variable-radius circular plots will be used. Variable-radius circular plots enable quantification of percent cover of vegetation at herb, shrub, and tree layers. A single survey at a point of interest consists of three concentric, nested circles (*Figure 27*). The largest circle is used to survey vegetation at the tree layer (> 10 m height), and has a radius of 11.28 m, which equals a survey area of 400 m². The medium-sized circle is used to survey vegetation at the shrub layer (< 10 m height, excluding herbaceous species), and has a radius of 2.82 m, which equals a survey area of 25 m². The smallest circle is used to survey vegetation at the herb layer (all herbaceous species, regardless of height), and has a radius of 1.26 m, which equals a survey area of 5 m². Cover mid-points will be used to mitigate bias in assessing percent cover of each species. Results of the vegetation plots will yield percent cover of each species as a function of area. Assuming that the transects and the locations of the vegetation plots along each of the transects are a representative sampling design, inferences about the composition of vegetation for the entire watershed can be made, and changes can be measured over time.
