**The effects of canopy closure on precipitation
throughfall: Ecological restoration considerations
for Spanish Bank Creek**

Project Submitted in Partial Fulfillment of the
Requirements for the Degree of
Master of Science

in the
Ecological Restoration Program

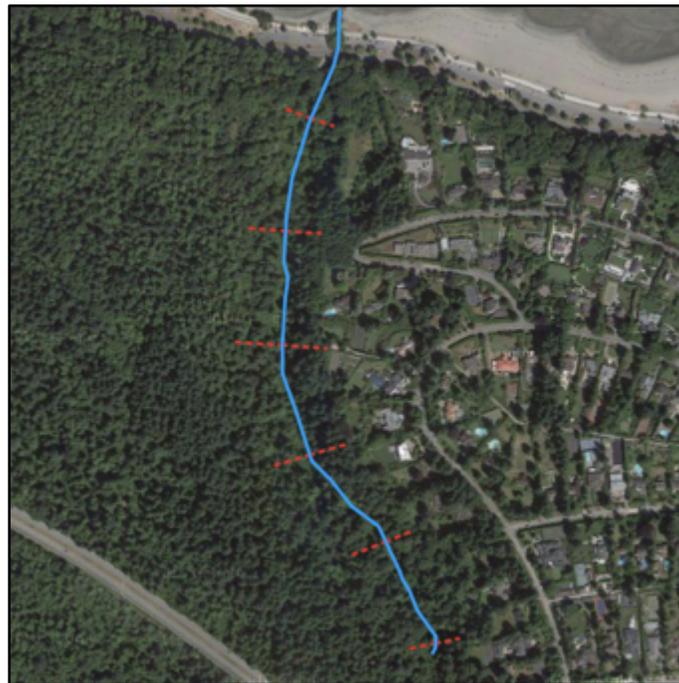
Figure 28: Variable-radius circular plots will be used to assess vegetation composition at a random location along each of the twelve transects, as represented by the red lines (QGIS Development Team, 2009).

A total of 12 variable-radius circular plots will be used to quantify changes in vegetation composition over time. Each of these plots will be conducted at a random distance along

each of the 12 transects that I used to assess vegetation throughout the watershed of Spanish Bank Creek (*Figure 28*). At each of the 12 variable-radius vegetation plots, surveyors will also record percent of trees that have had climbing *Hedera* vines severed around the tree stems. From this data, inferences can be made about the percent of trees that have been treated in each of the four priority areas of *Hedera* vine treatment (*Figure 24*; *3.5 Metrics-of-Success*). Variable-radius circular plots should be conducted once every year in the spring or summer, when vegetation is budding. This will facilitate accurate species identification.

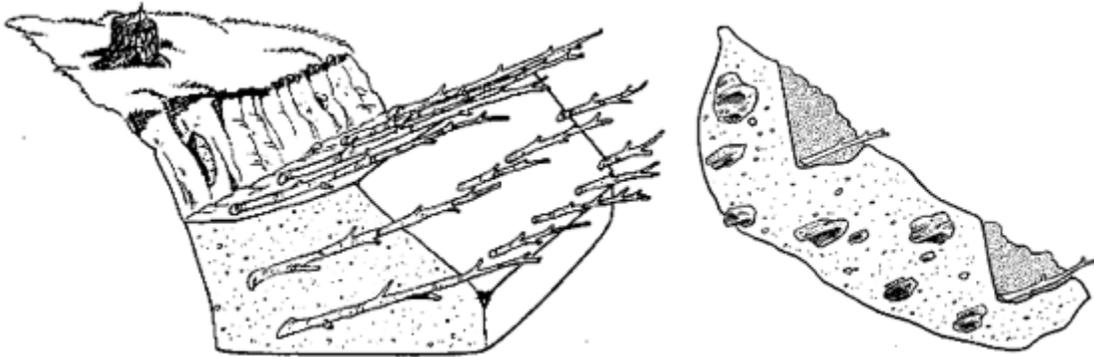
Brush Layer Installation Design (Polster, 2014).

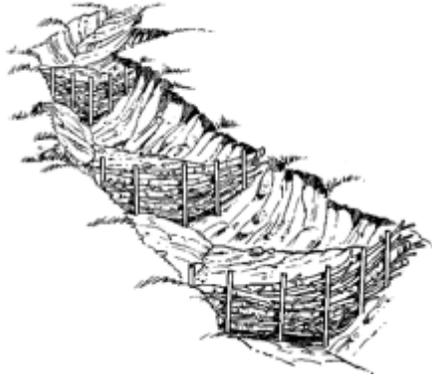
Live Gully Break Installation Design (Polster, 2014).

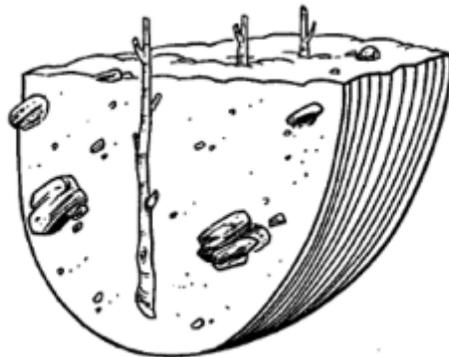
Live Staking Installation Design (Polster, 2014).
